Carter Ground Fueling

**SB017051147566
May 11, 2007**

UNIVERSAL (D3) SWIVEL JOINT FAILURE REPORTED

SAFETY BULLETIN

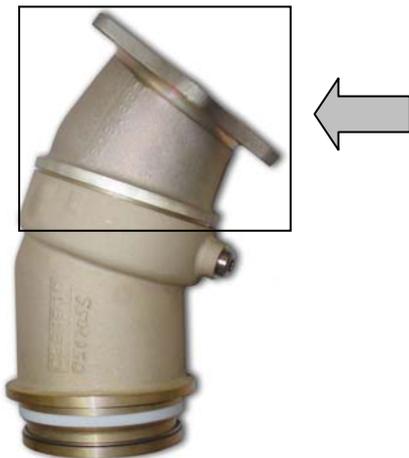
It has come to our attention that one fracture failure has occurred as the result of an accidental dropping of the nozzle assembly after the completion of a refueling. The distance of the drop was less than 3 feet and should not have resulted in a failure of this nature. Inspection of our inventory revealed that a combination of a casting problem and a machining problem provided for an uneven/thin wall thickness on the half that incorporated the MS33786-40 flange. The resulting wall thickness gives us cause for concern and all units presently in service need to be recalled and replaced.

See the picture below showing the half to be replaced.

Prior to the receipt of the replacement parts, we recommend a visual inspection of each Universal Swivel Joint before each use. Any crack or fracture noted in the area where the elbow meets the MS flange is cause for discontinued use. Additionally, operators are warned that rough handling or dropping of the nozzle and/or Universal Swivel Joint may lead to damage as reported above.

Carter will replace, free of charge, the flanged half of these Universal Swivel Joints in a kit with the necessary seals and a set of instructions outlining how to remove and replace the suspect part. New parts will be marked "Rev. B", so if your inspection does not show this mark, they need to be replaced.

The repair will take only a few minutes and it can be completed with simple hand tools. The entire repair will take less than 15 minutes. To get the "no charge" replacement parts please provide your local Carter Distributor with the serial number of the nozzle assembly on which it is installed and order one each of part number KD47558 for everyone you have to replace.
