Carter Ground Fueling

**APPLICABLE TO UNIVERSAL (D3) SWIVEL JOINTS FOR
UNDERWING FUELING NOZZLES PART NUMBERS:**

**SB017051147566
May 11, 2007**

UNIVERSAL (D3) SWIVEL JOINT FAILURE REPORTED

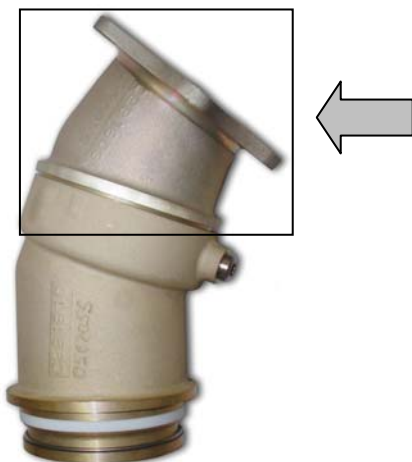
It has come to our attention that one fracture failure has occurred as the result of an accidental dropping of the nozzle assembly after the completion of a refueling. The distance of the drop was less than 3 feet and should not have resulted in a failure of this nature. Inspection of our inventory revealed that a combination of a casting problem and a machining problem provided for an uneven/thin wall thickness on the half that incorporated the MS33786-40 flange. The resulting wall thickness gives us cause for concern and all units presently in service need to be recalled and replaced.

See the picture below showing the half to be replaced.

Carter will replace, free of charge, the flanged half of these Universal Swivel Joints in a kit with the necessary seals and a set of instructions outlining how to remove and replace the suspect part. New parts will be marked "Rev. B", so if your inspection does not show this mark, they need to be replaced.

Prior to the receipt of the replacement parts, we recommend a visual inspection of each Universal Swivel Joint before each use. Any crack or fracture noted in the area where the elbow meets the MS flange is cause for discontinued use. Additionally, operators are warned that rough handling or dropping of the nozzle and/or Universal Swivel Joint may lead to damage as reported above.
