# Service BULLETIN

APPLICABLE TO 64348, 64349 & 64049  
NOZZLES AS OUTLINED BELOW

SB3480801A  
Nov. 1, 1998

## REVISION TO AUGUST 1, 1998 BULLETIN! NEW TWO-PIECE HANDLE BREAKAGE REPORTED

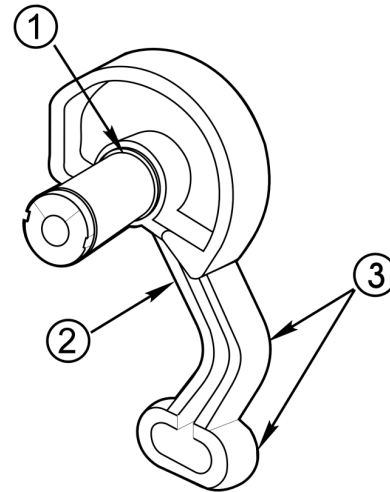
**FIGURE 1**

It has been reported that several of the newer 220878-1 handles have been broken on nozzles installed on hose reel applications. Reports of leakage from the handle shaft area were initial signs of breakage. Reports of the single screw coming loose were also signs of the breakage. The handle is an integral part of the nozzle interlock system. The breakage, result of mishandling (dropping), has occurred at a machined radius area "1", as shown in Figure 1 on the next page. If not detected, further use can cause

the handle to loosen and overcome the interlock system. The result can then be a possible spill since it can then be possible for the operator to take the nozzle off of the aircraft with the nozzle poppet in the open position. The breakage has been the result of impact on the handle in the areas marked with a "3", Figure 1. The handle first bends until it contacts the carrying handle or sometimes the bolt head attachment of it. The bolt head impact results in an impression in the handle and produces a stress riser in the area marked "2" which may result in the handle breaking at that point. This is a maintenance problem but not a safety issue. Further impacts in the areas marked "2" and "3" can result in the fracture at "1" which is the object of this bulletin. All operators should be provided the following information (instructions) to prevent spills and possible bodily injury from spilled fuel:

1. **No nozzles, to our knowledge, have had a handle breakage problem where they are installed on a deck type application; hence dropping is a major contributor to the problem. Even though it has been done in the past, another caution not to drop the nozzle should be extended to the operators.**
2. **If fuel leakage, no matter how slight, appears from the area of the operating handle do not use the nozzle. Take it out of service immediately. Inspect the handle for evidence of a crack at "1". It may start out as a very minute crack and may be difficult to see with the eye. Replace the handle if not certain.**

**If the handle or attaching screw appear to be loose, DO NOT ATTEMPT TO TIGHTEN THE SCREW, you will only cause the insert in the crank to be damaged. Remove the nozzle from service immediately.**
