Service BULLETIN

APPLICABLE TO 64348, 64349 & 64049
NOZZLES AS OUTLINED BELOW

SB3480801A
Nov. 1, 1998

REVISION TO AUGUST 1, 1998 BULLETIN! NEW TWO-PIECE HANDLE BREAKAGE REPORTED

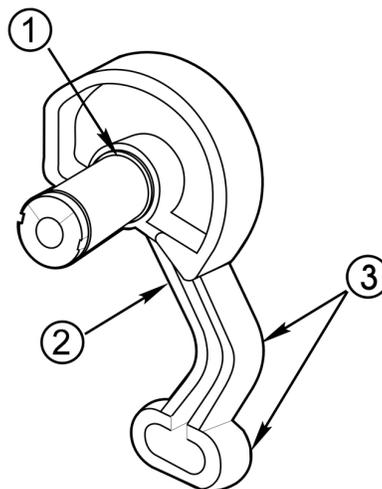
FIGURE 1

It has been reported that several of the newer 220878-1 handles have been broken on nozzles installed on hose reel applications. Reports of leakage from the handle shaft area were initial signs of breakage. Reports of the single screw coming loose were also signs of the breakage. The handle is an integral part of the nozzle interlock system. The breakage, result of mishandling (dropping), has occurred at a machined radius area “1”, as shown in Figure 1 on the next page. If not detected, further use can cause

the handle to loosen and overcome the interlock system. The result can then be a possible spill since it can then be possible for the operator to take the nozzle off of the aircraft with the nozzle poppet in the open position. The breakage has been the result of impact on the handle in the areas marked with a “3”, Figure 1. The handle first bends until it contacts the carrying handle or sometimes the bolt head attachment of it. The bolt head impact results in an impression in the handle and produces a stress riser in the area marked “2” which may result in the handle breaking at that point. This is a maintenance problem but not a safety issue. Further impacts in the areas marked “2” and “3” can result in the fracture at “1” which is the object of this bulletin. All operators should be provided the following information (instructions) to prevent spills and possible bodily injury from spilled fuel:

1. **No nozzles, to our knowledge, have had a handle breakage problem where they are installed on a deck type application; hence dropping is a major contributor to the problem. Even though it has been done in the past, another caution not to drop the nozzle should be extended to the operators.**
2. **If fuel leakage, no matter how slight, appears from the area of the operating handle do not use the nozzle. Take it out of service immediately. Inspect the handle for evidence of a crack at “1”. It may start out as a very minute crack and may be difficult to see with the eye. Replace the handle if not certain.**

If the handle or attaching screw appear to be loose, DO NOT ATTEMPT TO TIGHTEN THE SCREW, you will only cause the insert in the crank to be damaged. Remove the nozzle from service immediately.

The design of the handle does not allow for any other type of manufacturing (within cost limits) than die-casting. The material of all three types of handles, although much stronger than an aluminum die casting, has minimum ductile properties (properties that allow bending rather than breakage). The solution to the problem therefore is to change to a more ductile material that will allow for severe bending but no breakage within the physical limits of the geometry of the handle installation. This will prevent the potential spills now apparently possible. When the handle is bend beyond use (and does not break) then it will have to be replaced. Preventing the operator from dropping the nozzle will minimize the maintenance costs greatly. If a hose end regulator is also used then the installation of a drag ring will also prevent the handle from being damaged. Ask your Carter distributor for more information on this possibility. The drag ring, as it is apply named, is a sacrificial part that prevents wear from dragging the nozzle while rewinding the hose reel.

The new more ductile material will be available shortly. It will easily be identified since it will be black in color in lieu of the normal gray aluminum color of the existing one. The part number will remain the same and all future production nozzles will be fitted with the new handle. Return any broken handles (in the area marked “1” only) to your Carter distributor for a free replacement kit to upgrade the nozzle. Replacement kits, KD64349-12, will be used to replace the broken handles. The kit will contain the parts needed to replace the handle and attaching parts only. All future orders for 220878-1 Handles will be filled with the newer material.
