**APPLICABLE TO ALL CARTER API STYLE
HYDRANT COUPLERS***

PN700092705
Revised May 26, 2006

EXCESSIVE WEAR CAN CAUSE COUPLER EJECTION

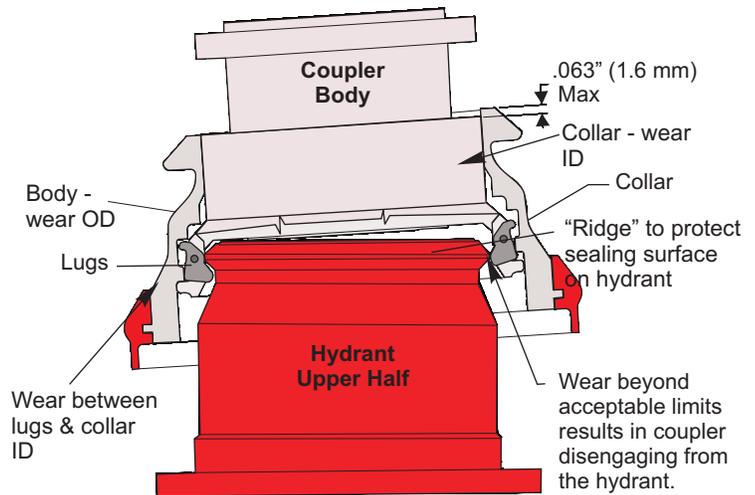
FIGURE 1 - RESULTS OF WEAR ON COUPLER/HYDANT INTERFACE

- The internal wear mainly between the collar and the lower housing was found to be extreme. A closer investigation into this situation was conducted to determine the results of the wear on these internal surfaces and also to aid in the development of additional inspection tests that can be recommended to determine the end of the useful life of the coupler components. The latching lug wear was less severe, indicating that the lugs may have been replaced (possibly several times) during earlier overhauls.

Figure 1 (top right) shows the results of an excessively worn Coupler and how the collar shifted from the centerline and rotated around the lugs directly opposite the operating handle. The surface where the collar ID contacts the coupler body OD must be excessively worn for this to occur. This rotation results in the Collar lifting on one side (directly opposite the operating handle) .100 of an inch (2.5 mm) or more when the coupler is pressurized. When the Collar is lifted, the latching lugs become partially unsupported and the lugs start rotating toward the disengaged position. The lugs are made of 7075-T6 aluminum with an ultimate strength of 83,000 psi, and the collar is a casting made of 356-T6 aluminum with an ultimate strength of 30,000 psi. As pressure increases the lugs (being stronger) rotate and deform the internal ring in the collar until the collar is lifted to the full disengaged position and the coupler separates from the hydrant valve.

RECOMMENDATION The following procedure should be incorporated into your maintenance program for all Carter Couplers (regardless of Coupler part number) and Hydrant Valves made to API/IP 1584 Specification:

1. Periodically use the 60554ST1 Gauge on all API style hydrant valves to determine whether the interface configuration is within acceptable wear limits. See the appropriate service manuals for instructions on its use. If the hydrant valve fails the 60554ST1 wear test, then the upper housing or replaceable API ring must be replaced.

2. DO NOT resurface or machine any of the surfaces on the interfaces on either the hydrant valve or the coupler. Removing material from these parts will increase clearances within the coupler/hydrant valve interface and make it more likely to result in a coupler ejection.

3. Periodically inspect all Carter Couplers for wear limits, as determined by the user. (Please note that the couplers that separated from the hydrant valves were over ten (10) years old and were excessively worn.) Quarterly inspections should be more than sufficient to identify possible problems well before the coupler wears beyond the safe useable limits.

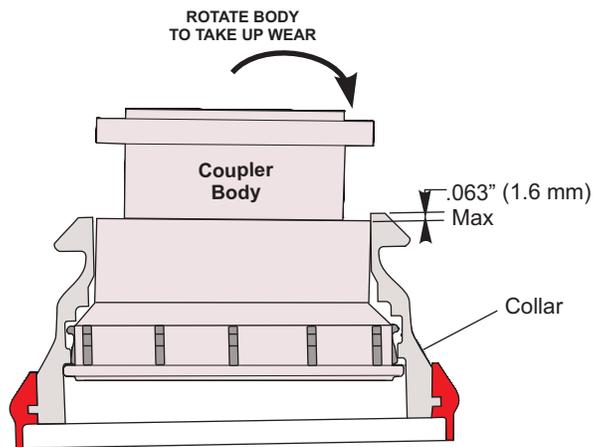
FIGURE 2 - INSPECTION PROCEDURE

B. See Figure 2. Using hands only (no tools), push down on one side of the collar to hold it stationary relative to the coupler body, while simultaneously lifting firmly upward from beneath the collar on the coupler's opposite side. This action takes up the clearance between the housing and collar. If these components are worn, this will result in the top of the collar lifting away from the coupler housing, which normally is flush with the collar. Take note of the offset of the collar relative to the housing (directly opposite the operating handle). Refer to Figure 2, and if the offset exceeds .063 inch (1.6 mm), the coupler has too much wear for continued use. On a new coupler these surfaces would be flush or the housing would be slightly proud of the collar by approximately .025 inch (.6 mm) due to manufacturing tolerances.

A. Install the coupler to be tested onto a non-pressurized API/IP 1584 adapter that is within allowable wear limits (see Figure 1 above). Ensure that the collar has dropped completely into the engaged position. It is not necessary or recommended to open the poppet; however, if the coupler is pressurized or is full of fuel, this should be done over a basin to catch any fuel that may spill. Opening the poppet removes the capability to rotate the parts relative to each other. This test may require the participation of two people to achieve an accurate measurement.

C. If the coupler is within the above acceptable limits, then use the 61362 Gauge to complete the additional wear checks on the latching lugs. These checks will indicate wear on the individual latching lugs when the new gauge is used in accordance with the Service Manual or our Product News PN900051505.

D. If a lower coupler half fails the "lift test" outlined in A. thru C. above, it can be disassembled and inspected and maybe one of the two components may be reused with a new mating part, as long as the "lift test" is repeated following the assembly and it passes the limits set forth above.
