**APPLICABLE TO ALL CARTER API STYLE
HYDRANT COUPLERS***

PN700092705
Revised May 26, 2006

EXCESSIVE WEAR CAN CAUSE COUPLER EJECTION

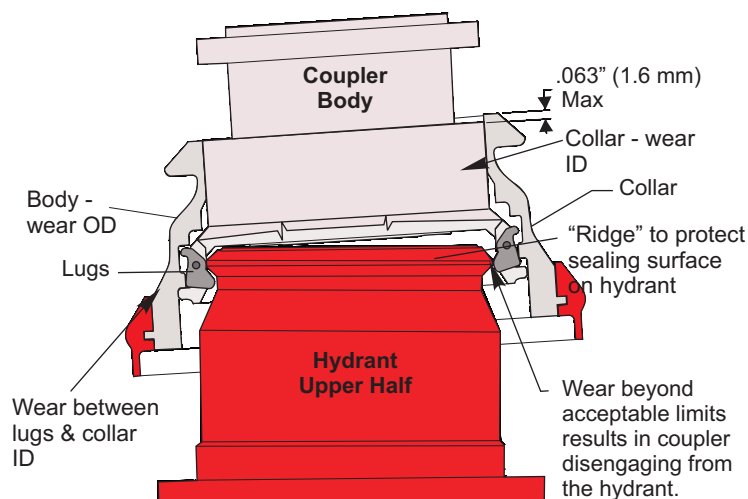
FIGURE 1 - RESULTS OF WEAR ON COUPLER/HYDANT INTERFACE

- The internal wear mainly between the collar and the lower housing was found to be extreme. A closer investigation into this situation was conducted to determine the results of the wear on these internal surfaces and also to aid in the development of additional inspection tests that can be recommended to determine the end of the useful life of the coupler components. The latching lug wear was less severe, indicating that the lugs may have been replaced (possibly several times) during earlier overhauls.

Figure 1 (top right) shows the results of an excessively worn Coupler and how the collar shifted from the centerline and rotated around the lugs directly opposite the operating handle. The surface where the collar ID contacts the coupler body OD must be excessively worn for this to occur. This rotation results in the Collar lifting on one side (directly opposite the operating handle) .100 of an inch (2.5 mm) or more when the coupler is pressurized. When the Collar is lifted, the latching lugs become partially unsupported and the lugs start rotating toward the disengaged position. The lugs are made of 7075-T6 aluminum with an ultimate strength of 83,000 psi, and the collar is a casting made of 356-T6 aluminum with an ultimate strength of 30,000 psi. As pressure increases the lugs (being stronger) rotate and deform the internal ring in the collar until the collar is lifted to the full disengaged position and the coupler separates from the hydrant valve.

2. DO NOT resurface or machine any of the surfaces on the interfaces on either the hydrant valve or the coupler. Removing material from these parts will increase clearances within the coupler/hydrant valve interface and make it more likely to result in a coupler ejection.
