MEDIUM VOLTAGE REDUCED VOLTAGE AUTOTRANSFORMER STARTER FAILURES – EXPLAINING THE UNEXPLAINED –

Abstract- For the past century the Autotransformer, or “Korndorfer” Starter has been a standard in the electrical industry. However for more than the past thirty years the autotransformer starter has been experiencing unexplained “High Voltage Stress” failures in typical applications. These failures have been reported on 2,400-volt starters from South America to 11,000-volt starters in the North Sea. In most cases the Zero Tap or the turns close to the zero tap are involved in the failure. This paper discusses the failure mode and the corrective action that prevents “High Voltage Stress” failures.

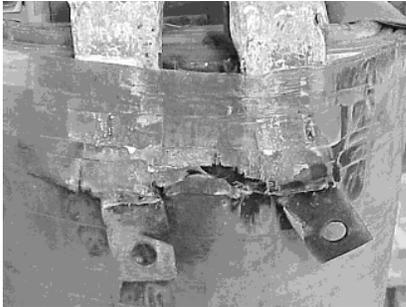
Fig. 2. Tap-to-Tap Strike

This transformer, shown in Fig 2, failed from the 0% tap to the 50% tap underneath the tape. The distance was 3.1 cm (1.25 in). This configuration withstood a 60 sec 20kV power frequency dielectric test.

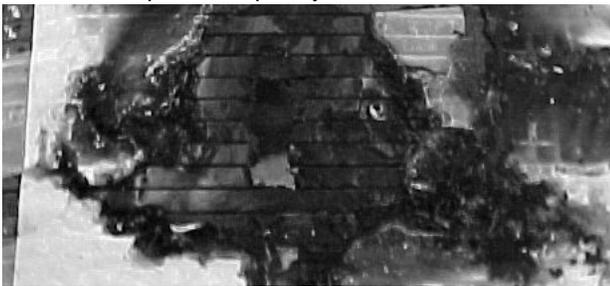
Fig. 3. Layer-to-Layer Failure Point

This transformer failed layer-to-layer through two layers of .178 mm (.007 in) 410 Nomex. This configuration withstood a 60 sec 14 kV power frequency dielectric test.

Studies of these failures indicated a common thread: forced-transition on 4,160-volt autotransformers connected to the 80% tap.

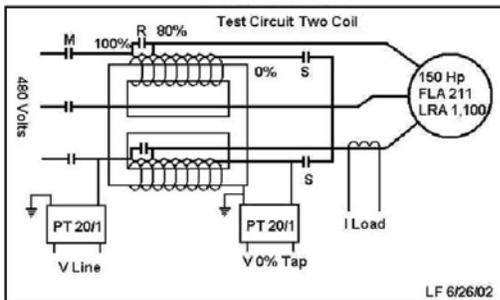
Fig 4. Two-coil, three-legged Autotransformer

Two-coil, three-legged: The test program found that during forced transitions and when connected to the 80% tap, the 0% taps voltage rose as high as 1,270% of the line-to-line voltage. These peaks appeared twice each cycle while the “S” and “R” contactor were open.

Inferences: As a result of this test program, the two-coil design was no longer offered as standard. The control circuit was changed to require transition on current and trip on time-out if the current had not dropped below 125 % of FLA.

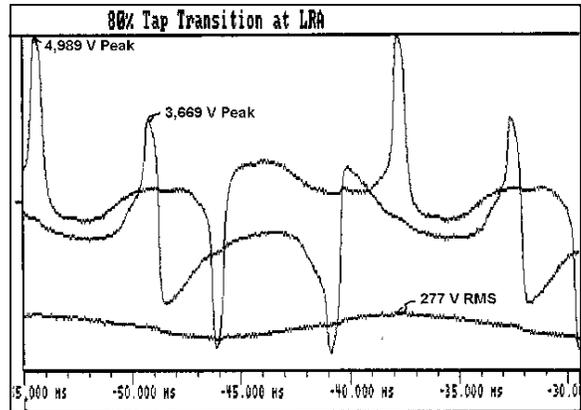
Fig. 5. Tap Voltages During Forced Transition

The voltages Fig 5 were recorded when the transformer was connected on the 80% tap with the transition taking place some 0.3 sec into a 4 sec acceleration cycle. The curves were recorded after the “S” contactor was opened and before the “R” contactor was closed.

When the motor was allowed to accelerate so the motor current decreased to 75% FLA, the voltage was only 2.6 pu voltage above normal.

When the same tests were run on the 65% tap, the voltage escalation was only 6.0 pu voltage rise above line-to-neutral voltage.

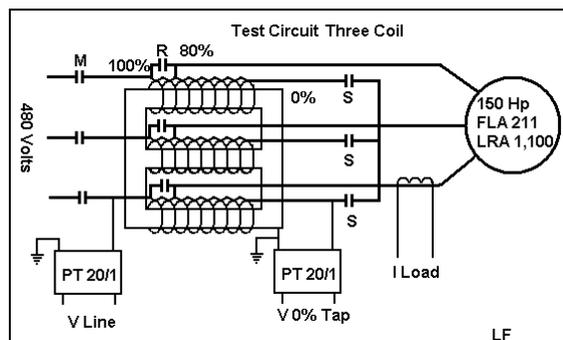
Fig. 6. Three coil Three Legged Autotransformer

Three Coil Three Legged: The same tests were run with a three-coil, three-legged transformer Fig. 6. and the voltage on the zero taps was less than a 2.0 pu Fig. 7. at locked rotor.

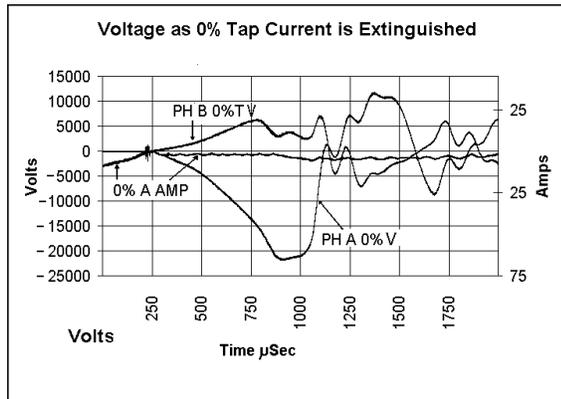
Fig. 10. Tap Voltage When Tap Current is Extinguished

Case where the VI did not restrike: This test, shown in Fig.10, is where the current in phase "A" coil went to zero (at 200 μ Sec) when the VI extinguished the coil current. The VI did not restrike and the voltage across the coil escalated to 23,000 V and the voltage across the VI peaked at 25,000 V.

The flux in phase "A" core leg was zero and the voltage develops as phase "A" core leg is saturating.

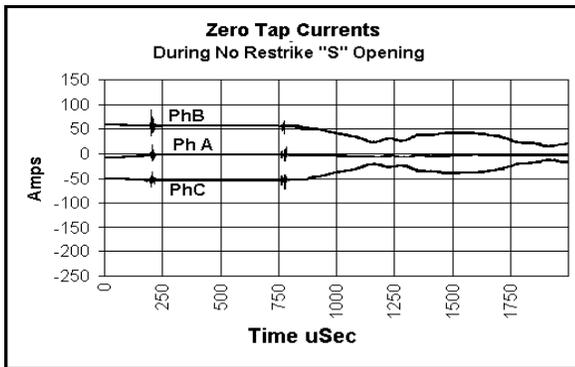
Fig.11. Tap Currents After One is Extinguished

The other two zero tap currents remained constant while the phase "A" core leg is saturating.

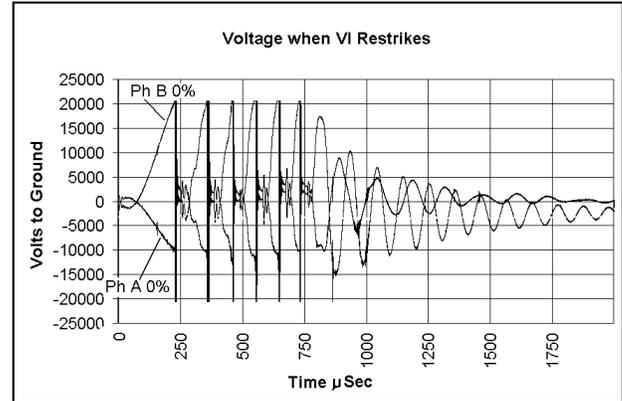
Fig.12. Voltage Across VI's When a VI Restrikes

Case where the VI did restrike: This test, shown below, is where the current in phase "B" coil extinguished. The voltage across the VI went to 30,000 volts and arced across the open contacts. When the voltage across the coil collapsed, there were oscillations of unknown magnitude and frequency. This High dV/dT occurred six times until the core finally saturated.

David L Swindler [5], in his paper on Switching Resonance, estimates that, at this high dV/dT, inter-layer voltage escalation occurs in the order of 5 and 50 times normal layer-to-layer voltages.

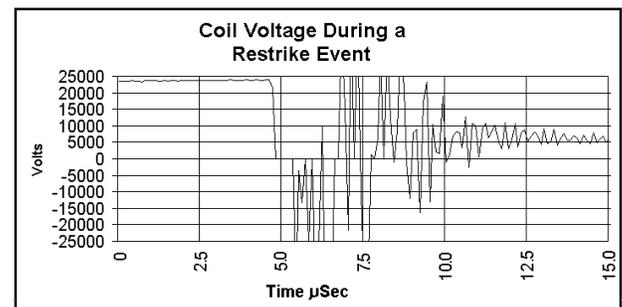
Fig. 13. Coil Voltage During A Restrike Event.

Detailed look at a Restrike Event: When the VI struck (Fig. 13), the voltage change across the coil occurred in 0.3 μ Sec or less. This is a 50-70 kV per μ Sec event. The resonant frequency was estimated to be between 2 and 3 MHz.

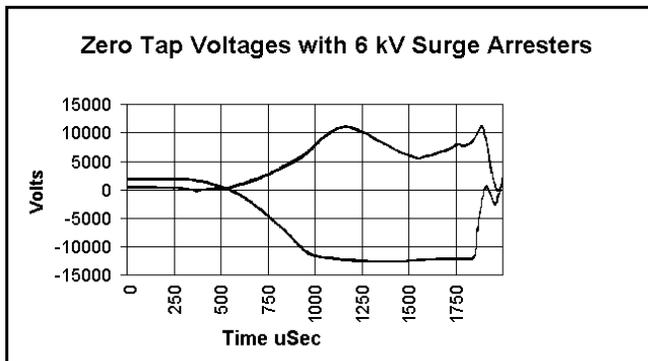
Fig.14. Tap Voltage With Surge Arresters

Solution: When 6 kV distribution surge arresters were installed from the 0% tap to ground, the voltage (Fig.14). was clamped to 13kV without the resultant high dV/dT across the coil. These voltages were observed only once during each motor start.

The current flowing in the surge arrestors was measured at 12-18 amps for 800 microseconds, which is well within the rating of distribution arrestors.
