A Journey Toward Electrical Workplace Safety and Production Reliability

Abstract -- This paper outlines the experience of one global cement producer that embarked on site surveys and studies to achieve arc flash safety compliance at 13 cement plants in the U.S. and Canada. The enterprise wide electrical workplace safety initiative resulted in compliance by all plant sites to the latest standards, with new labels affixed to each openable electrical panel that quantified the hazard. Labels designated the proper personal protective equipment (PPE) required to ensure electricians performing energized work would be safe from potential arc events. The experience of one plant in deploying select new technologies to mitigate arc flash in areas where hazards were very high will be reviewed in detail. Site electrical upgrades resulted in enhanced safety along with an unexpected benefit; a significant improvement in production reliability. A follow-up project to increase the plant grinding capacity at the site outlines how new additions to the electrical infrastructure employed a “safety by design” approach to ensure arc flash safety.

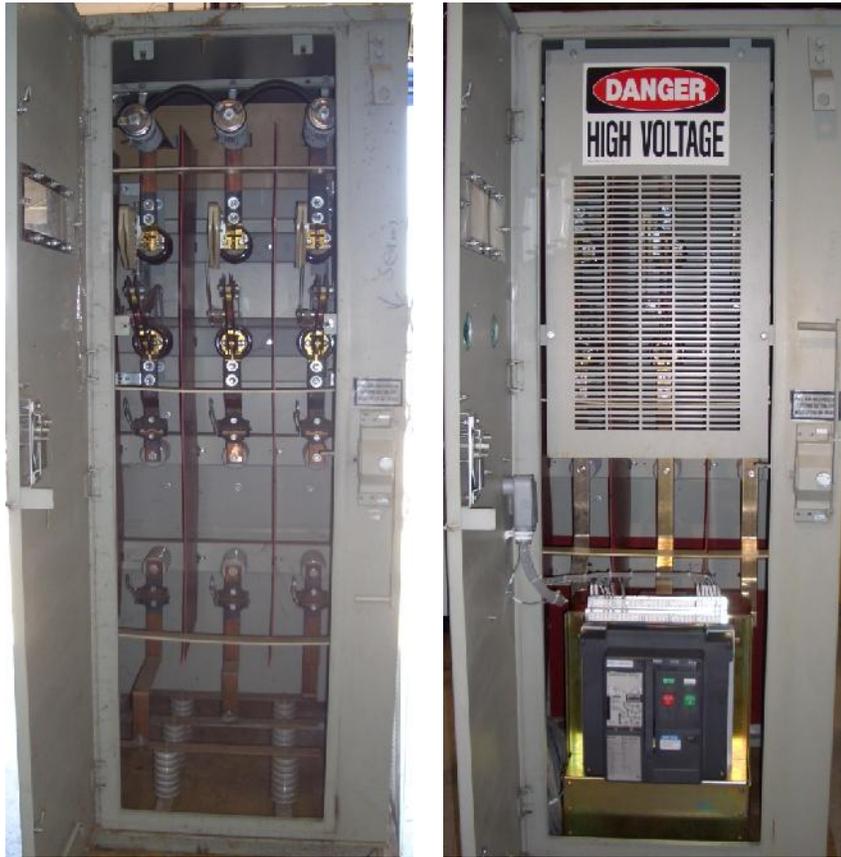
Fig. 3. Above left is a photo of the existing primary fused load-break primary switch for each substation with the fuse holders still in place. Above right is modified assembly after modification, with fixed mounted mini-vacuum circuit

In all 10 identified high hazard substations, a decision was made to pursue the recommended solution included in the original arc flash study. The primary medium-voltage fuse in a fused load-break switch assembly was retrofitted with a high performance vacuum breaker as shown in Fig. 3. This approach has been successfully implemented in other process industry applications [5] with proven success. Adding this functionality, along with updated electronic protective relays, offered enhanced protection and device clearing times that reduced the substation secondary bus arc flash energy from levels that topped out at over 100 cal/cm² to levels ranging between 5.8 and 35.7 cal/cm². The arc flash incident energy available for downstream low-voltage switchgear was further reduced by the addition of a primary and secondary bus overcurrent protective relay equipped with an “arc flash reduction maintenance switch”. This allowed electricians to set the feeder circuit breaker to a fast tripping maintenance setting prior to performing energized work in downstream electrical equipment. In select low-voltage switchgear of the same critical substations, existing 600V main circuit breakers were also equipped with the arc flash maintenance switch to reduce the arc flash energy for downstream low-voltage motor control centers.

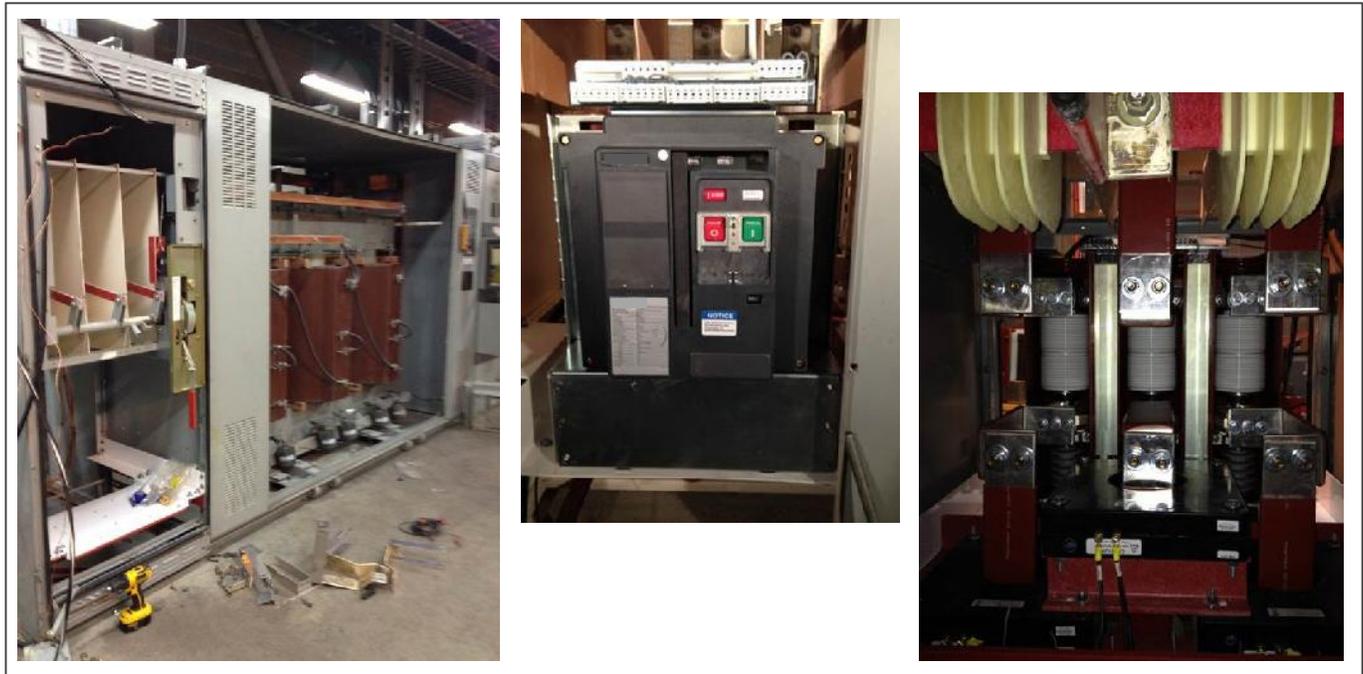
Fig. 4. Existing primary switch at left, retrofitted with new vacuum circuit breaker at center and current transformers at the rear of the breaker at right.

The project work commenced in mid-2014 and was completed on time and within the proposed budget. Photos in Fig. 4 show one of the 10 substations in the process of being upgraded during the scheduled outage. The image at the left shows the 4160V existing primary fused load-break switch structure with the existing dry type transformer. The fuse elements have been removed and the lower compartment in the structure was then up-fitted to accommodate the new fixed mounted vacuum circuit breaker. The center image shows the new circuit breaker mounted in the existing structure. Secondary control terminals above the breaker are shown along with a breaker open/close controls on the face of the breaker. The device can be mechanically charged via the lever at the left of the breaker controls but in this case the device was supplied as electrically operated so a charging motor was included. At the right is an image of the rear of the vacuum breaker showing new current transformers installed at the load terminals.

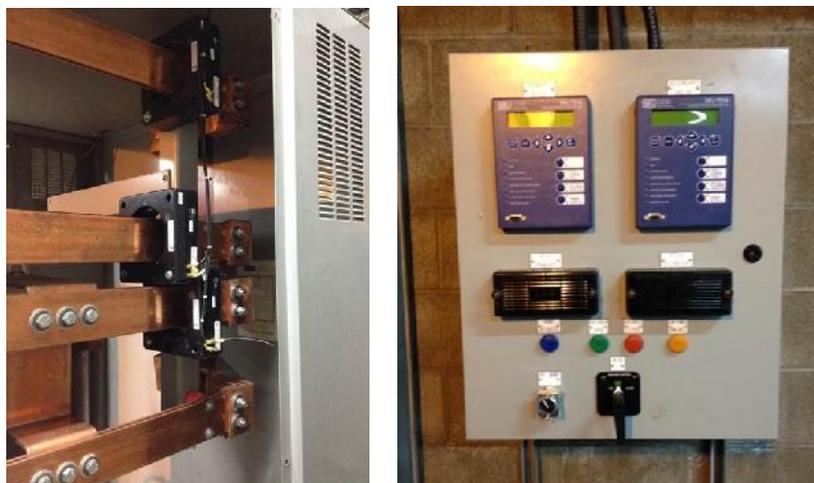
Fig. 5. Transformer secondary bus with new current transformers at left, new protective relay cabinet at right.

The image at the left in Fig. 5 shows the transformer secondary bus with new current transformers that were added for secondary bus protection. New primary and secondary current transformers were wired to the new protective relay cabinet shown at the right. Note the new relay cabinet includes a breaker control switch at the lower section. This is used to

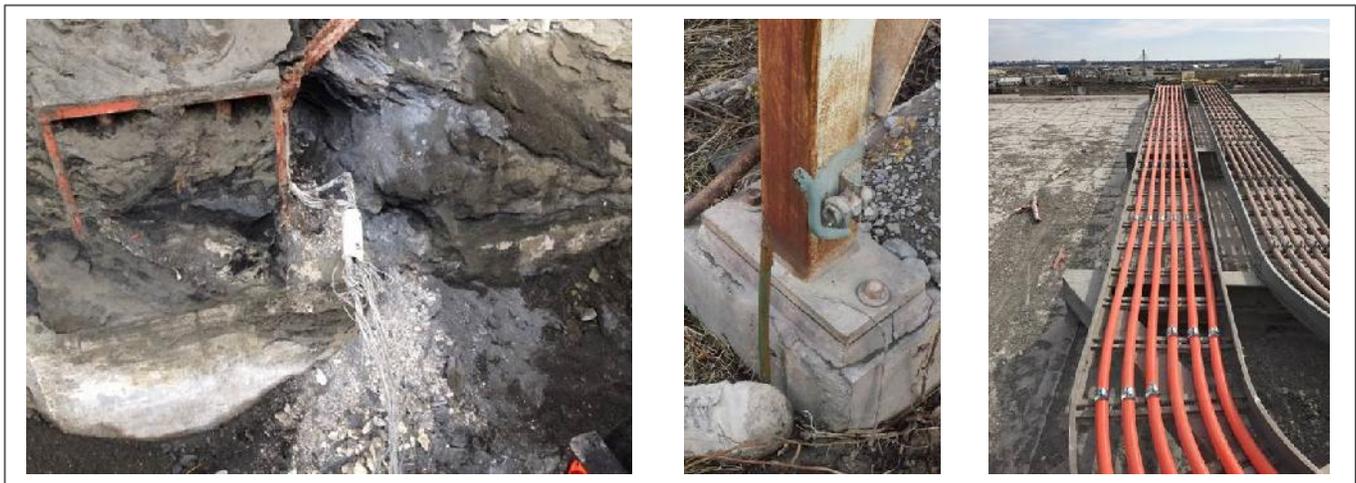
As discussed in [6] and [7], the installation and maintenance of the ground grid is the single most important structure of any electrical installation. A faulty or non-existent ground grid can produce lethal step and touch voltages to personnel, cause destructive damage to equipment (electrical and mechanical) and contribute to costly down time. Low impedance is the key to electrical equipment protection. An operating plant should have a maximum ground impedance (resistance) of 1 to 2 ohms. Testing throughout the plant site revealed ground impedance at 100 to 120 ohms of resistance – extremely high levels with step potentials that could potentially cause serious personnel injury and equipment damage. Existing ground cable and ground rods at various locations throughout the plant site were unearthed, revealing that several 4/0 ground cable and rods were either severely damaged or heavily oxidized. Several incidents of premature motor failure, nuisance ground faults, instruments faulting on calibrations, etc. had been experienced. Repairs were implemented, including adding 1,800 feet of 4/0 bare ground cable and installing 200 ground rods to protect each low-voltage motor control center (MCC). After the upgrades, a TIME versus VOLTAGE chart dropped from a worst-case 127V to 10-12V. Plus, nuisance “ghost” trips of larger motors – which had resulted in the plant shutting down – almost immediately stopped. In addition, flash-overs to the PLC racks, instruments, and MCCs subsided; dangerous “sheath currents” on cables were dramatically reduced; and “ground fault” trips on larger motors were significantly reduced.

Investigation of medium voltage cables installed at the plant revealed areas where cables were nearing imminent failure. Critical polyethylene insulation plant cables were showing signs of water tree aging [8]. Water trees grow from defects – contaminants (ions), protrusions or voids – when the insulation is subjected to electrical stress and moisture. These lower the dielectric strength of cable insulation and cause a large number of failures of cables in service, particularly in older vintage cables that have higher levels of defects than more recently installed cables. Electrical failure usually occurs when an electrical tree initiates from a water tree and bridges the insulation or by thermal runaway when a water tree that bridges the insulation reaches a sufficiently high conductivity. All the 5kV main feeder cables that supplied power to each of the 10 MCCs (approximately 14 kilometers in total length) showing signs of extensive water tree defects and insulation cracks were replaced with new conductors. Implementation of the 5kV cabling upgrade began during the arc flash compliance upgrade and continued after installation was complete. The installation of the 5kV cabling was accelerated due to the fact that newly installed protective relays on the 5kV systems were sensitive enough to detect insulation cracks, sheath currents and ground faults for the existing cables. In some cases, the newly installed protective relays settings did not allow plant operators to reenergize substations until the faulty cables were replaced. Fig. 7 shows examples of ground grid and cable systems issues.

Fig. 7. As found ground connections compromised or severed grid at left and center, 5kV existing replaced cable at right.
