CASE STUDY OF HAZARDS ASSOCIATED WITH NEUTRAL CONDUCTORS

Copyright Material IEEE
Paper No. ESW2019-30

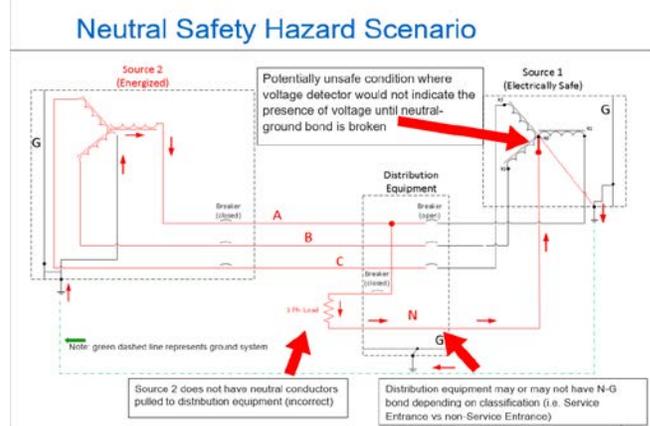
Fig. 1 Neutral Safety Hazard

It was discovered that the temporary generator caused the voltage potential to appear. The customer was continuing to perform lab work for the refinery that required internal power for lighting loads and miscellaneous lab equipment. It was later determined that the main switchboard had neutral loads connected to the main 480 volt switchboard. The lighting system requires a 277 voltage source. The temporary generator was rated at 480 volts and could generate up to 400 amps of capacity. The temporary cables coming from the generator to the main switchboard were connected to a 400 Amp circuit breaker on the main switchboard that was being utilized as a back-feed breaker. The main switchboard is service entrance rated equipment with ground fault protection. This is a three phase, four wire panel rated for 1200 Amps. The main circuit breaker was lockout/tagout with the customer lock attached using a lock box for all contractors. The temporary cables were connected in a three phase, three wire configuration. A neutral conductor was not installed between the temporary generator and the switchboard as the National Electric Code requires in this situation. Functionally this would have been needed because there were neutral loads on the main switchboard and a return path was needed to complete the single phase circuits. However, a ground conductor was installed from the generator to the main switchboard. It was also determined that the neutral ground jumper located inside the main distribution section was removed at some prior time, but not during the work being performed, nor when the temporary generator was connected. The neutral lighting load was subsequently left with one remaining path to ground, and that was through the neutral cable running to the pad mounted transformer where the cables were being disconnected. In summary, the neutral conductor from the main switchboard back to the generator did not exist and this is the reason for the presence of unmeasurable

The voltage potential appeared when the last neutral was disconnected from the landing pad on the transformer and created an open condition between the neutral return path and grounded conductor.

Upon completion of the investigation, focus shifted to the containment action plan, which would be the primary method for ensuring there would be no other similar incidents in the future. The immediate communication was highly technical to call attention to the hazard itself and a full “stop work” was implemented with any task requiring the removal of a neutral conductor from any equipment with the potential of being fed from multiple sources.
