December 2020

Important Product Bulletin
Eaton 9PXM, CTO Number 9PXM08xxxxx and 9PXM12xxxxx
Eaton 9PXM Product Accessories, 730-06185 and 730-06196
Customer Notification

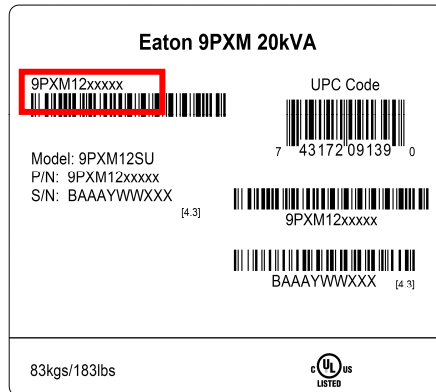
Figure 1: Part Number on the UPS packaging

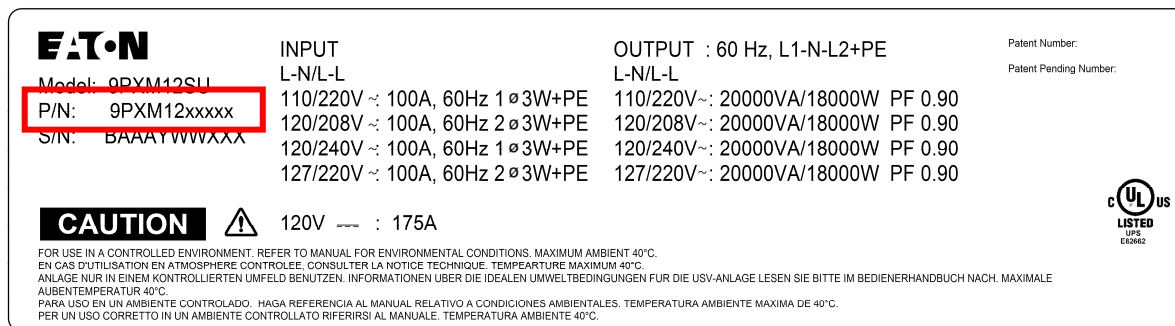
Figure 2: Part Number on the UPS

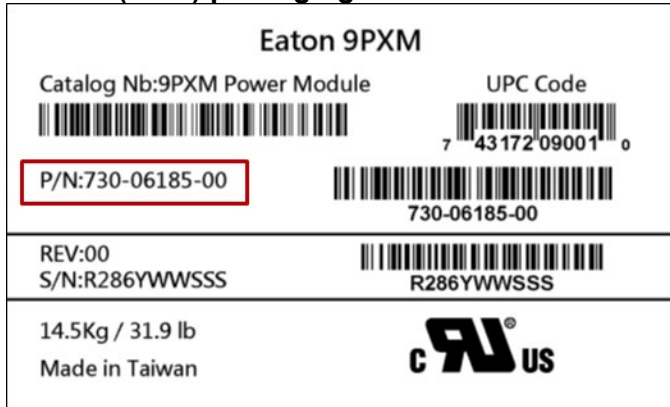
Figure 3: Part Number on the Universal Power Module (UPM) packaging

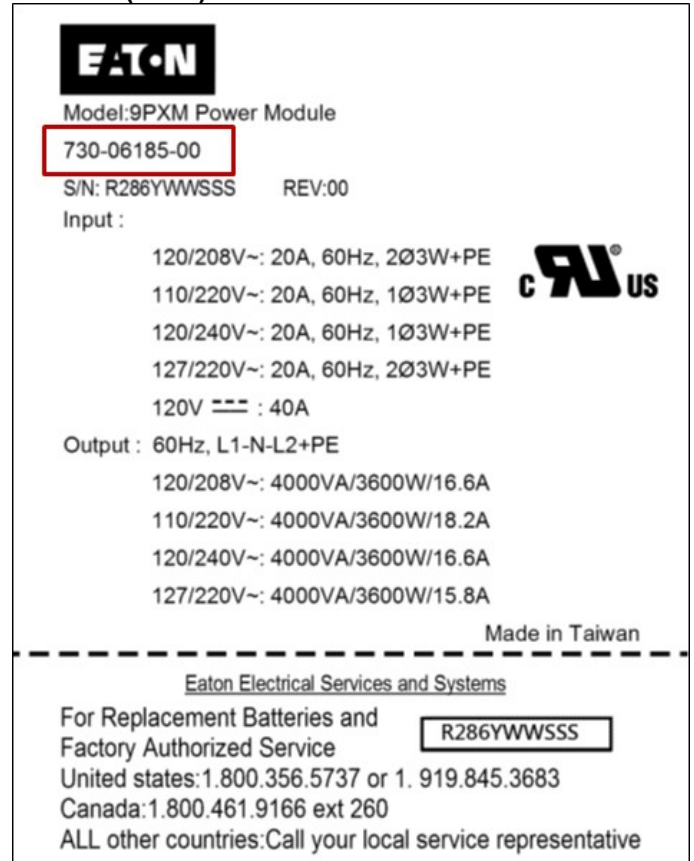
Figure 4: Part Number on the Universal Power Module (UPM)

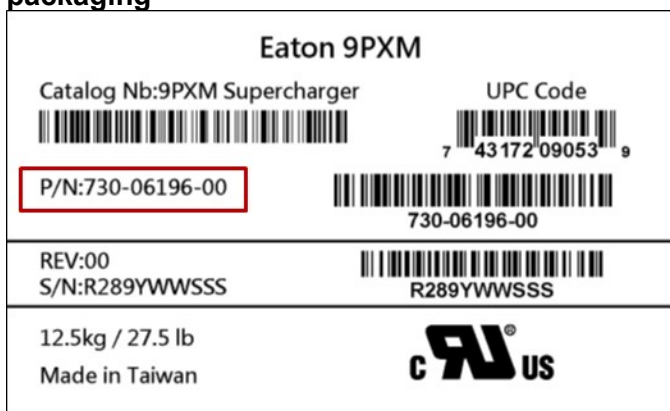
Figure 5: Part Number on the Supercharger packaging

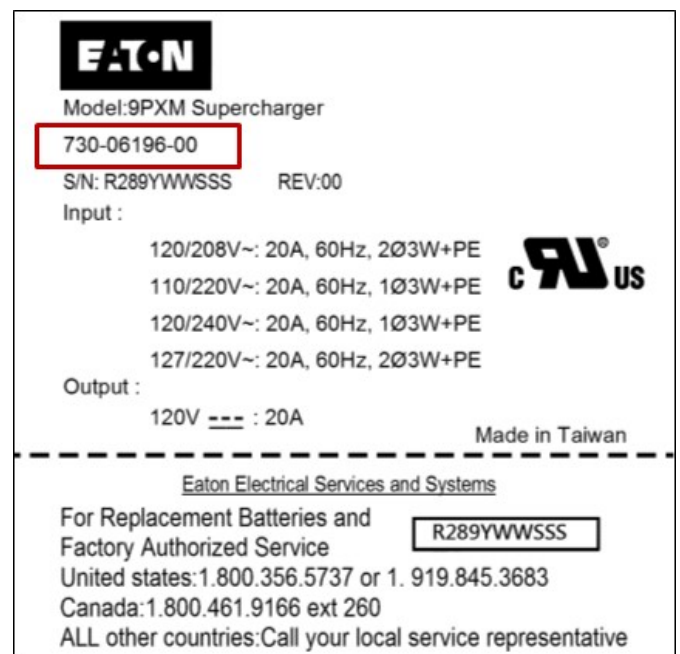
Figure 6: Part Number on the Supercharger

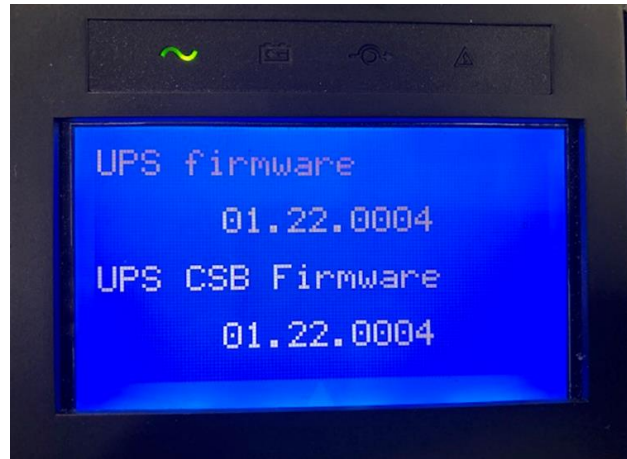
1. Identify potentially affected UPS units by looking for Part Number 9PXM12xxxxx or 9PXM08xxxxx on the carton, as shown above in Figure 1, or the label on the UPS, as shown above in Figure 2.
2. Use the display to go to the Menu/Identification/CSB Firmware as shown below in Figure 7. If the UPS CSB firmware is any version besides version 1.22.0004, your UPS is an Affected Product and the UPS CSB firmware should be updated (reference Affected Product Remediation section below).

Figure 7: Display showing the latest update of UPS CSB Firmware

1. Reach out directly to our Technical Support team for assistance:
 - a. **1-800-356-5737 Option 2 for Technical Support**
2. Update the Affected Product(s) yourself using the firmware available on Eaton's website:
 - a. Click this [LINK](#) OR
 - b. Copy and paste this URL into your browser
 - i. <https://www.eaton.com/content/dam/eaton/products/backup-power-ups-surge-it-power-distribution/Firmware/eaton-9pxm-firmware.zip>
 - c. Email SinglePhaseTS@eaton.com the Affected Product serial numbers that have been updated.

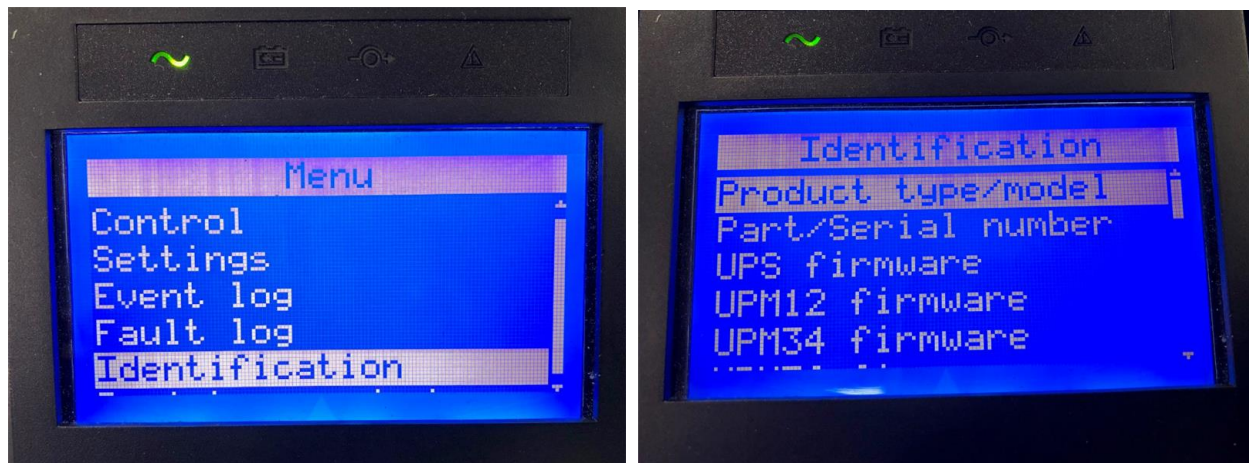
3. Identify potentially affected Universal Power Modules (UPM) by looking for Part Number 730-06185 on the carton, as shown above in Figure 3, or on the UPM, as shown above in Figure 4.
4. Identify potentially affected Superchargers by looking for Part Number 730-06196 on the carton, as shown above in Figure 3, or on the Supercharger, as shown above in Figure 4.
5. Use the UPS display to go to Menu/Identification as shown below in Figure 8. Select the appropriate device. If the UPM/Supercharger firmware is any version besides version 1.06.0001, then your UPM/Supercharger is an Affected Product and both the UPM and Supercharger firmware should be updated (reference Affected Product Remediation section below). The UPS display with firmware version 1.06.0001 is shown below in Figure 9.

Figure 8: UPS display appearance when checking the UPM/Supercharger Firmware

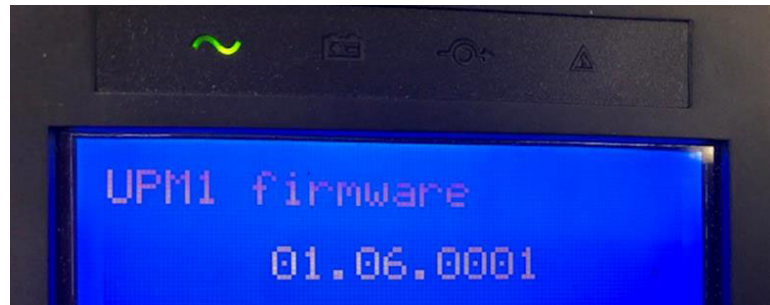
Figure 9: UPS display showing the latest update of UPM Firmware
