**Subject:** Advantage Automated Series 430MM Clutch Cover Inspection and Fault Code 706 – Endurant HD/XD and PACCAR TX-12/TX-18

**Service Bulletin:** CLIB-0040

**Date:** April 2, 2024

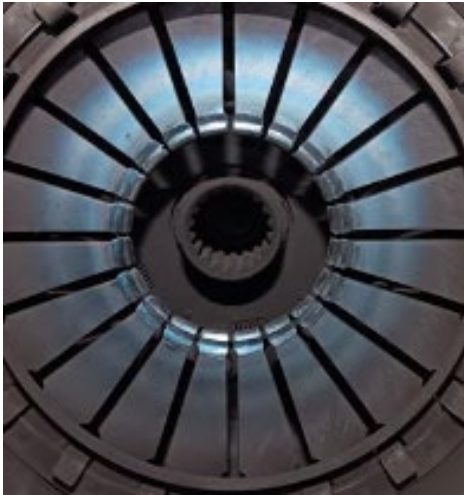
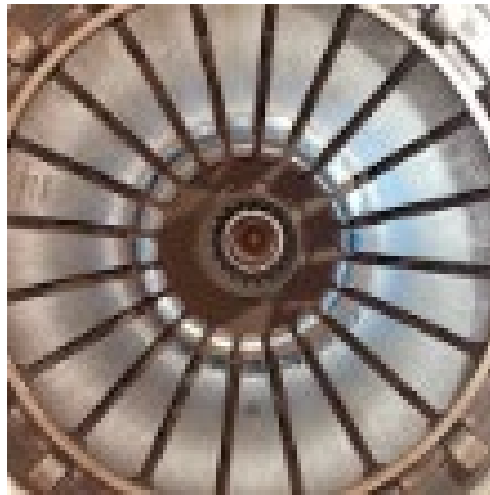
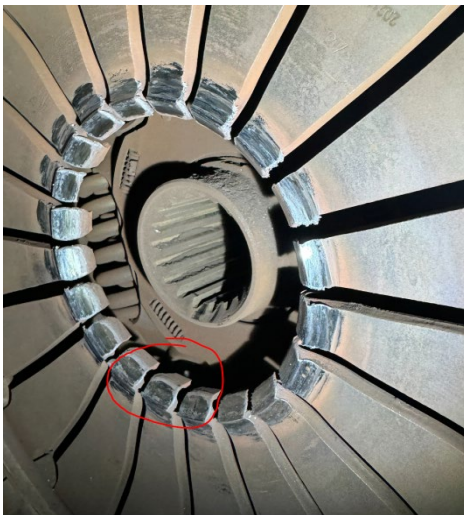
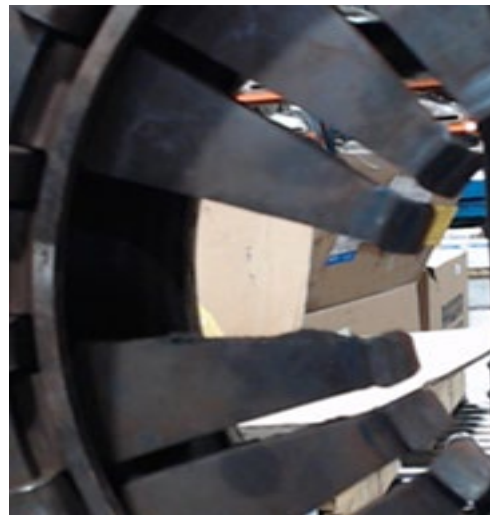
6. Inspect clutch diaphragm spring fingers for heat traces (bluing), deformation, or missing fingers with heat traces. See examples below.
  - If heat traces, deformation or missing fingers with heat traces exists, take pictures, replace the clutch, and proceed to 2020-FSUD-4226/TAIB-0889 for Transmission clutch actuation system inspection..
  - If no heat traces, deformation, or missing fingers with heat traces exists, go to **Step 7**.

- Diaphragm Clutch Spring Fingers with heat traces, smeared metal at the finger / release bearing contact point, deformation, or missing fingers at the release bearing contact surface (with heat traces or deformation) is considered NOT warrantable for the clutch.
- Do not file a warranty claim for clutches with these conditions as this is progressive damage from a transmission component failure.

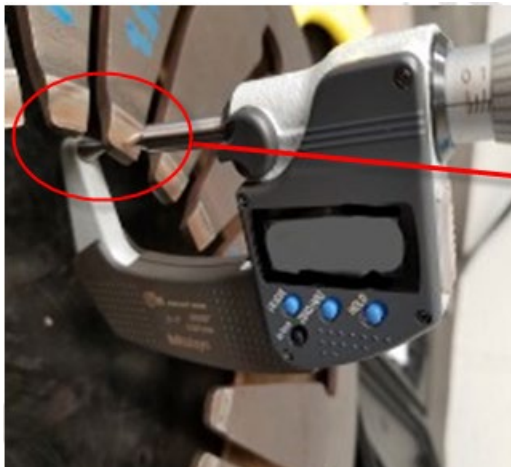
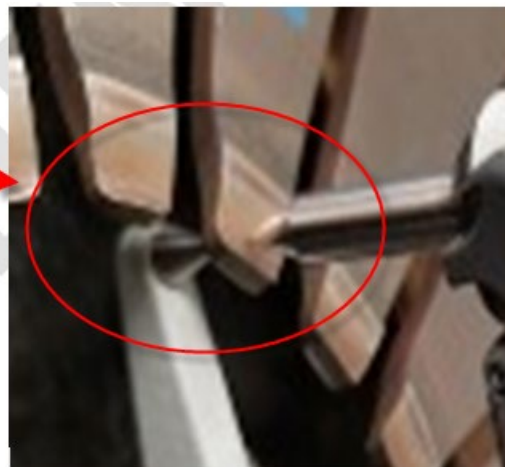
7. Use a digital pointed-tip micrometer to measure all the clutch diaphragm spring fingers for wear - record measurements.

**Note:** Measurement must be taken just inside the fingertip as shown.

- If **a** clutch diaphragm finger thickness is less than ( $<$ ) 3mm, take pictures of the measurement, replace the clutch, and proceed to 2020-FSUD-4226/TAIB-0889 for transmission clutch actuation system inspection..
- If **all** clutch diaphragm finger thicknesses are 3mm or greater ( $>$ ), go to **Step 8**.

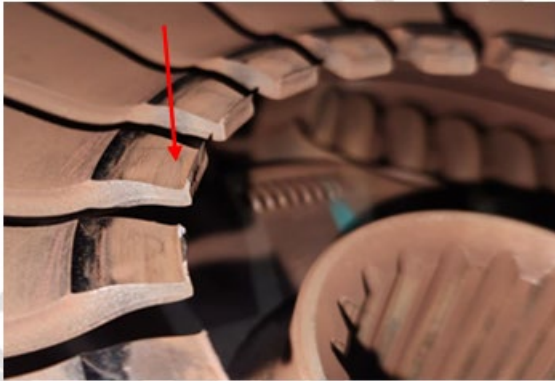
**Notice:** If the clutch diaphragm spring finger has a “hook”, take finger measurements as indicated in the pictures below and above.

**Note:** If “Hook” diaphragm spring fingers thicknesses are 3mm or greater ( $>$ ) the clutch is still considered satisfactory for use.

**Note:** Do not measure the hook height, measure behind the hook as shown above.

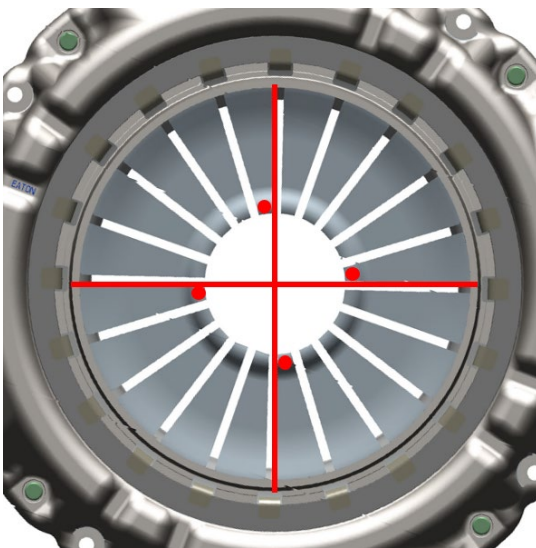
8. Using digital Vernier calipers, measure the heights of the clutch diaphragm spring fingers at minimum in the four positions indicated below and take pictures of measurements. Reference TRSM0950 – Clutch Section.

- If **a** diaphragm spring finger does **not** meet the height measurement criteria in the table below, record and take a picture of the measurement, replace the clutch, and proceed to 2020-FSUD-4226/TAIB-0889 for transmission clutch actuation system inspection..
- If **all** diaphragm spring fingers meet the appropriate height measurement criteria in the table below, go to **Step 9**.

Clutch Condition	Finger Height
New Install	17mm - 21mm (0.669 – 0.827 inch)
Less than 100K miles / 160,934 km	Maximum 22mm (0.866 inch)
Greater than 100K miles / 160,934 km	Maximum 24mm (0.944 inch)

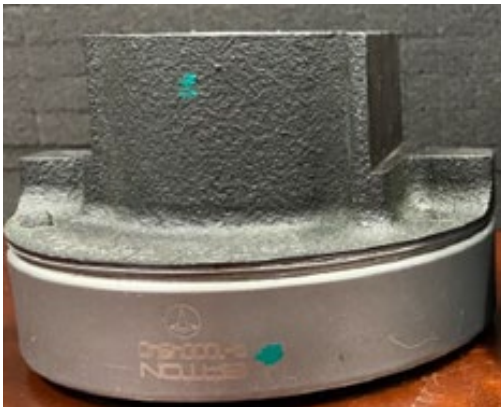
ISO Fitment (Metallic Color)

9. Verify the correct release bearing is installed. Reference TRPB0950 for application details (Service Parts and Kits section).
- If the correct release bearing is installed, go to 2020-FSUD-4226/TAIB-0889 for transmission clutch actuation system inspection.
  - If the correct release bearing is not installed, take a picture of the bearing and replace with the correct release bearing, and go to **Step 10**.
