One-Piece HP2 Duct Assembly
Boeing P/N 312N5306-1
Eaton P/N 14J98-1

Two-Piece HP2 Duct Assembly
Duct Assembly
Boeing P/N 312N5306-20
Eaton P/N 14J98-2

Boeing released Service Letter (757-SL-35-021) in April 2010, recommending that the HP2 and HP6 duct flexible joints installed on all 757 airplanes equipped with Rolls Royce RB211-535C and RB211-535E4 Series engines be repaired or replaced between 10,000 to 12,000 flight hours.

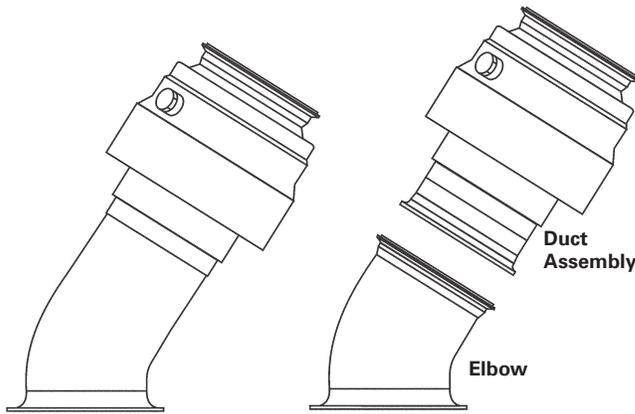
Elbow
Boeing P/N 312N5306-18
Eaton P/N 22J4-1

The two-piece HP2 Duct Assembly is made from a one-piece HP2 assembly. The one piece unit is cut into two pieces, trimmed and a flange is added on each piece. Reference Boeing Service Bulletins 75-36-0028 and 757-36-0029 for installation instructions.

When removing HP2 ducts for overhaul, Boeing recommends that operators modify any one-piece HP2 ducts to the two-piece configuration to make it easier to remove the HP2 duct with the engine installed. According to operators, the replacement time for the one-piece HP2 Duct and the HP6 Duct can be 24 man hours per engine. Boeing estimates it will require only 3 man hours per engine to replace the HP2 and HP6 Ducts on airplanes fitted with the two-piece HP2 Duct.

The one-piece HP2 ducts (Boeing P/N 312N5306-1) can be modified to the two-piece configuration (Boeing P/N 312N5306-20 and 312N5306-18) per Boeing Service Bulletins (SB) 757-36-0028, dated 20 June 2002 and (SB) 757-36-0029, dated 27 June 2002.
