Eaton Clutch Failure Analysis Guide All Clutch Models CLTS1271 EN-US

January 2025

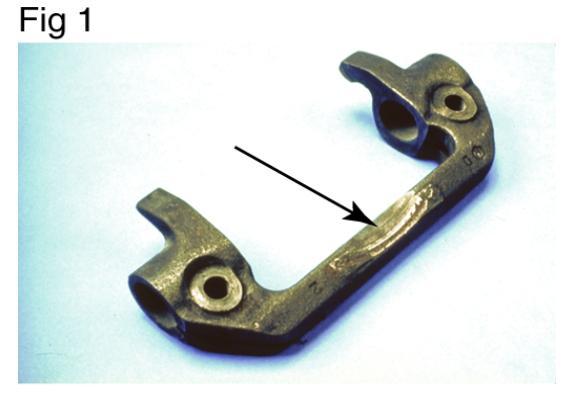
Failure - Yoke Bridge Rubbing into Cover

The arrows in Figures 1 and 2 show the areas of contact between the release yoke bridge and the clutch cover. Overstroking of the yoke, in an attempt to obtain the required 1/2" - 1" clutch brake squeeze, is a typical cause of this failure.

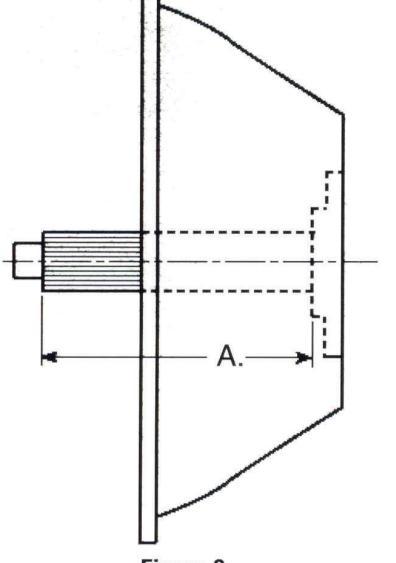
TRANSMISSION BEARING RETAINER CAP

Dimension A, based on SAE standards, is 8.657" (219.9 mm) nominal, and should not be greater than 8.71" (221.5 mm) Ref. 1990 S.A.E. handbook 4:36.106

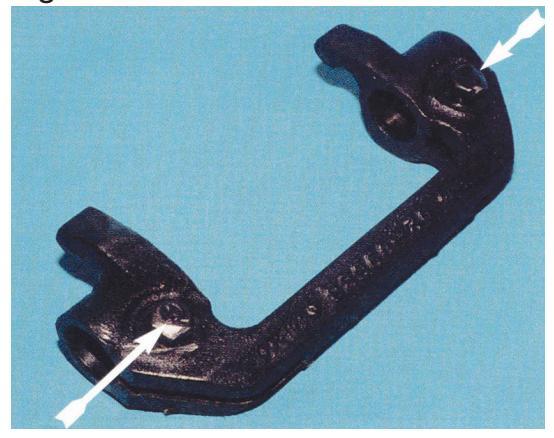
Fig 10

Additional damage occurred to both the clutch cover and the release yoke as a result of their interference with each other (refer to the arrows in Figures 9 and 10). It is worth noting that this service clutch had accumulated 50,000+ miles before it failed.

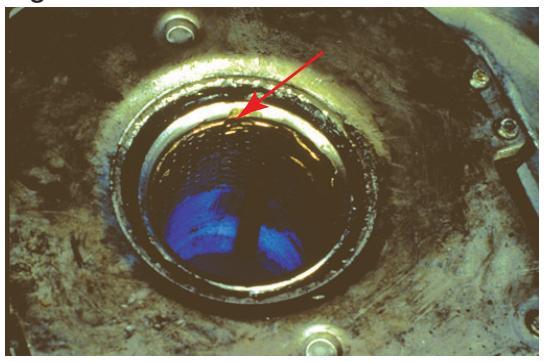
Fig 12

Failure to center the input shaft with the sleeve of the release bearing assembly, when installing the transmission, can cause this failure. If the transmission hangs up during installation, investigate the cause before preceding as excessive force can damage the bushing (see arrow in Figure 12). Allowing the transmission to hang unsupported in the sleeve bushing can damage the bushing. The arrow in Figure 11 shows another example of sleeve bushing damage on a heavy duty clutch. Fig 11

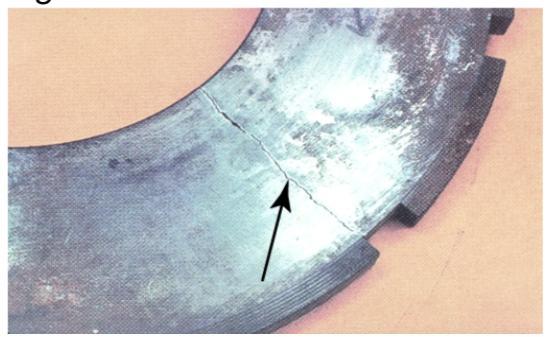
Fig 14

Figure 14 shows a broken intermediate plate. As in the previous example, the heat flow was so intense that the metal could not disperse the heat quickly enough.

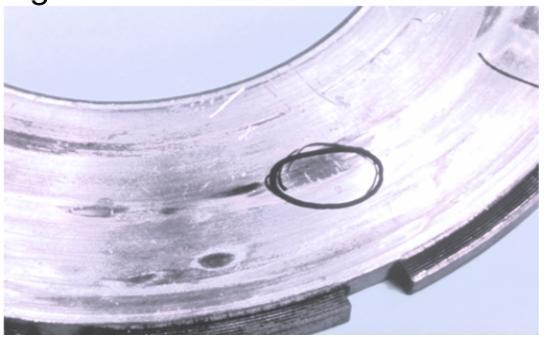
In Figure 15, an area of the intermediate plate has been circled to reveal the damage of heat checks. These heat checks are actually small cracks with raised ridges that are capable of shaving off the facings of the driven disc.

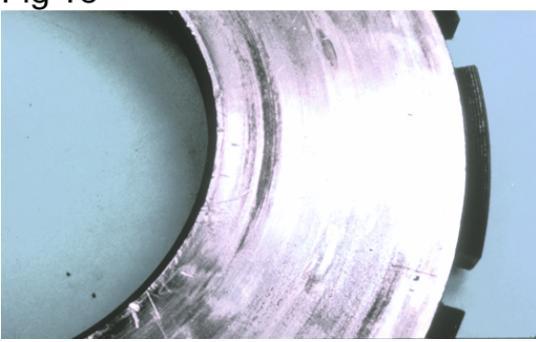
Fig 16

Finally, Figure 16 reveals an example of a burned or scorched intermediate plate in which the metal became so hot that it began to flow. The typical evidence of such a failure will be one or more of the following:

- High and low spots on the plate
- Partial transfer of the facing material (ceramic or organic) from the driven disc onto the plate
- A blue discoloration throughout the failed part

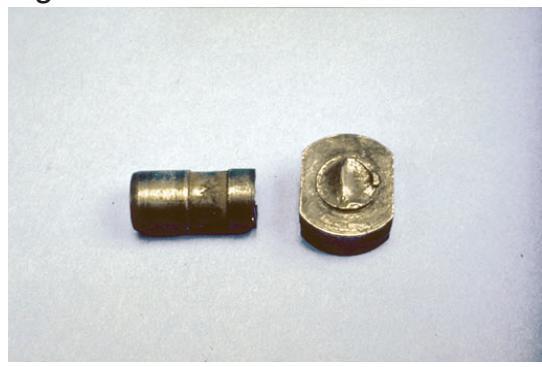
Fig 22

Figure 20 shows a broken drive pin head that has become wedged into the intermediate plate's drive slot. Figure 21 is the same intermediate plate but with excessively worn and broken drive slots. Figure 22 shows a broken drive pin. The above failures can be caused by one or more of the following:

- Failure to use the anti-rattle springs packaged with each super-duty clutch
- Misapplication of the clutch
- Unequal loading on the drive pins as a result of filing the drive slots.

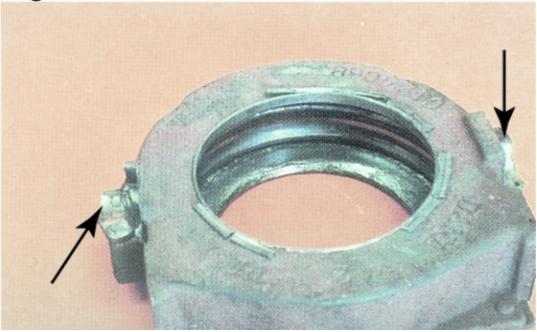
Fig 29

- A dry release bearing due to lack of periodic lubrication (does not apply to sealed bearings).
- Failure to fully release or riding the clutch pedal will place a constant thrust load on the bearing, (see arrows in Figure 29) leading to higher temperatures and consequential loss of lubricant. Failure to maintain free play up in the cab can also cause this condition. Not only will the bearing begin to fail, constant contact in this area will cause both the release yoke fingers (Figure 79), and the wear pads (Figure 29), to wear excessively.

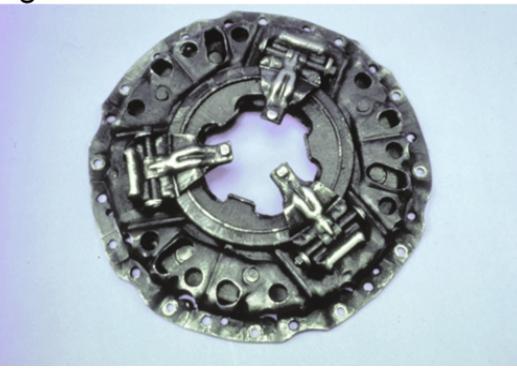
A leaking transmission or a leaky rear main engine seal can coat the clutch cover with oil, as indicated in Figure 30. Figure 41 shows the disc which was run with this cover.

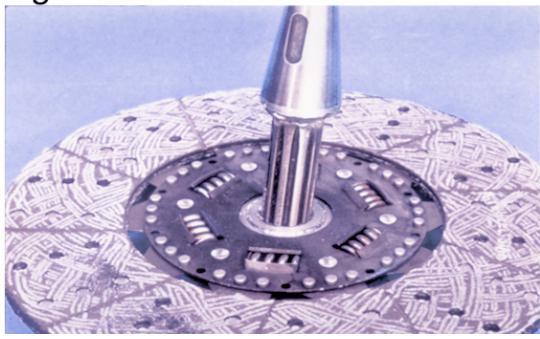
Fig 47

Shown in Figure 47 is a brand new driven disc which was warped during transmission installation (as indicated by the dummy input shaft which is not perpendicular to the disc's hub). More specifically, the transmission was allowed to hang unsupported in the driven disc hub. A driven disc which has become bent due to improper installation techniques should not be reused because of the potential for a "poor release" complaint.

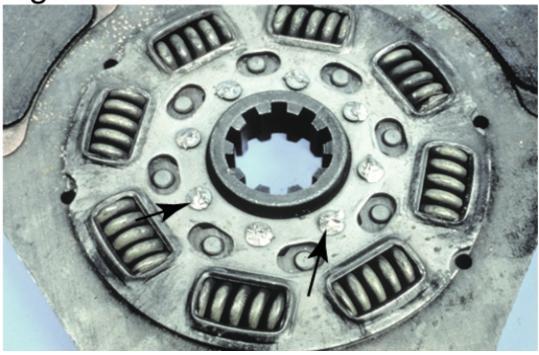
Fig 48

- The rivets of the disc (Figure 48) have been contacting the flywheel's mounting bolts. Some potential causes of this particular interference are as follows:
 - a. Loose flywheel mounting bolt(s) due to inadequate torquing.
 - b. Forgetting to tighten one or more or the mounting bolts when reinstalling the flywheel.
 - c. Installing an extra washer under the flywheel mounting bolt.
 - d. A flywheel which has been resurfaced too many times.
- The damper springs (see arrows, Figure 49 and 50) have been contacting the flywheel mounting bolts because the front driven disc was installed backwards. The driven disc (in Figure 49) had been wearing for a period of time before the interference occurred (as indicated by the full wear pattern on the ceramic buttons) while the one in Figure 50 was run for a very short period.

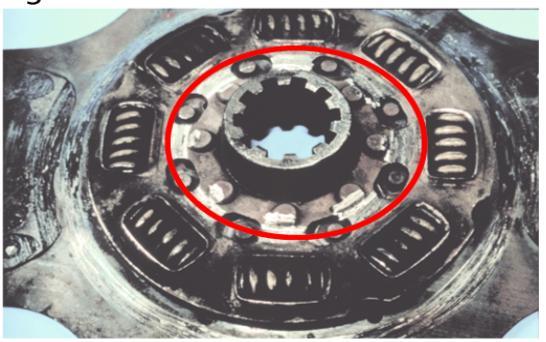
Fig 57

Figure 57 (see circle) shows the damage that will occur to the rear disc when it makes contact with the retainer assembly (refer to the arrow in Figure 25 concerning the subsequent damage to this part). This type of interference was so great that the clutch began to slip while engaged, thus creating enough heat to cause the ceramic buttons to self-destruct (Figure 58).

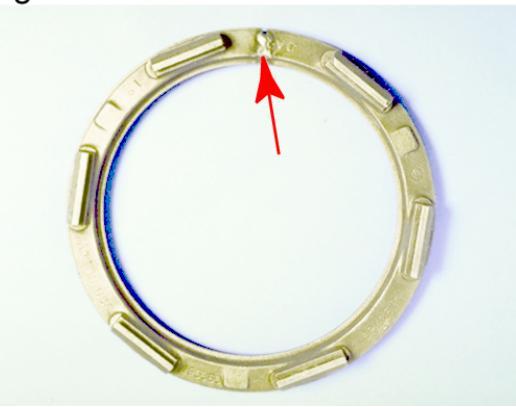
Fig 65

Note also the adjusting ring pictured in Figure 65. It was removed from a non-Eaton rebuilt clutch. This ring was cut open on one side, spread apart, and then welded (see arrow) at a larger diameter to prevent the adjusting ring from becoming loose once it was reinstalled. (Eaton Clutch does not weld adjusting rings, but rather discards any rings that are too loose.)

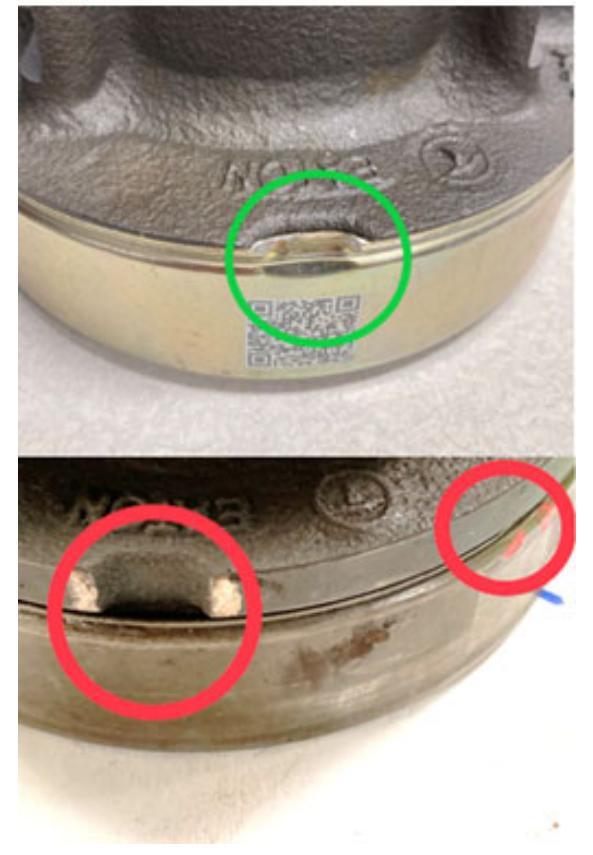
Fig 100

- When the outer baffle of the release bearing has rotated beyond its original staked position, the release bearing assembly should be replaced.
- Figure 100 illustrates the correct (green / top) and incorrect (red / bottom) positions of the outer baffle.

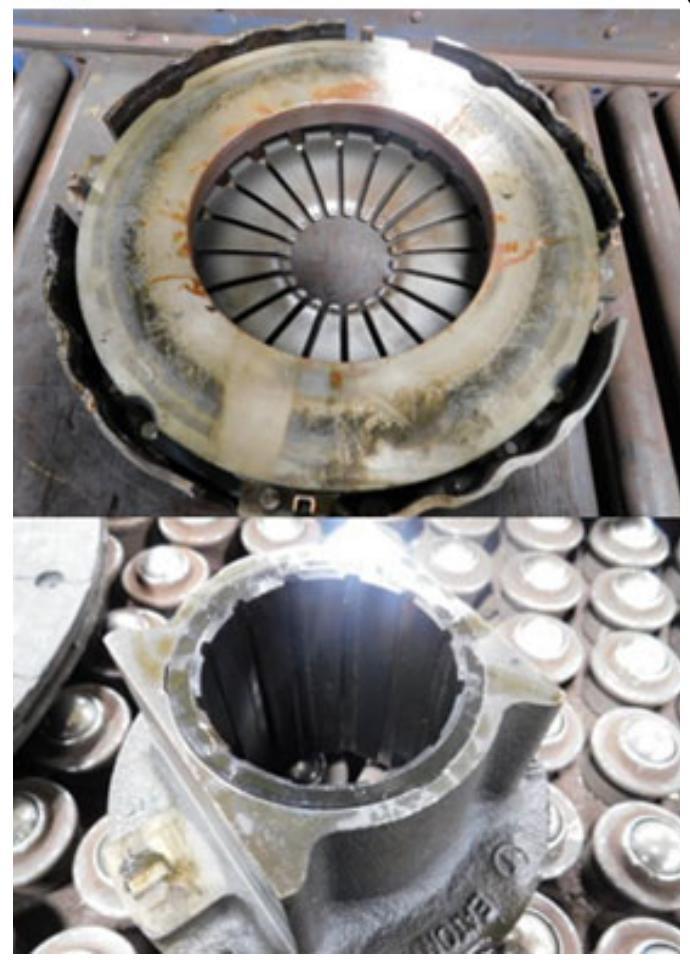
Fig 112

• As illustrated in Fig 112, this failure is caused by a leaking transmission, leaking rear main engine seal, and/or engine blow by tube. This leakage allows oil to contaminate the clutch ant its components. This contamination leads to clutch slip, engagement, and adjustment issues.
