BACKED BY  
**Roadranger**  
SUPPORT

**Subject:** Heavy Duty Clutch May Not Achieve Full Departure – Mechanical and Automated

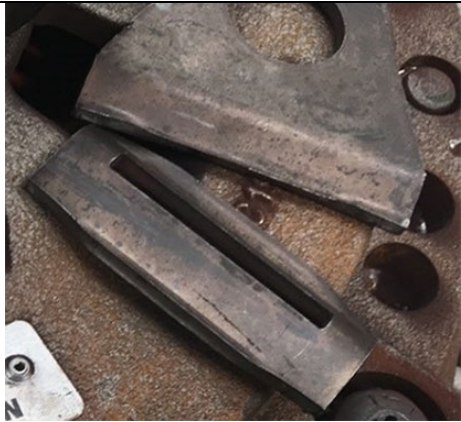
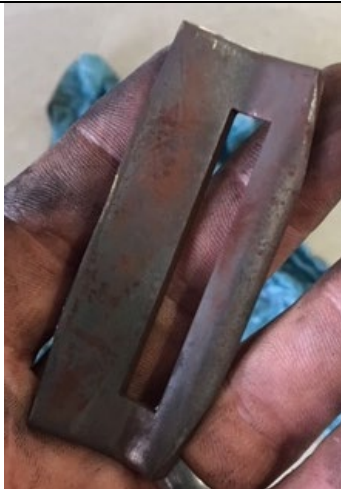
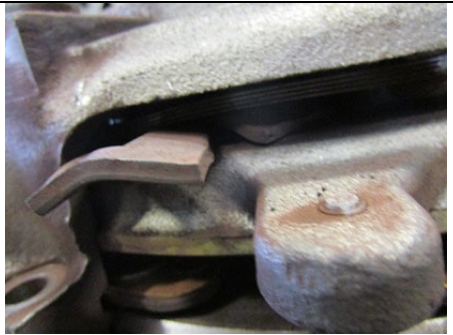
### Automated Transmission Complaints:

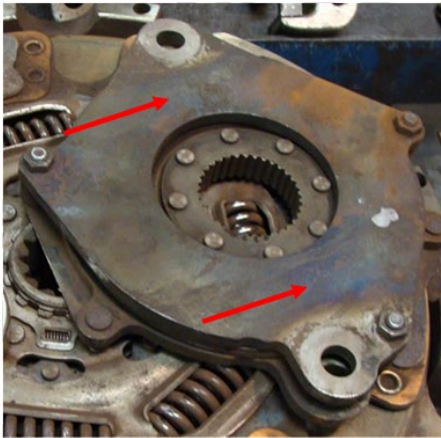
- Clutch Kit Part Numbers as listed in Affected Models/Population section.
- Progressive damage coverage is limited to the ECA, clutch housing, speed sensors, engine flywheel housing.
