**APPLICABLE TO ALL CARTER 4" API  
HYDRANT COUPLERS**

**PN900051505**  
**Revised May 26, 2006**

**REVISED COUPLER WEAR GAUGE**

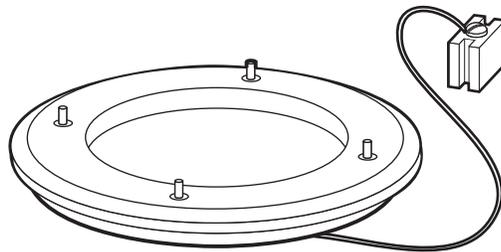
**61362 COUPLER WEAR GAUGE with  
LUG INSPECTION GAUGE**

The 61362 Wear Gauge has been revised to add a second step in inspection of the coupler connection system, including a more definitive gauge for checking the wear on the individual lugs.

The revision to the 61362 Inspection Gauge entails the addition of the lug inspection attachment shown to the right in the drawing above.

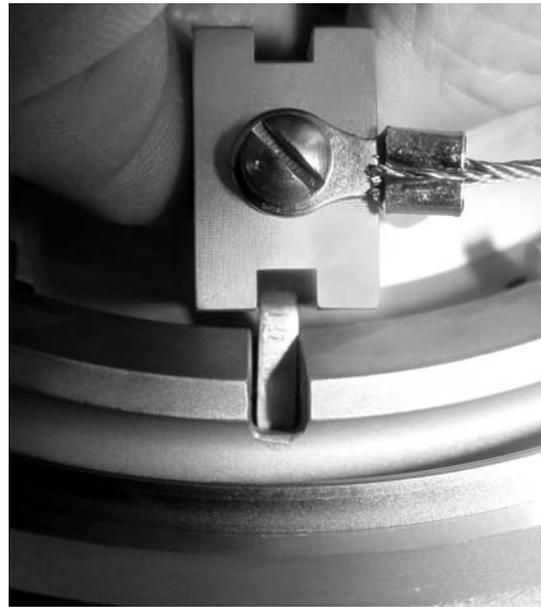
Refer to the photo, above, and check each lug separately by placing the lug part of the gauge onto a lug. If the gauge sits squarely onto the I.D. of the coupler with the tip of the lug not touching the bottom of the gauge slot, the lug or the actuating collar has excessive wear. Inspect all 16 lugs. A lug in good condition will raise the gauge away from the coupler I.D. allowing it to rock on the lug.

If any lugs are found to fail this test, we strongly recommend that all 16 lugs be replaced.

After replacing, check new lugs to determine if the actuating collar could have also been worn.
