Surge Protection for Ladle Melt Furnaces

T.J. Dionise¹, S.A. Johnston²

EVALUATION OF LMF TRANSFORMER SURGE PROTECTION

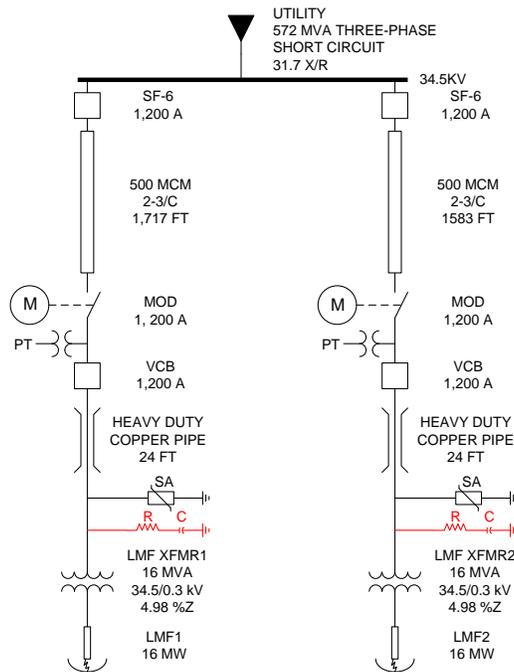
Figure 1. A diagram of the electrical distribution system for LMFs

This steel mill is served by a utility dedicated 34.5 kV substation located within 1 mile. The utility substation supplies the rolling mill circuits through separate 1,200 A SF6 breakers than those that feed both LMFs and the EAF. A static var compensator (SVC) rated 106 MVAR is located in the substation to provide voltage support and power factor correction for the EAF and both LMFs. A zig-zag grounding transformer is connected to the 34.5 kV utility bus to limit the ground fault current to 400 A. The utility breakers dedicated to the LMF transformers first feed 34.5 kV switchgear using 2 x 500 MCM EPR cables per phase as shown in Figure 1. These cables are 1,717 ft to LMF1 and 1,583 ft to LMF2. The 34.5 kV switchgear for each LMF circuit consists of a non-load breaking motor operated disconnect (MOD), a 1,200 A VCB, and a grounding switch. The VCBs feed 3/4 inch bus to the LMF transformers. The bus bars are 24 to 34 ft in length, depending on the phase. LMF1 and LMF2 have 16 MVA transformers with 4.98% impedance and 200 kV BIL primary winding.

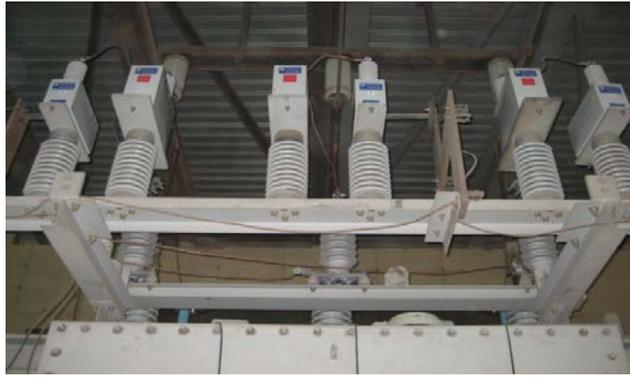
Figure 2. The surge arrester, capacitor and resistor removed for LMF1

The LMF transformer 34.5 kV surge protection consists of a surge arrester in parallel with a surge capacitor and resistor (removed) as shown in Figure 2. The surge arresters are rated for 36 kV and connected from the bushing of the LMF transformers to the ground jumper. The two surge capacitors in series with values of $0.125 \mu\text{F}$ at 24 kV and $0.25 \mu\text{F}$ at 13.8 kV are also connected between transformer bushing and ground. The effective surge capacitance is $0.083 \mu\text{F}$. The resistor was sized after the manufacture of the LMF transformer and no record of the original designed value of the resistor is available. The resistors were removed from the circuit after operations commenced due to overheating.

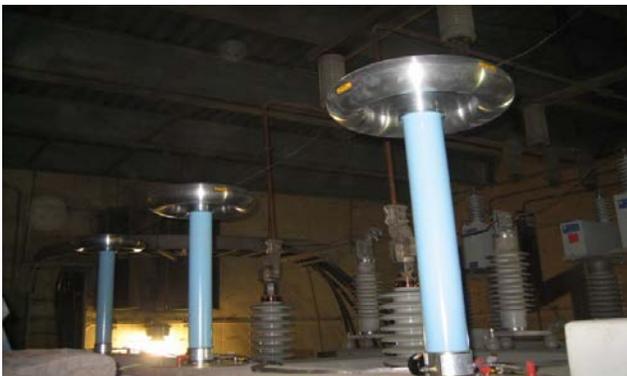
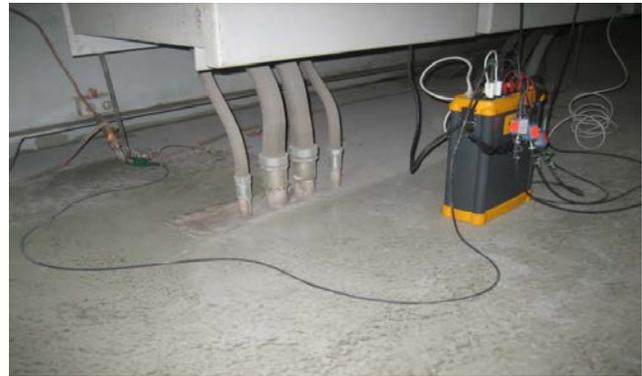
Figure 3. (a) The voltage dividers installed at LMF1 primary, (b) The transient recorder and grounding for LMF1

The test measurement setup consisted of voltage dividers and a transient recorder as shown in Figure 3. Proper measurement equipment was selected to assure accurate capture of the switching transient overvoltages at the 34.5 kV primary of the LMFs. The voltage dividers were sized for the system kilovolts and specified with a secondary output impedance to match the input impedance of transient recorder. The voltage dividers were placed on top of the transformer, as close to the LMF transformer bushing as possible, to detect any voltage reflections that occur when the incoming wave hits the sudden change in surge impedance of the transformer bushing. Vibrations were minimized by fastening the voltage dividers to a sheet of plywood clamped to the transformer. The voltage dividers were connected to the transformer primary bushing with a sweeping arc of number 10 insulated wire (120 V) as shown in Figure 3a. Care was taken to maintain proper phase-to-ground clearances between the voltage dividers and jumper wire to nearby equipment, as well as phase-to-phase clearances between the dividers. Figure 3b shows the measurement setup for LMF1 typical of both transformers.

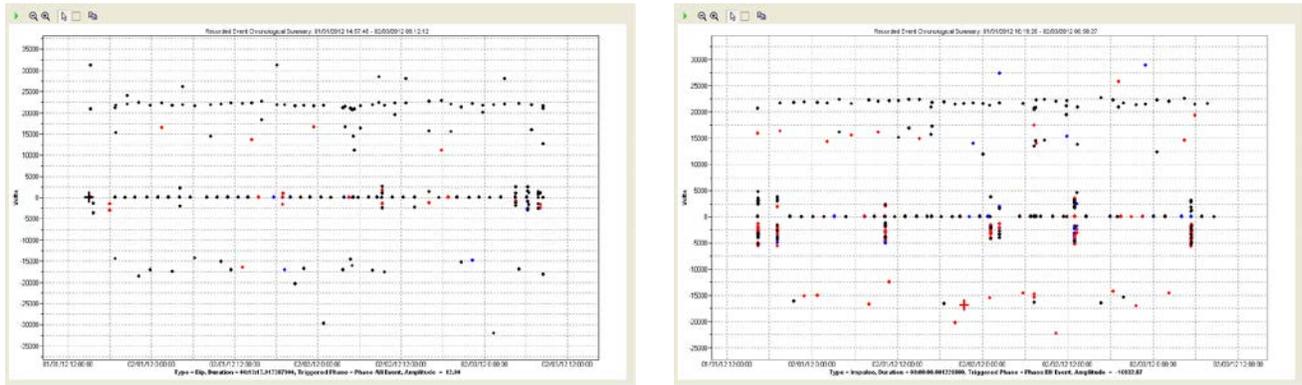
Figure 4. (a) TM1 showing captured transient overvoltage events at LMF1, (b) TM2 showing captured transient overvoltage events at LMF2

Many switching transient overvoltage events captured during the monitoring period are summarized in Figure 4. Figure 4 gives a chronological summary of the transient magnitude vs. time for the four-day monitoring period. This view shows a well-defined boundary with some higher peaks. The transient overvoltages peaked as high as 42.5 kV at LMF1 and 46.5 kV at LMF2. The higher magnitude transients occur during closing of the VCB. Figure 5a is representative of the higher magnitude transients at LMF1. Figure 5b is representative of those at LMF2. Both are similar in magnitude and do not exceed the BIL of the primary winding. LMF1 and LMF2 experienced a similar number of transients.

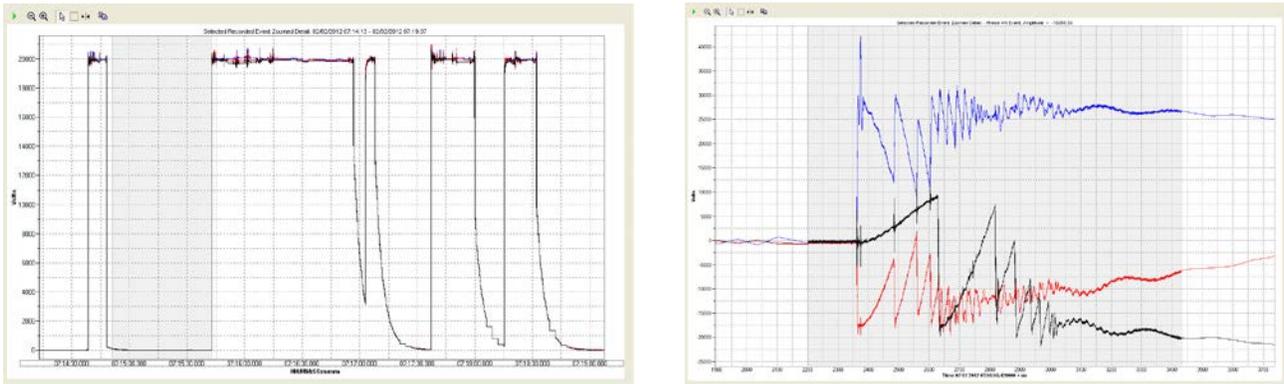
Figure 6. (a) TM2 during Event 221 showing RMS voltage for five open/close of VCB, (b) TM2 during Event 239 showing the fifth close of VCB results in pre-strike

Figure 6a shows the RMS voltage trend at the LMF2 transformer, as captured by the TM2 on 2 December 2012, and included 5 closings and 5 openings of the VCB in 4.5 min, totaling 17 recorded events. The transient overvoltages corresponding to these open and close operations in such a short period of time are of concern for several reasons, outlined below.

This type of repeated operation leads to a breakdown of the dielectric between the VCB contacts, resulting in prestrike of the arc as the contacts were closing. This type of high-frequency voltage will degrade the transformer turn-to-turn insulation over time. Prestrike actually occurs on the 3rd and 5th closing. The prestrike for the 5th closing is shown in Figure 6b. In both the 3rd and 5th closings, the breaker is closing in on a measurable amount of trapped charge, as shown in Figure 6a. The charge is trapped on the surge capacitors located at the terminals of the LMF. The initial charge is one per unit which decays due to the discharge resistor across the terminals of the surge capacitor. Per IEEE Standard 18, the caps must have discharge resistors and bleed-off the charge to 50V in 5min. In these two instances, not enough time has passed for the resistor to discharge the voltage entirely.

In comparison, a typical closing event is shown in Figure 5b above. The Temporary Overvoltage (TOV) is minimal and the voltage goes sinusoidal almost immediately after the VCB is closed. In contrast, the fifth closing in Figure 6b shows a breakdown of the dielectric between the VCB contacts lead to a pre-strike of the arc as the contacts were closing. This type of high-frequency repetitive voltage transient will degrade the transformer turn-to-turn insulation over time. There is a similar waveform for the third closing of the sequence.

No arrester counts or transients of a severe enough magnitude to cause an arrester operation were measured during the three-day monitoring period as shown in Table II. Excessive, rapid VCB operations are occurring on LMF2 which is evident by the 5 breaker operations that occurred between 7:14:27 a.m. and 7:18:15 a.m. on Feb 2, 2012 shown in Figure 6. This rapid reclosing of the VCB does not allow enough time for the dielectric medium surrounding the contacts to fully recover. Fortunately, the only ignition events that occurred were prestrike. If a reignition were to occur during the opening of the VCB, a much higher TOV/TRV would result on the furnace transformer and breaker. (see Case 5.) We suggest that at least 5 min should be allowed in between the breaker opening and reclosing for the dielectric to fully recover and the charge to bleed off the surge capacitor. This may be accomplished by placing a time delay in the closing of the breaker in the control system. At a minimum, the operator practice should be revised. We also suggest that a damping resistor be added to the secondary of the PT a proven solution^{11,12,13}, which can be easily implemented by using a switchgear heater. This added load will provide a method to dissipate the possible ferroresonant energy.

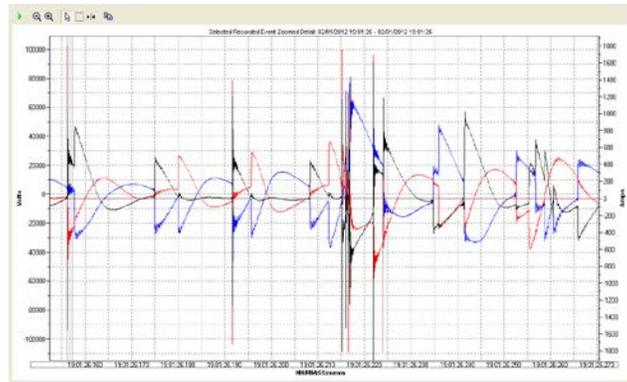
Figure 7. PM1 during Event 98 showing possible PT ferroresonance

After a long outage, the furnace transformer circuit is energized by closing the MOD and then closing the VCB. Transients of 100 kV at the PT for LMF1 as shown in Figure 7 persist for approximately 3 s every time the MOD is closed and are visible through the arcing as the blades approach. PT ferroresonance is one possible cause of these high overvoltages. Ferroresonance is a phenomenon usually characterized by overvoltages and very irregular wave shapes and associated with the excitation of one or more saturable inductors through a capacitance in series with the inductor^{3,4,5,6}. Fortunately, the erratic voltage is damped within 3 s. This affect occurs at the MOD for both LMF1 and LMF2. The high peak due to the PT circuitry was not seen by the voltage dividers at the LMF transformer primary.

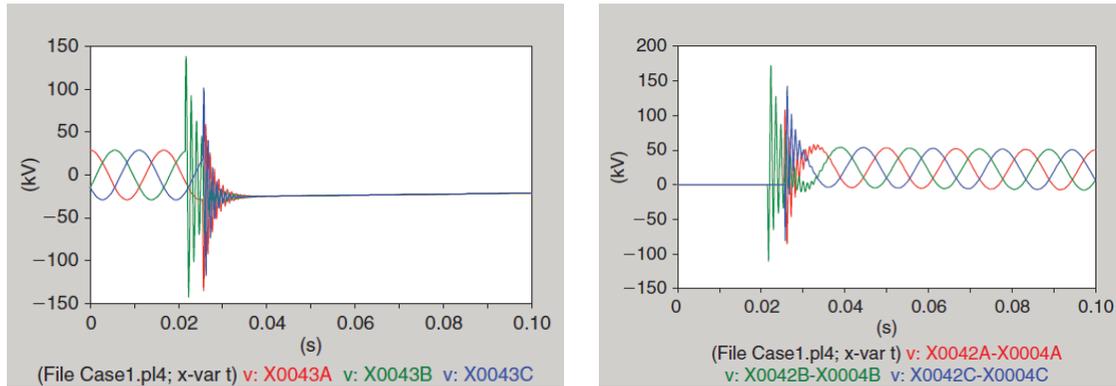
Figure 8. (a) Case 1, a transformer TOV with no snubber, (b) Case 1, a VCB TRV with no snubber

Figure 8a shows the results for Case 1 where the VCB de-energizes the LMF transformer under load. The TOV magnitude at the primary side of the LMF transformer was 142 kV, which is below the LMF transformer BIL of 200 kV. The frequency of 1.053 kHz, however, is above the recommended maximum of 1 kHz. Figure 8b shows the TRV across the VCB. The voltage peak of 171 kV is above the limit of 74.5 kV, and the voltage rise time of 328 μs is longer than the t_3 time of 24 μs allowed by IEEE/ANSI C37.06.

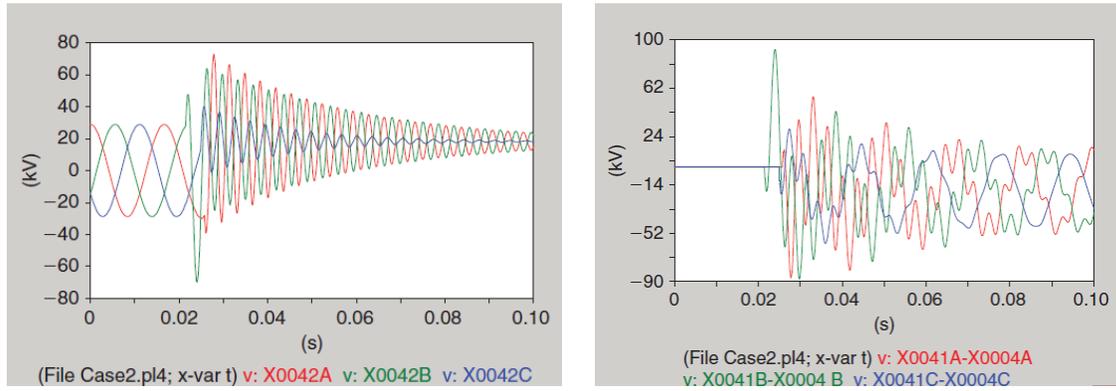
Figure 9. (a) Case 2, a transformer TOV with existing surge capacitor, (b) Case 2, a VCB TRV with existing surge capacitor

Figure 9a compares the results for Case 2 where the VCB de-energizes the LMF transformer under load with the existing surge capacitors at the transformer terminals. The TOV magnitude at the primary side of the LMF transformer was 72.9 kV, which is below the LMF transformer BIL of 200 kV. The frequency of 339 Hz is below the recommended maximum of 1 kHz. Figure 9b shows the TRV across the VCB. The voltage peak of 82.5 kV is above the limit of 74.5 kV, but the voltage rise time of 658 μs is longer than the t_3 time of 24 μs allowed by IEEE/ANSI C37.06.

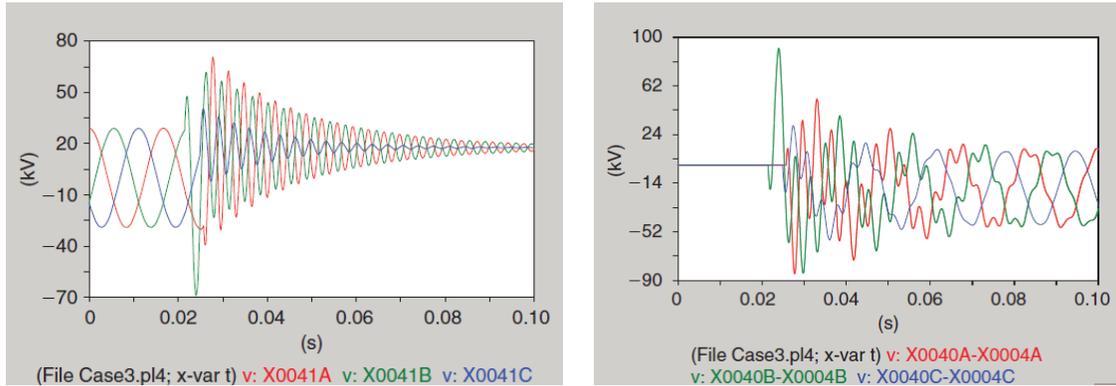
Figure 10. (a) Case 3, the transformer TOV existing surge capacitor and new resistor, (b) Case 3, the VCB TRV existing surge capacitor and new resistor

Figure 10a shows the results for Case 3 where the VCB de-energizes the LMF transformer under load. The TOV magnitude at the primary side of the LMF transformer was 70.6 kV, which is below the transformer BIL of 200 kV. The frequency of 336 Hz is also well below the recommended maximum of 1 kHz. The resistor adds damping to the voltage ring wave at the transformer terminals. Figure 10b shows the TRV across the VCB Circuit breaker. The voltage peak of 78.2 kV is above the limit of 74.5 kV, but the voltage rise time of 480 μ S is longer than the t3 time of 24 μ S allowed by IEEE/ANSI C37.06.

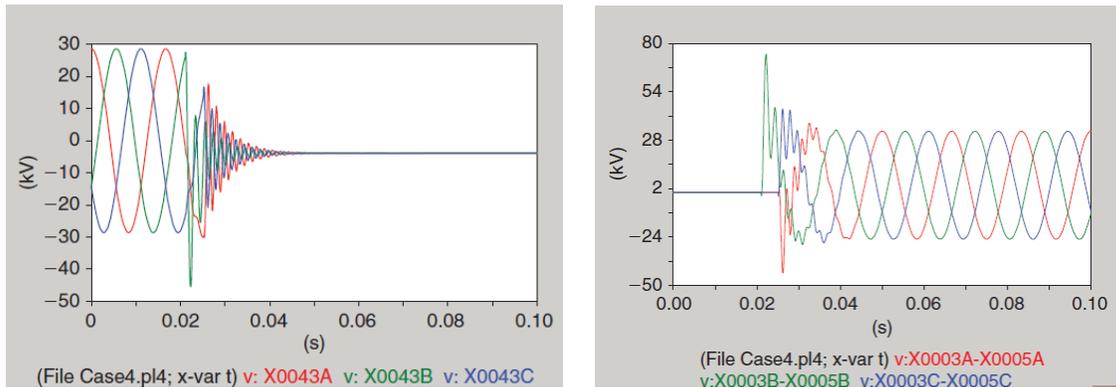
Figure 11. (a) Case 4, a transformer TOV new surge capacitor and new resistor, (b) Case 4, a VCB TRV new surge capacitor and new resistor

Figure 11a shows the results for Case 4 where the VCB de-energizes the LMF transformer under load. The TOV magnitude at the primary side of the LMF transformer was 45.6 kV, which is below the transformer BIL of 200 kV. The frequency of 287 Hz is below the recommended maximum of 1 kHz. The new surge capacitor of 0.125 μ F dampens the ringing that is present in Cases 2 and 3. Figure 11b shows the TRV across the VCB. The voltage peak of 74.2 kV is within the limit of 74.5 kV, and the voltage rise time of 884 μ S is longer than the t3 time of 24 μ S allowed by IEEE/ANSI C37.06.

The existing surge capacitor and surge arresters at the terminals of the LMF transformers are not enough to properly protect the transformers from switching surges that occur due to the opening and closing of the VCB. The TOV at the LMF transformer and the TRV of the breaker exceeded the limits in Cases 1 and 5. Therefore, based on the results of the study, we recommended installation of a new RC snubber network with ratings given in Table III, and installed at the terminals of the two LMF transformers as shown in Figure 13. This new RC snubber network should be created by removing the existing series surge capacitors rated 0.25 μF at 13.8 kV and 0.125 μF at 24 kV and should be replaced with a single capacitor rated 0.125 μF at 35 kV. Then, a single 100- Ω resistor should be installed on the line side of the new surge capacitor. This new RC snubber along with existing surge arrester will ensure no switching transients will damage the VCB or the transformer^{2,7}. As is shown in Case 4 and 9, this new RC snubber is able to effectively dampen the transients seen at the transformer terminals as well as across the breaker contacts.

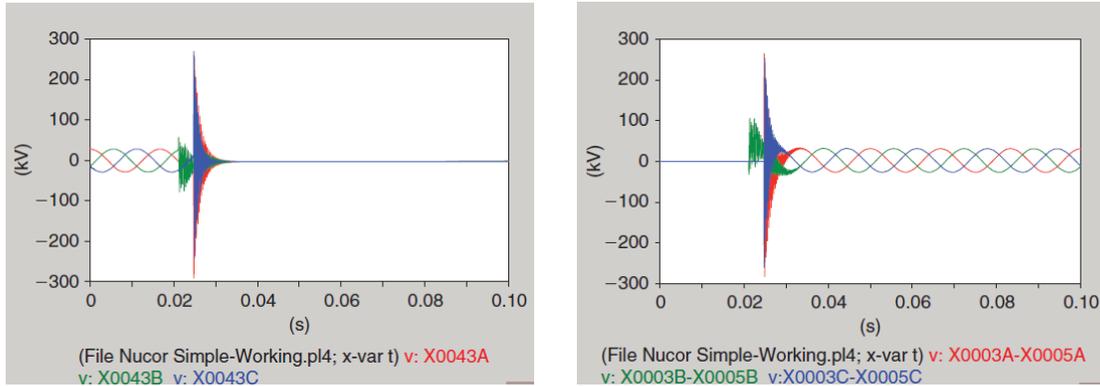
Figure 12. (a) Case 5, a transformer TOV with no snubber, (b) Case 5, a VCB TRV with no snubber

Due to the high-voltage magnitude across the VCB contacts, as shown in Table I, a restrike condition may occur. This was simulated in Case 5 and the results are plotted in Figure 12. Figure 12a shows the results for Case 5 where the VCB de-energizes the LMF transformer under load, which then causes a reignition event. The TOV magnitude at the primary side of the LMF transformer was 290.7 kV, which is over the LMF transformer BIL of 200 kV. The frequency of 3.378 kHz is above the recommended maximum of 1 kHz. Figure 12b shows the TRV across the VCB. The voltage peak of 268 kV is outside the limit of 74.5 kV and the voltage rise time of 71 μ s is longer than the t3 time of 24 μ s allowed by IEEE/ANSI C37.06. Reignitions cause the worst case TOV. Cases 6–9 were analyzed in a similar manner, and only the results are reported in Table I. The new snubber was effective in mitigating TOVs and TRVs for these cases.
