Benchmark tests of factory production and third-party reconditioned mining circuit breakers

This paper examines the quality, safety, and reliability of a random sample of 12 reconditioned circuit breakers resold and refurbished by third parties for mining applications ①. Improper modifications to circuit breakers could lead to application failure, unsafe conditions, unreliable operation, or personal injury. This paper contrasts test results of the 12 refurbished breakers with newly manufactured Eaton molded-case circuit breakers. When breakers fail to perform to specifications, there is an increased possibility of application failure and unsafe conditions for personnel.

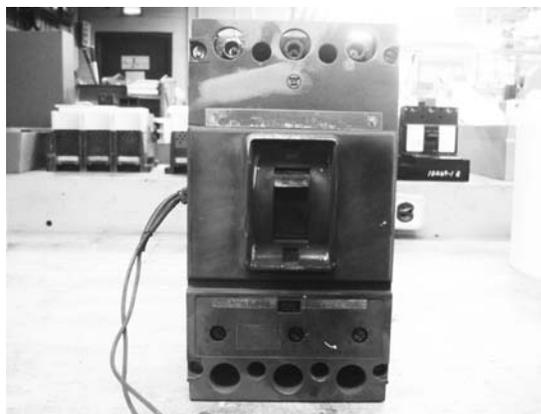
An HKA labeled third-party breaker was tested and compared to a new Eaton circuit breaker. The third-party breaker failed to trip on time in pre-test calibration, and then received its first high-level fault-interrupting test, which resulted in the center pole cable pulling out of the breaker, and the cover separating from the base (see **Figure 1** and **Figure 2**). The test breaker failed to interrupt the fault in time, so the laboratory backup breaker had to clear the circuit. The refurbished breaker was unable to attempt a second interruption. Eaton's new breaker received both high-current faults and is in notably better condition post-interruption (**Figure 3**) than the sample third-party modified breaker, pictured in **Figure 1** and **Figure 2**.

Figure 1. HKA Breaker Repaired by Third-Party Refurbisher, Following Testing

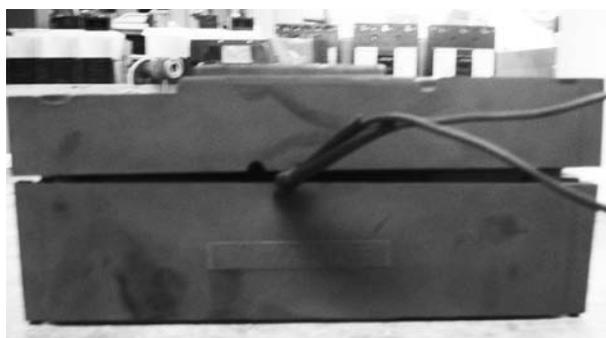
Figure 2. Breaker Cover Separated from Base During High Fault Test

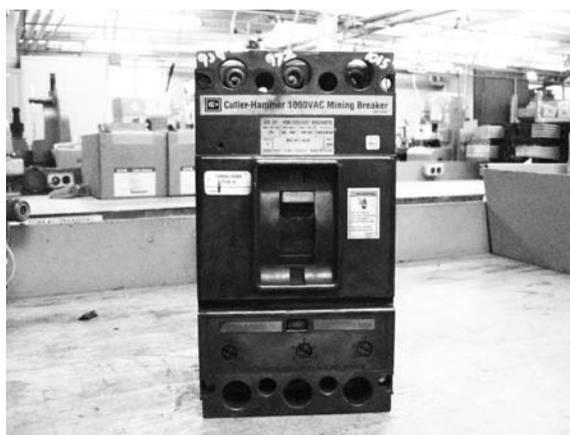
Figure 3. Eaton Manufactured Mining Breaker with Proper Identification and Labeling; Successfully Passed Testing Sequence

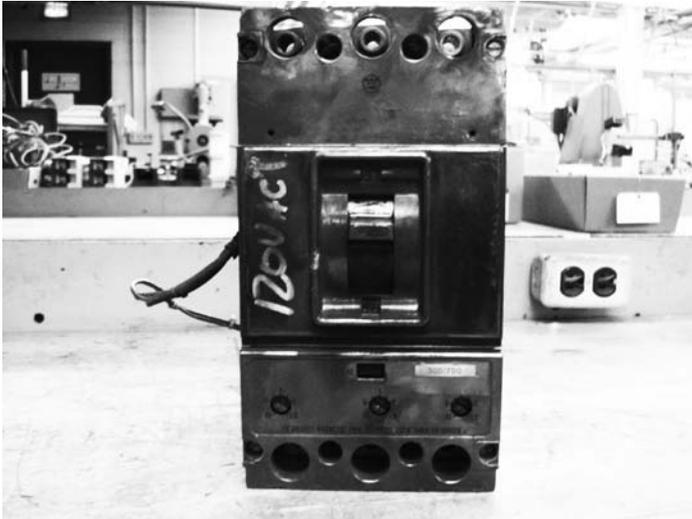
A similar looking breaker from a third party was tested. This breaker appeared like Eaton's HKA; however, it had no nameplate or catalog information to properly identify it or its ratings. The breaker's ratings were assumed to be those of the Eaton HKA design, and it was subjected to the high interruption test. When the breaker was first closed, there was no continuity in the center and right poles, which prevented it from being calibrated. It failed the first high fault interrupting test, with the cover separating from the base, and the laboratory backup breaker cleared the fault (see **Figure 4** and **Figure 5**). The sample third-party breaker is in worse condition than the comparable newly manufactured Eaton breaker after the same test (**Figure 3**).

Figure 4. Third-Party Refurbished Breaker Without Nameplate or Product Identification

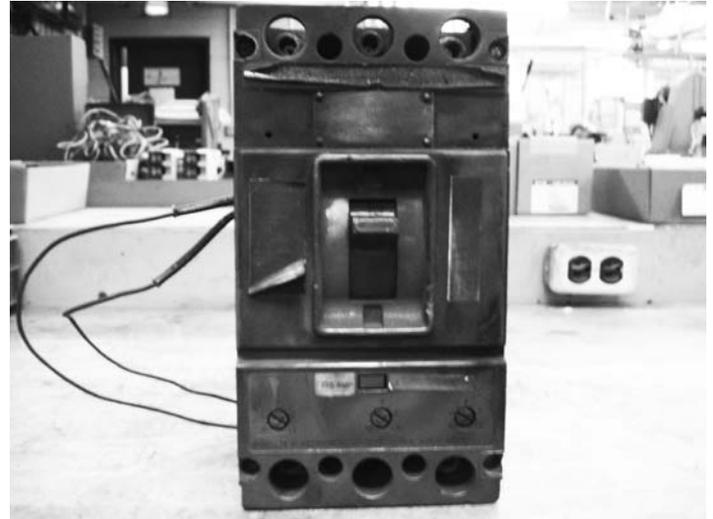
Another sample modified breaker, type HKA, was tested in the high interruption test at 480V, 60 Hz, with 35,000A available. The third-party sample failed the first high fault interruption test, with the base separating from the cover and the lab back-up breaker clearing the fault. The wires were pulled out of the left and center poles. The third-party sample is again in much worse condition than the new Eaton sample, even after the Eaton breaker endured a second fault interruption test. **Figure 6** shows the third-party unit after testing, and **Figure 7** shows that the A and C phase line conductors (on top) overheated and the material melted off.

Figure 6. Third-Party Refurbished Breaker Shown Post-Testing; No Nameplate Provided

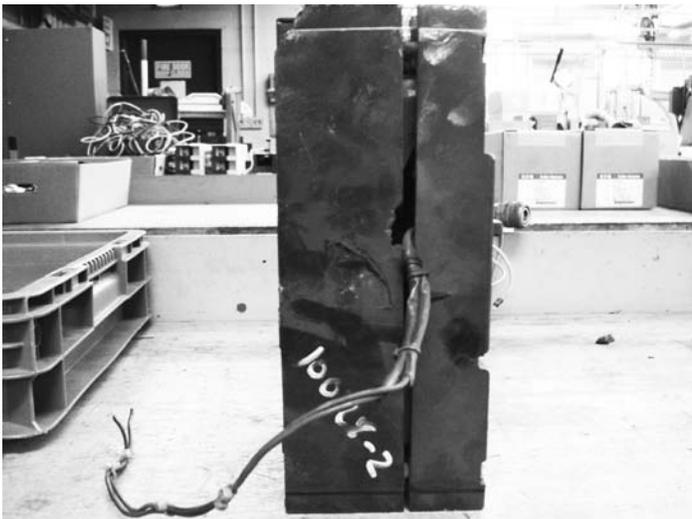
Figure 5. Post High Fault Test; Breaker with Cover Separate from Base

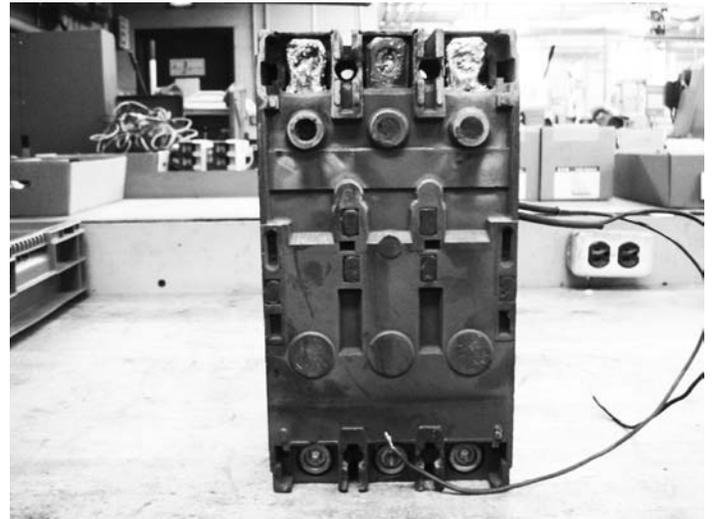
Figure 7. Breaker After High Fault Test; Conductor Material Overheated and Melted Away

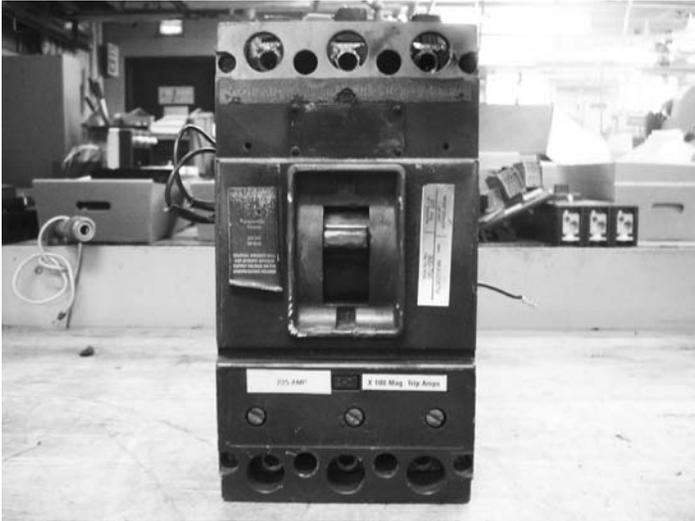
Another HKA third-party reworked breaker was subjected to a low-level short-circuit test. The third-party sample passed pre-test calibration, but it failed to interrupt in the first short-circuit test and allowed an arc to strike the test enclosure. The ground fuse connected to the enclosure was opened by the excess current of the arc to ground, and the wires welded to the terminals. In addition to failing to interrupt, the opening of the ground fuse is also a non-conformance. **Figure 8** and **Figure 9** show the unit after testing.

Figure 8. Third-Party Refurbished Breaker Failed to Interrupt on Short-Circuit Test

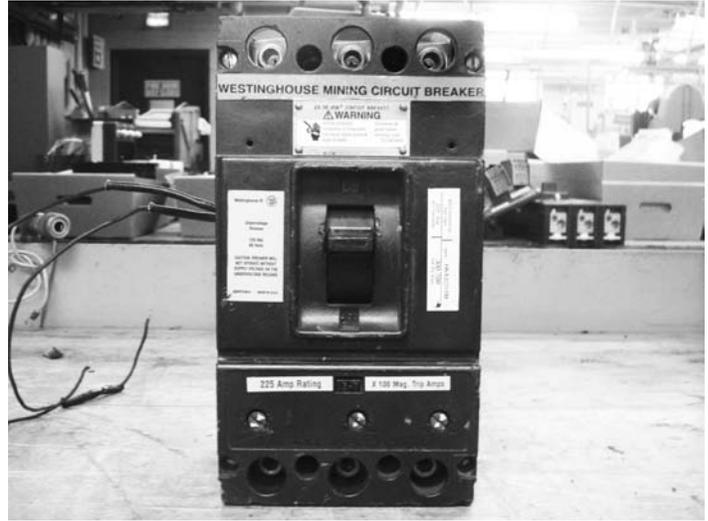
The unit was believed to be an HKA; the sample was tested for endurance based on Eaton's published data for the HKA frame. The third-party sample passed initial calibration, but failed the endurance test when the ground fuse opened during the load operations at the rated current. After the ground fuse opened, the center pole of the breaker did not have continuity when closed. **Figure 10** and **Figure 11** depict the third-party breaker after testing.

Figure 10. Third-Party Refurbished Breaker After Failing Load Endurance Test

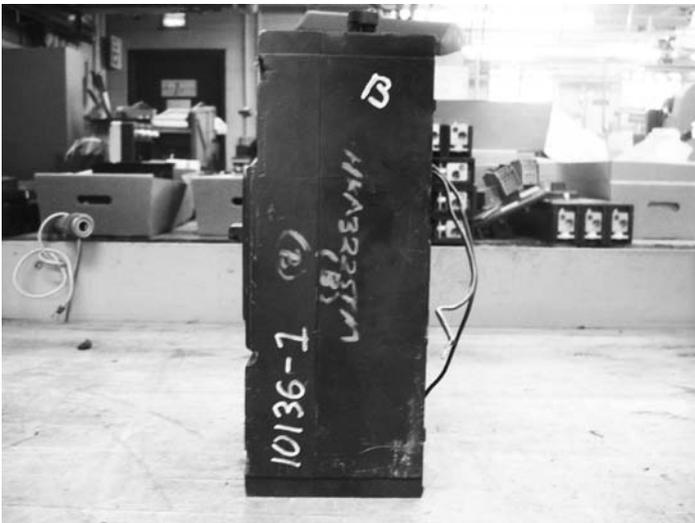
Figure 9. Wires Welded to Terminals After Excess Current Traveled to the Ground

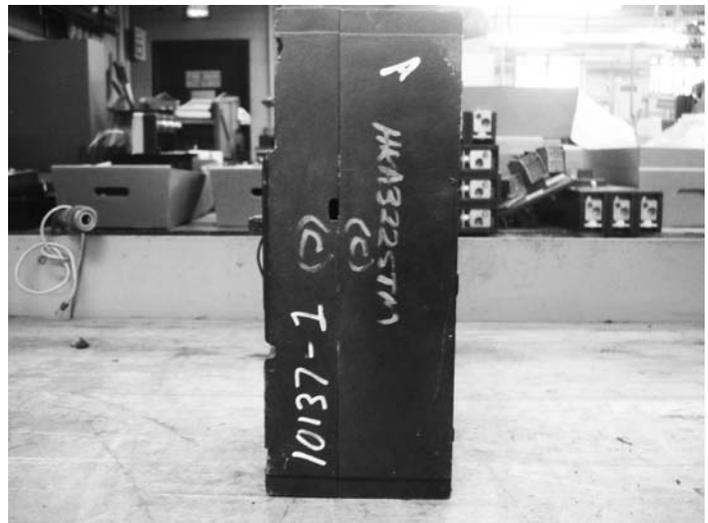
Figure 11. After Failure, Breaker Lost Continuity in the Center Pole

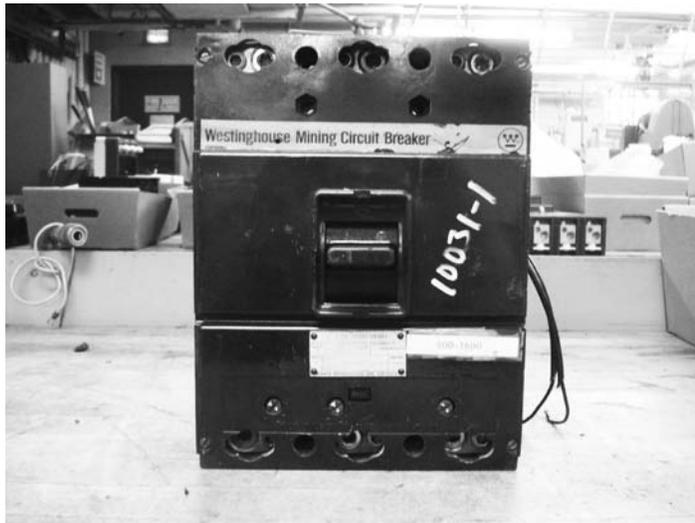
In this test, the third-party unit appeared similar to Eaton's LAM circuit breaker, but the nameplate had limited information. It was tested in accordance with the calibration test procedures. The third-party breaker tripped below the maximum time limits in 200% single-pole and 135% three-pole initial calibration tests and passed the overload portion, but it failed to remain closed during the temperature rise test at 100% of rated current. The breaker tripped before its temperature stabilized. The results indicated that the thermal release on the third-party sample was not properly calibrated; the error was likely to result in nuisance tripping. Eaton's production test procedures require trip units to be calibrated so that breakers will not trip before temperatures are stabilized at 100% of the rated current in their designated ambient temperature. **Figure 12** and **Figure 13** are photographs of the failed refurbished breaker after the test.

Figure 12. Third-Party Refurbished Mining Breaker with Limited Nameplate Information

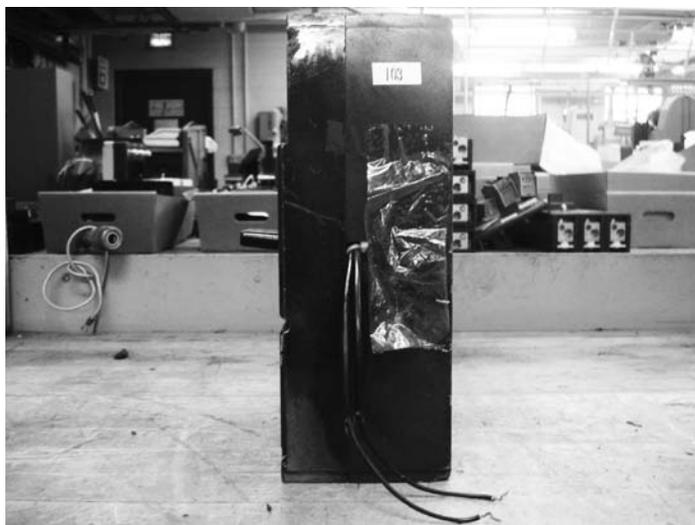
Figure 13. Breaker Did Not Stay Closed During Temperature Testing, Indicating Incorrect Calibration

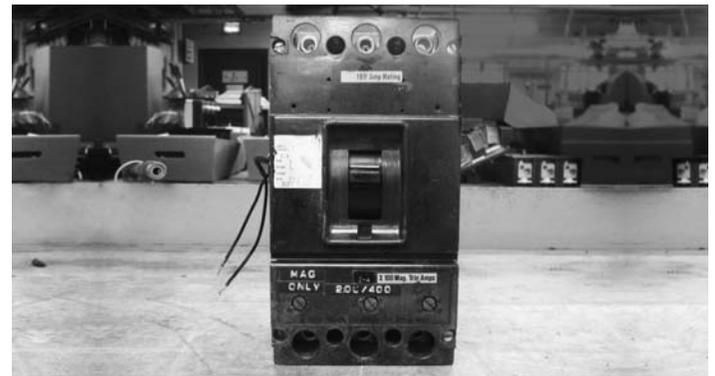
A sample third-party modified HKAM breaker was subject to the endurance testing and compared to an Eaton HKAM circuit breaker from current production. The third-party refurbished breaker had a malfunctioning undervoltage release (UVR) that would not stay engaged with the full rated 120V applied to it. Consequently, it would not remain latched and the breaker could not be closed; **Figure 14** and **Figure 15** are photographs of the third-party breaker after testing. In contrast, the Eaton newly manufactured breaker passed every portion of the testing procedure, which includes pre-calibration, endurance operations, a low-level interruption, post-calibration, and dielectric withstand. **Figure 16** is an image of the Eaton production breaker after testing. Eaton tests the pickup and dropout voltage of each UVR to ensure that the accessory functions properly when installed in the circuit breaker.

Figure 14. HKAM Mining Breaker Modified by Third-Party Refurbisher

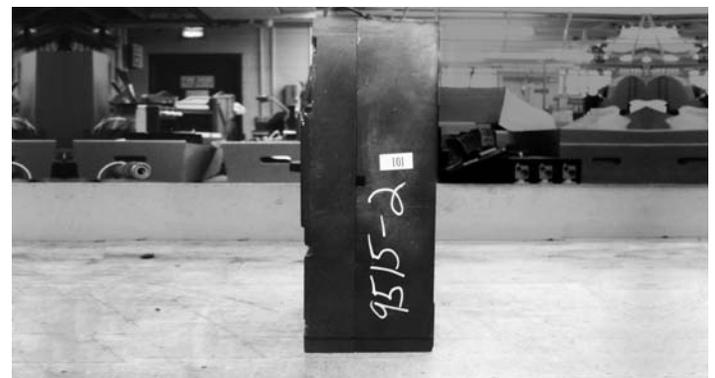
Figure 15. Undervoltage Release Accessory Malfunctioned; Breaker Could Not be Reclosed

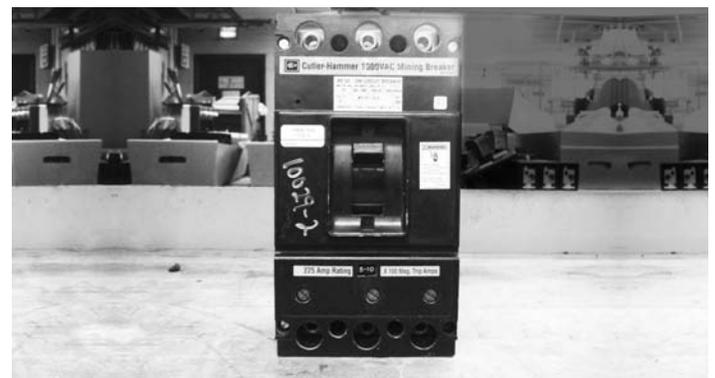
Figure 16. Eaton Manufactured Breaker; Undervoltage Release is Tested for Proper Operation

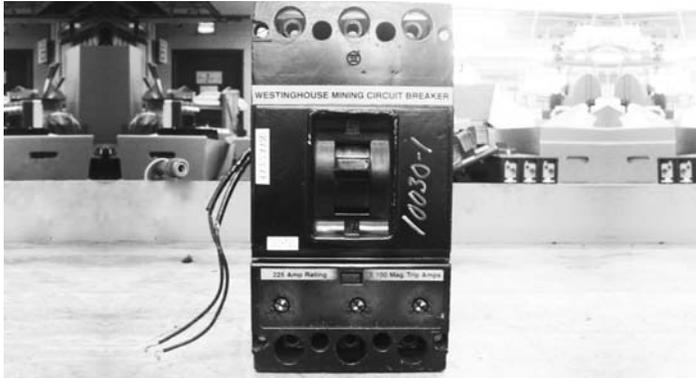
The third-party breaker had incomplete information on homemade labels. The sample was tested for low-level interruption and compared to a new Eaton HKAM circuit breaker from current production. The third-party breaker failed initial calibration, with one pole carrying 200% of rated current past the allowable trip time. The sample completed the short-circuit portion of the test and passed post-interruption dielectric withstand. Eaton's circuit breaker passed the sequence with no non-conformances.

Figure 17. Third-Party Refurbished HKA Breaker with Poor Quality, Homemade Labels; the Breaker Failed to Trip on Overload Test

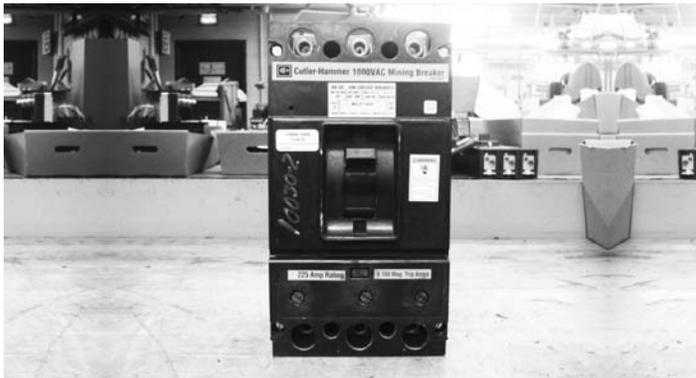
Figure 18. Eaton Production Breaker Shown After Testing; it Passed the Entire Test Sequence with No Issues
