## Surge Protection for Ladle Melt Furnaces

T.J. Dionise<sup>1</sup>, S.A. Johnston<sup>2</sup>

### EVALUATION OF LMF TRANSFORMER SURGE PROTECTION

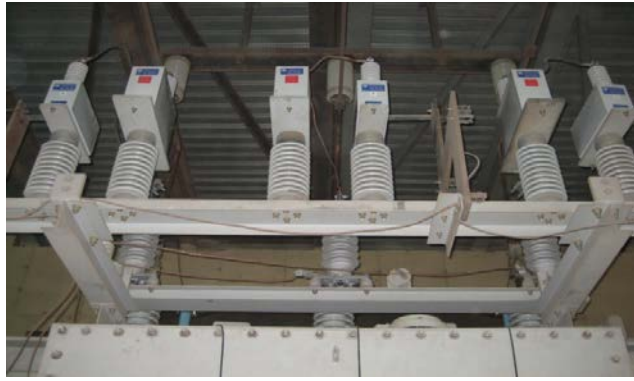
Figure 2. The surge arrester, capacitor and resistor removed for LMF1

The LMF transformer 34.5 kV surge protection consists of a surge arrester in parallel with a surge capacitor and resistor (removed) as shown in Figure 2. The surge arresters are rated for 36 kV and connected from the bushing of the LMF transformers to the ground jumper. The two surge capacitors in series with values of  $0.125 \mu\text{F}$  at 24 kV and  $0.25 \mu\text{F}$  at 13.8 kV are also connected between transformer bushing and ground. The effective surge capacitance is  $0.083 \mu\text{F}$ . The resistor was sized after the manufacture of the LMF transformer and no record of the original designed value of the resistor is available. The resistors were removed from the circuit after operations commenced due to overheating.

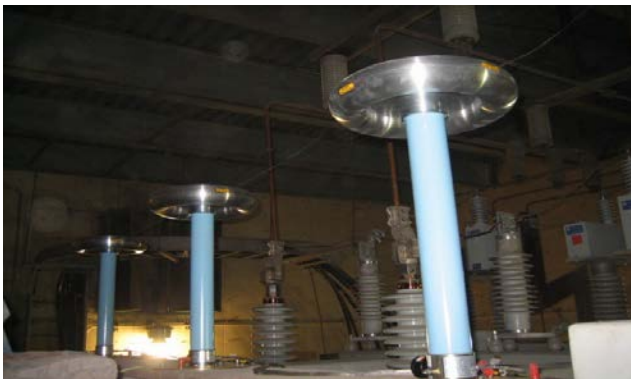
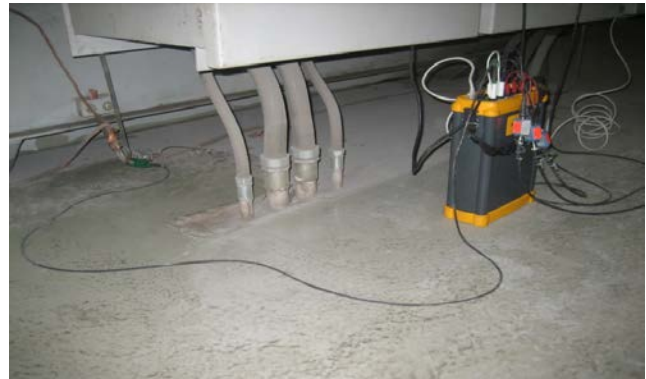
Figure 3. (a) The voltage dividers installed at LMF1 primary, (b) The transient recorder and grounding for LMF1

The test measurement setup consisted of voltage dividers and a transient recorder as shown in Figure 3. Proper measurement equipment was selected to assure accurate capture of the switching transient overvoltages at the 34.5 kV primary of the LMFs. The voltage dividers were sized for the system kilovolts and specified with a secondary output impedance to match the input impedance of transient recorder. The voltage dividers were placed on top of the transformer, as close to the LMF transformer bushing as possible, to detect any voltage reflections that occur when the incoming wave hits the sudden change in surge impedance of the transformer bushing. Vibrations were minimized by fastening the voltage dividers to a sheet of plywood clamped to the transformer. The voltage dividers were connected to the transformer primary bushing with a sweeping arc of number 10 insulated wire (120 V) as shown in Figure 3a. Care was taken to maintain proper phase-to-ground clearances between the voltage dividers and jumper wire to nearby equipment, as well as phase-to-phase clearances between the dividers. Figure 3b shows the measurement setup for LMF1 typical of both transformers.
