# Fuller Transmissions TRTS0920 EN-US

June 2015

The purpose of this manual is to assist in the diagnosis and repair of your air system. Use this manual in conjunction with other service literature produced by Eaton®, including Service Bulletins, Illustrated Parts Lists, Service Manuals, and OEM service material.

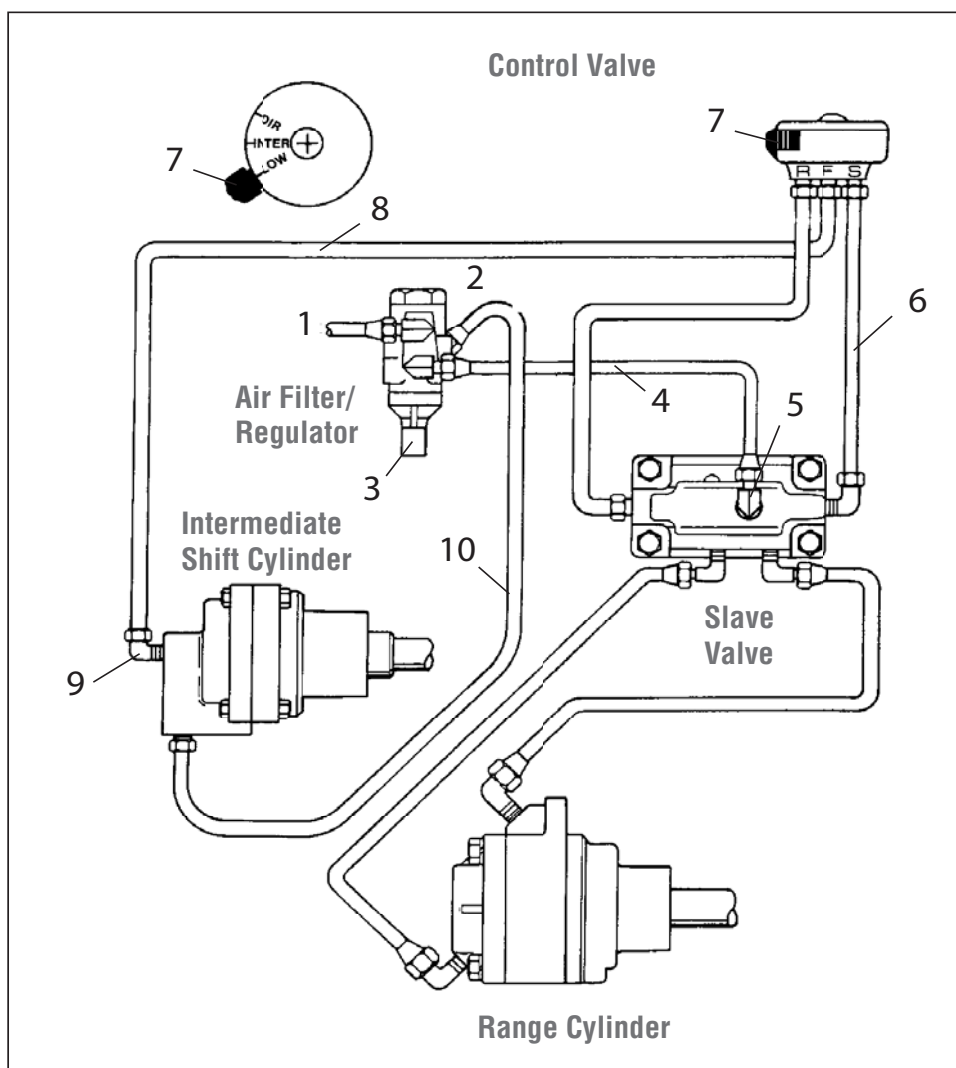
Air is supplied to the system at the air supply port (1) by the vehicle's air system. The air filter (2) removes foreign matter from the air then allows it to pass through the air regulator (3) where the pressure is adjusted for 58 to 63 PSI (4.0 daN/cm<sup>2</sup>). From there the air passes through the supply air hose (4) to the slave valve supply port (5) through the supply air line to the control valve (6).

Depending upon the position of the control button (7), if air passes through the air line (8) connected to the intermediate shift cylinder center port (9) then the intermediate/direct gearing is disengaged. If there is no air, the constant air from the air filter/regulator assembly (10) moves the intermediate piston forward to engage LO gearing.

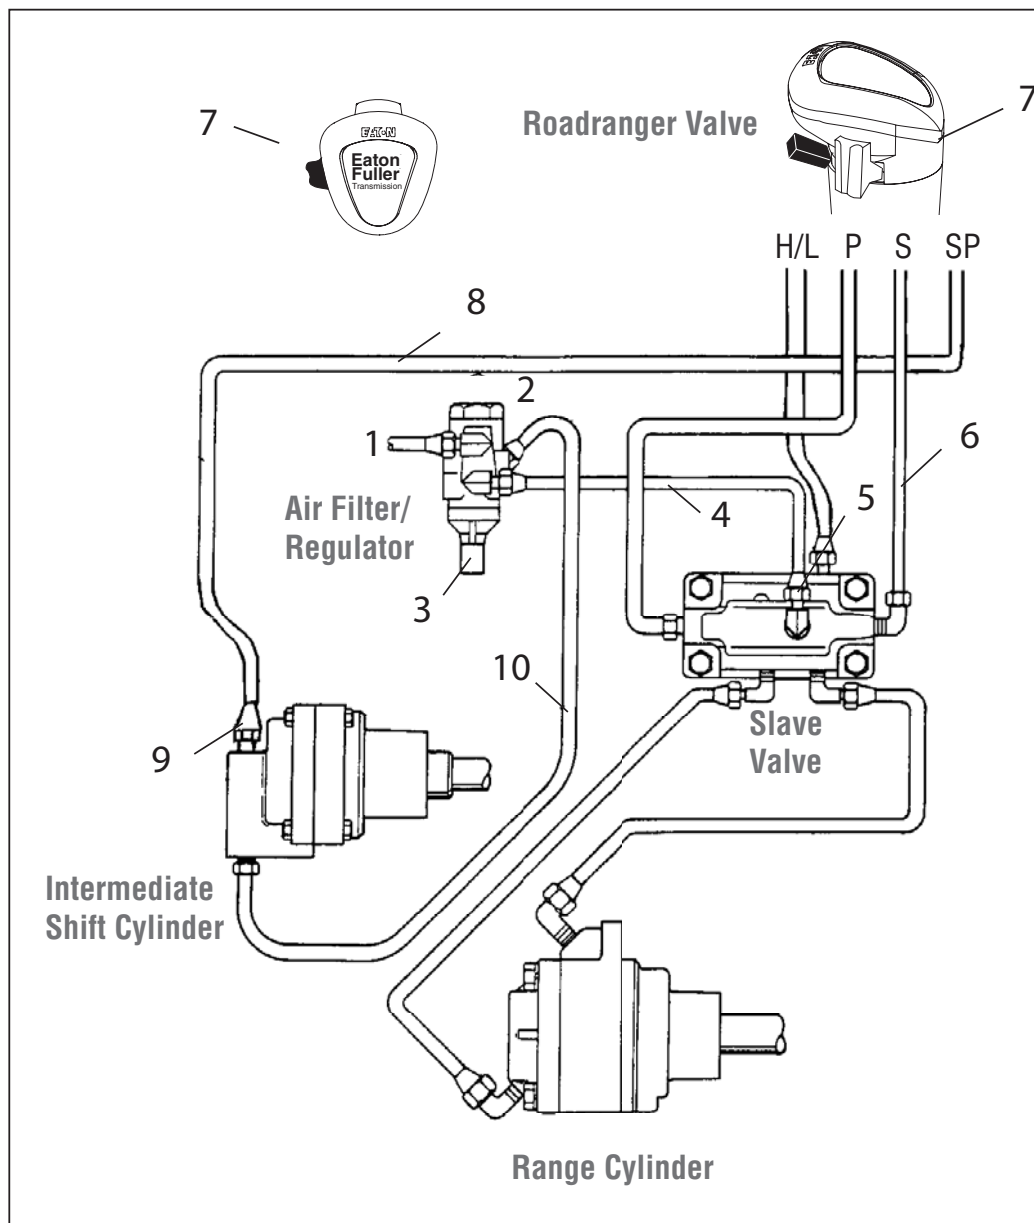
## RT & RTO 613 and 6615 Models With A-6913 Roadranger Valve

This system consists of a A-6915 Roadranger valve and an intermediate shift cylinder in addition to the range cylinder. The intermediate shift cylinder shifts the transmission between deep reduction and LO range, the range cylinder shifts the transmission between LO and HI range.

Depending upon the position of the splitter button (7), if air passes through the air line (8) connected to the intermediate shift cylinder top port (9) then the deep reduction gearing is engaged. If there is no air, the constant air from the air filter/regulator assembly (10) moves the intermediate piston rearward to disengage deep reduction gearing.

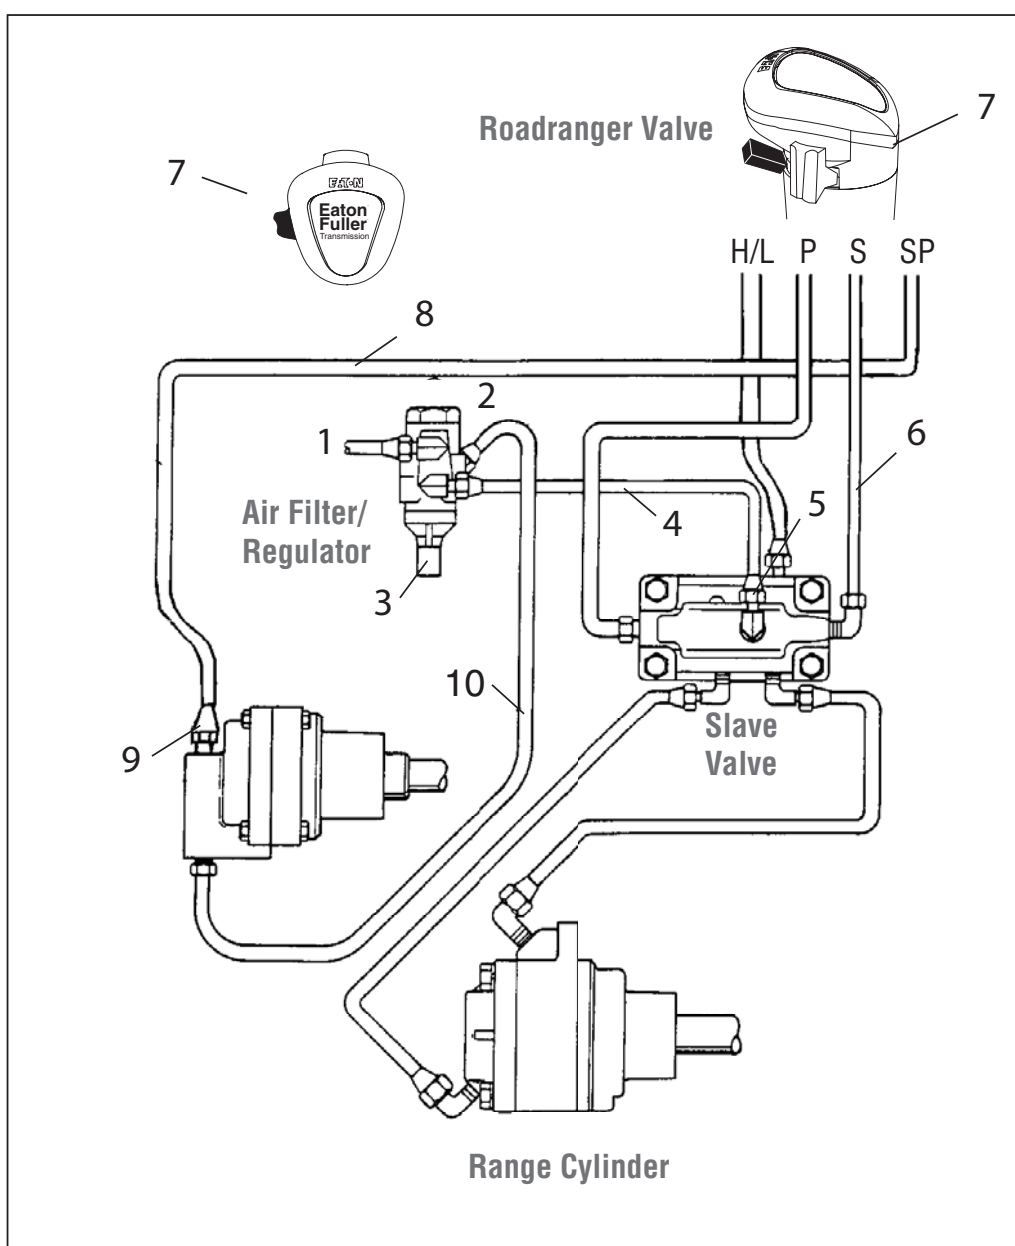
Depending upon the position of the splitter button (7), if air passes through the air line (8) connected to the deep reduction cylinder top port (9) then the deep reduction gearing is engaged. If there is no air, the constant air from the air filter/regulator assembly (10) moves the piston forward to disengage deep reduction gearing.

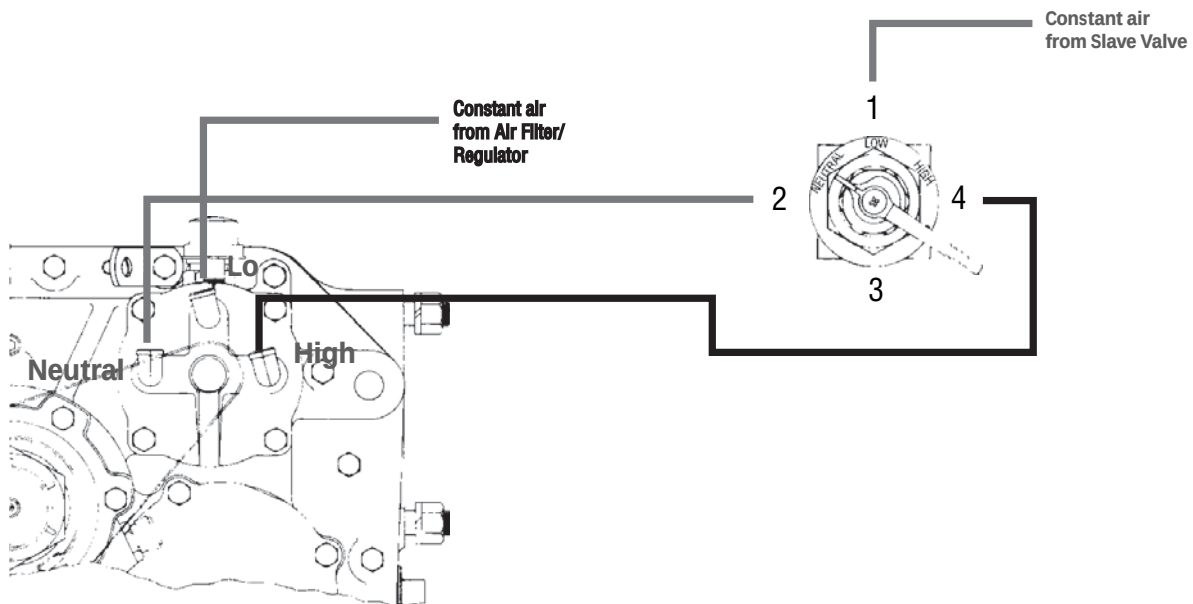
### *Neutral*

The valve allows air to pass from #1 to #2 placing the auxiliary transmission in neutral.

#4 is connected to #3 to exhaust the air.

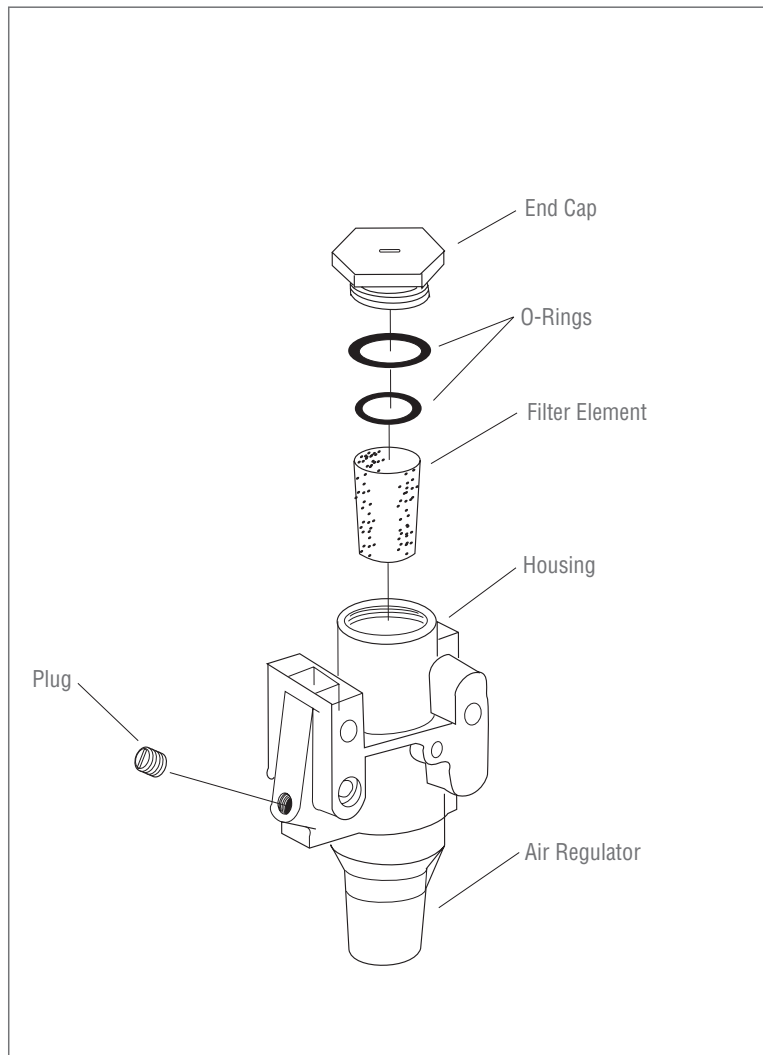
The air filter removes foreign matter from the air then allows it to pass through the air regulator where the pressure is adjusted to 58 to 63 PSI. The output air pressure will not be in range if the truck's air pressure is incorrect.

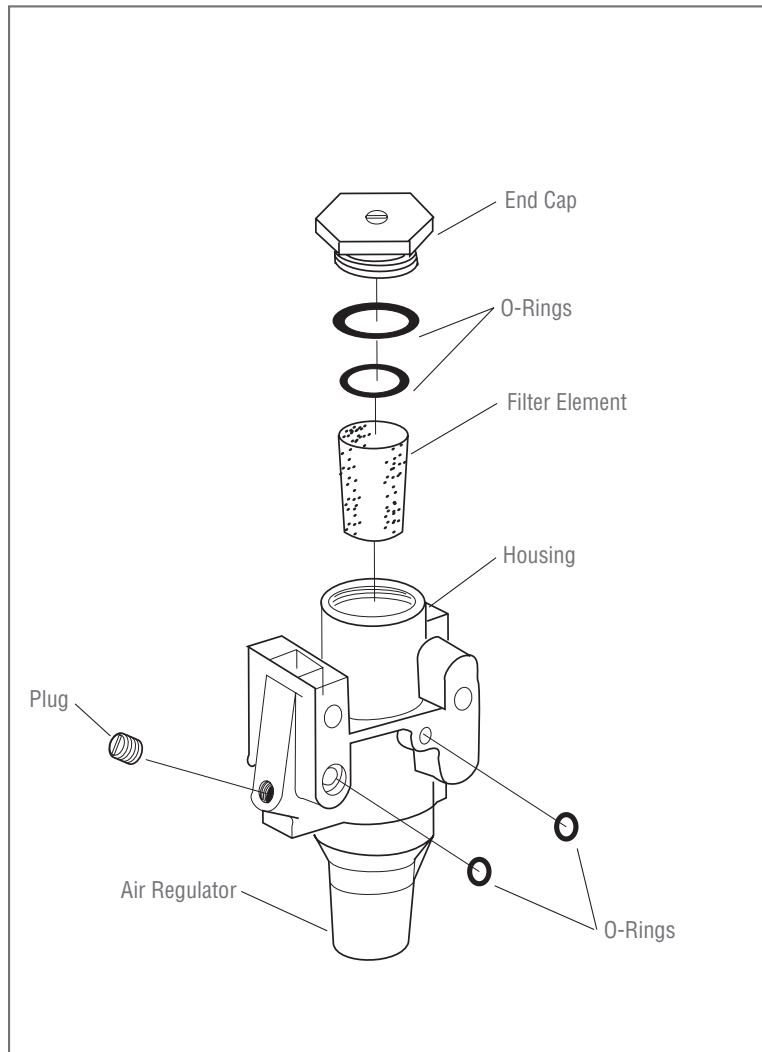
The air filter removes foreign matter from the air then allows it to pass through the air regulator where the pressure is adjusted to 58 to 63 PSI. The output air pressure will not be in range if the truck's air pressure is incorrect.

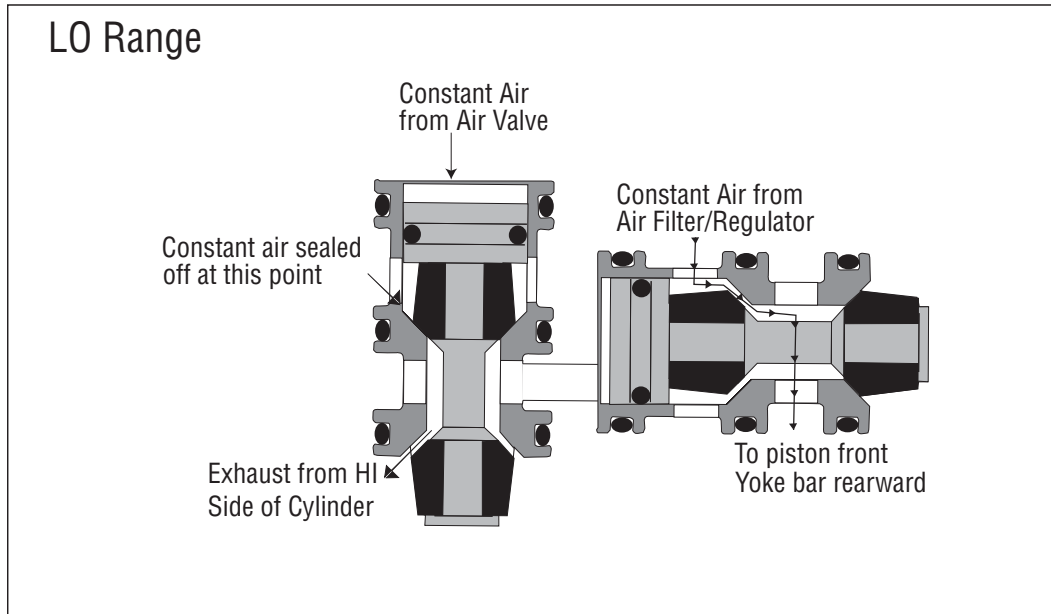
Insert valve piston travel is only 1/16". When air is applied to the valve piston top side, one piston moves down sealing off the constant air supplied from the air filter/regulator, the other piston allows the constant air supplied from the air filter/regulator to pass freely through the insert valve, to the cylinder piston front side, moving the yoke bar rearward to engage the LO range gearing.

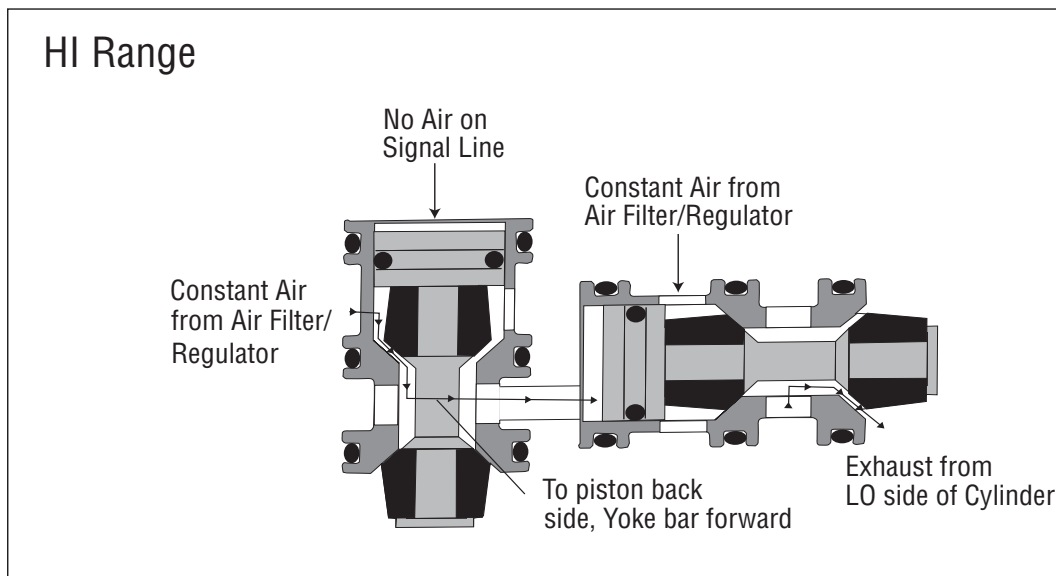
When no air is applied to the signal line, the piston moves up allowing the constant air supplied from the air filter/regulator to pass freely through one insert valve to the piston back side, moving the yoke bar forward to engage HI range gearing and sealing off the constant air from the air filter/regulator to allow the air from the piston front side to exhaust.

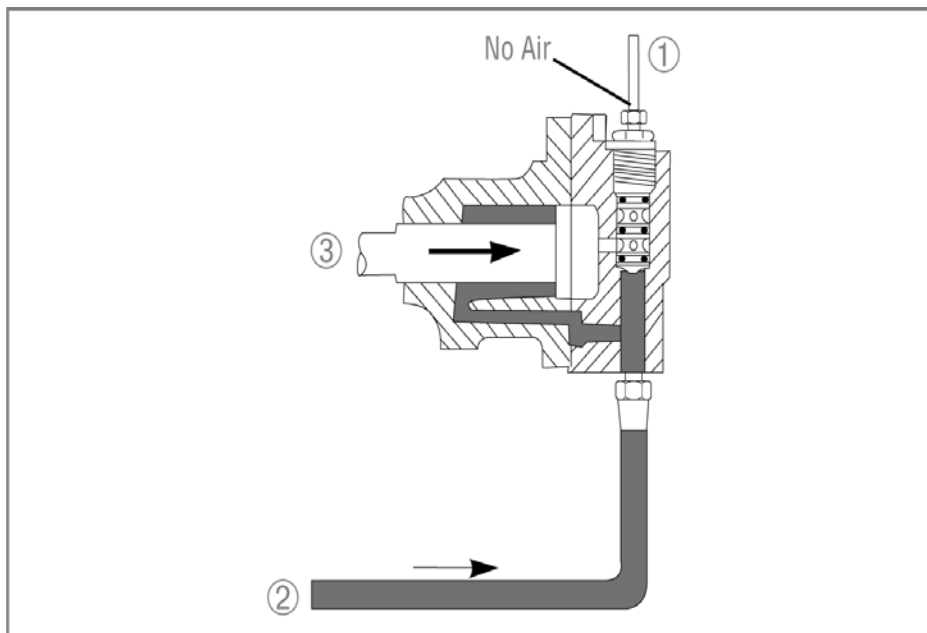
**LO or HI Range** - With the Roadranger valve lever in the down position, no air is supplied to the Intermediate cylinder cover port (1). The constant air from the air filter/regulator assembly (2) moves the piston rearward (3), disengaging deep reduction gearing.

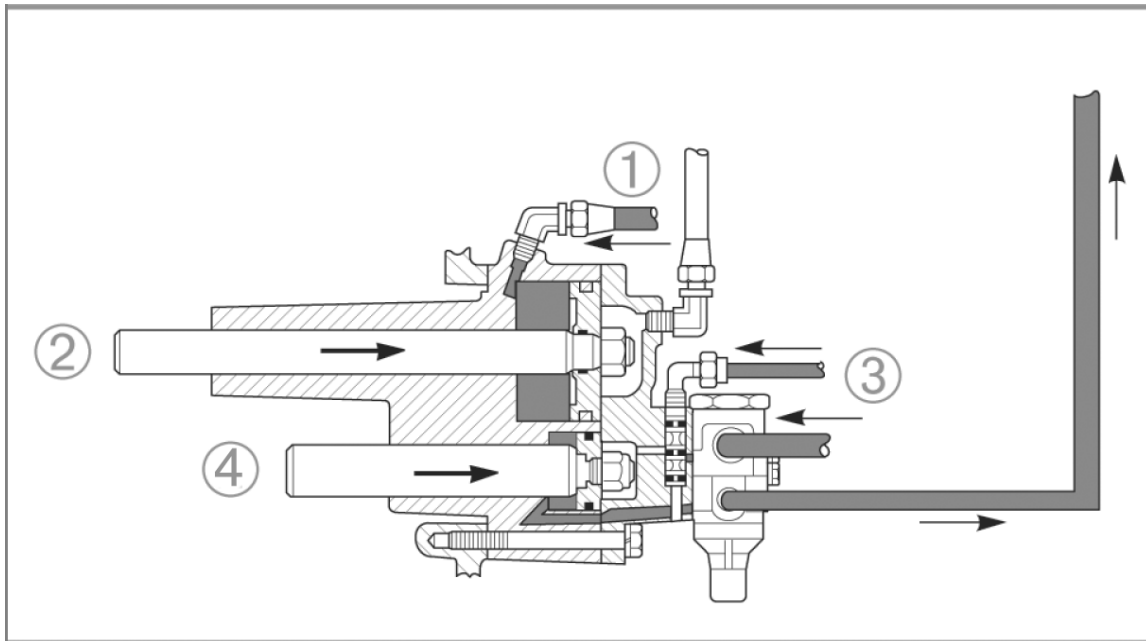
**Deep Reduction** - With the range lever in the "down" position, air is supplied to the LO range port (1), moving the range piston rearward to engage LO range gearing (2), and the deep reduction button is in the "forward" position. Air is supplied to the deep reduction cylinder cover center port (3), moving the reduction piston rearward (4), and engaging deep reduction gearing.

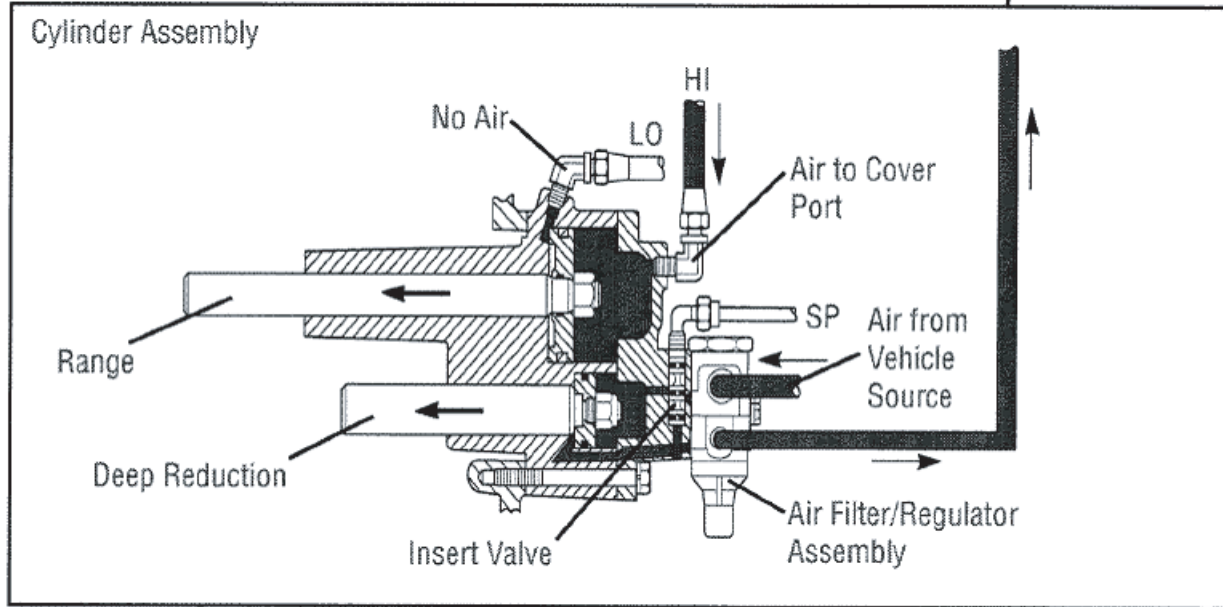
**HI Range** - With the range lever in the "up" position, air is supplied to the HI range port (1), moving the range piston forward (2), engaging HI range gearing AND the deep reduction button is in the "rearward" position. No air is supplied to the deep reduction cylinder cover center port (3). The constant air from the air filter/regulator assembly moves the reduction piston forward (4), disengaging deep reduction gearing.
