“WHISKERS” THE ROOT CAUSE OF SPONTANEOUS SHORT CIRCUITS

Abstract

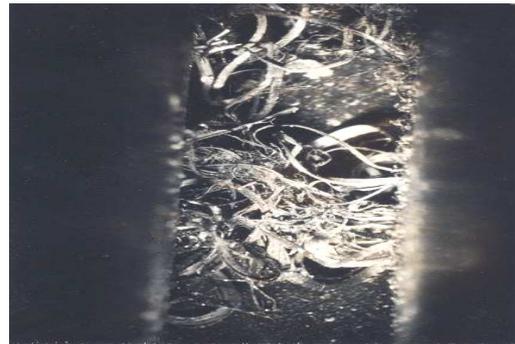
In the early 1970's, a serious problem occurred on one of the electro mechanical contactors in a low voltage switchgear assembly in Durban South Africa. By investigation of the contactor, strange fibres were found on the silver plated terminal flags.

During inspection of these fibres and tests carried out in the laboratory it was noticed that:

- the fibres were very good conductive,
- would turn into blank metal when heated up to $400^{\circ}C$,
- that they became blank by cleaning them with “Thiomeum Hydrochloric” and
- that the blank fibres would fully resolve again in nitric acid: proving that the fibres were pure silver.

It was concluded in first instance that the fibres found were silver sulphide (Ag_2S) in combination with pure silver. Literature reviews lead to an article in ETZ of December 1962 written by Albert Keil and Carl-Ludwig Meyer [2&3]. In these papers, fibres were described as found on the contactor and were called silver whiskers. The circumstances described in the articles were very similar to the circumstances of Durban South Africa. Sulphur in the ambient atmosphere (the switchgear was installed in a switch house adjacent to a sulphur plant) and a high relative humidity of the ambient air were the case. First thought was that the high tropical temperature was the 3rd ingredient, but later it was noticed that the high ambient temperature was not the reason of growing these fibres but the temperature rise just originating from a contact subjected to ageing.

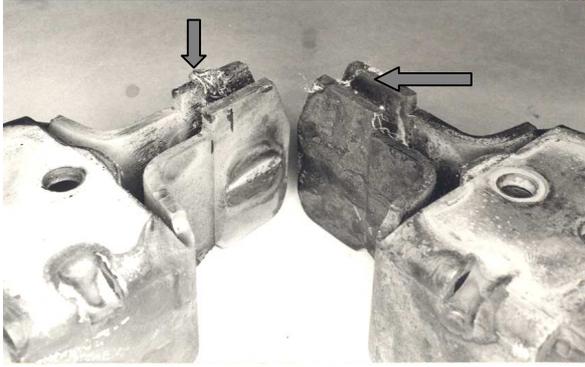
Mid 1974 another product failure appeared, this time on a refinery in the Caribbean's. During an investigation on switchgear installed the same type of fibres as found in Durban were detected.

Ambient circumstances on the Caribbean island were similar to the Durban refinery case that indicated again that silver whiskers were the cause. Above failures initiated a thorough literature survey as well several simulation tests were carried out in the laboratory. These laboratory tests were extended by investigations carried out by Shell Laboratory Amsterdam. Close co-operation between both the laboratories lead to the conclusion that again the phenomena of silver whiskers resulting from silver sulphide on the silver-plated contact surfaces of components used in the low voltage switchgear assemblies.

As there was no parallel to Durban in the respect of a Sulphur plant next to the switch house it was noticed that the Curacao refinery was cracking a high sulphur containing crude oil from Venezuela resulting in high sulphur content in the ambient atmosphere. Shortly after this incident, another one incident was received again with a similar short circuit incident in a Singapore refinery and also most probably initiated by silver whiskers. Actually in all three plants (Durban, Caribbean's and Singapore) it was found silver whiskers on relatively new switchgears (early 1970 supplies).

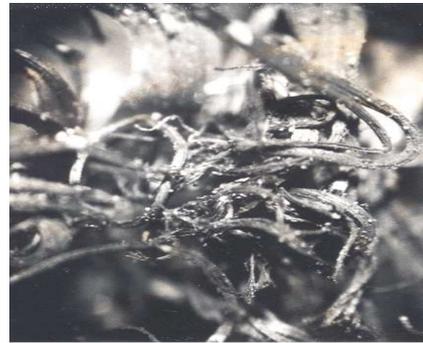
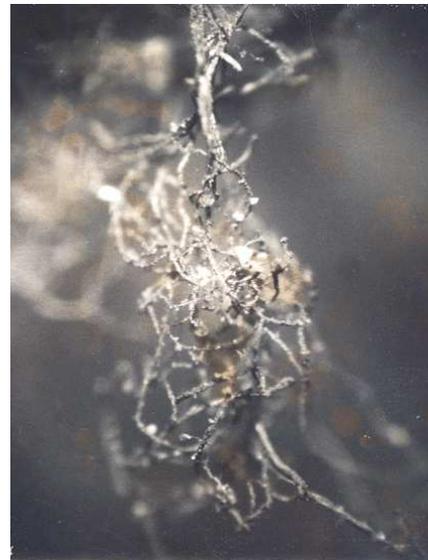
During laboratory tests subsequently conducted, it showed that by increasing the temperature or the humidity the growth of silver whiskers rapidly increased.

The next photographs show examples of these whiskers, grown under these laboratory circumstances.
