MEDIUM VOLTAGE REDUCED VOLTAGE AUTOTRANSFORMER STARTER FAILURES – EXPLAINING THE UNEXPLAINED –

Abstract- For the past century the Autotransformer, or “Korndorfer” Starter has been a standard in the electrical industry. However for more than the past thirty years the autotransformer starter has been experiencing unexplained “High Voltage Stress” failures in typical applications. These failures have been reported on 2,400-volt starters from South America to 11,000-volt starters in the North Sea. In most cases the Zero Tap or the turns close to the zero tap are involved in the failure. This paper discusses the failure mode and the corrective action that prevents “High Voltage Stress” failures.

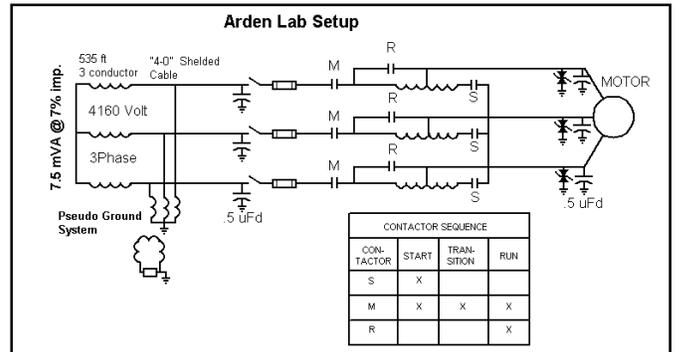
Fig. 8. Arden Test Lab Setup

In January 2003 the tests were moved to an indoor lab. The power system (Fig. 8). for this lab is an ungrounded wye system, so a high impedance, low frequency ground was established using three transformers in wye, open-cornered delta and a surge capacitor of 0.5 μ Fd supplying the high frequency ground.

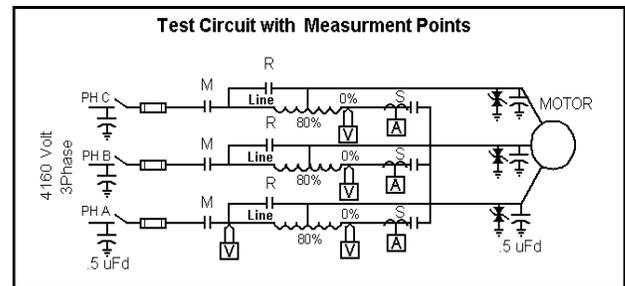
Fig. 9. Test Circuit Schematic.

Test Circuit: Voltage and current in the 0% tap circuit was measured and the line voltage on phase "A" as shown in Fig.9.
