A Journey Toward Electrical Workplace Safety and Production Reliability

Abstract -- This paper outlines the experience of one global cement producer that embarked on site surveys and studies to achieve arc flash safety compliance at 13 cement plants in the U.S. and Canada. The enterprise wide electrical workplace safety initiative resulted in compliance by all plant sites to the latest standards, with new labels affixed to each openable electrical panel that quantified the hazard. Labels designated the proper personal protective equipment (PPE) required to ensure electricians performing energized work would be safe from potential arc events. The experience of one plant in deploying select new technologies to mitigate arc flash in areas where hazards were very high will be reviewed in detail. Site electrical upgrades resulted in enhanced safety along with an unexpected benefit; a significant improvement in production reliability. A follow-up project to increase the plant grinding capacity at the site outlines how new additions to the electrical infrastructure employed a “safety by design” approach to ensure arc flash safety.

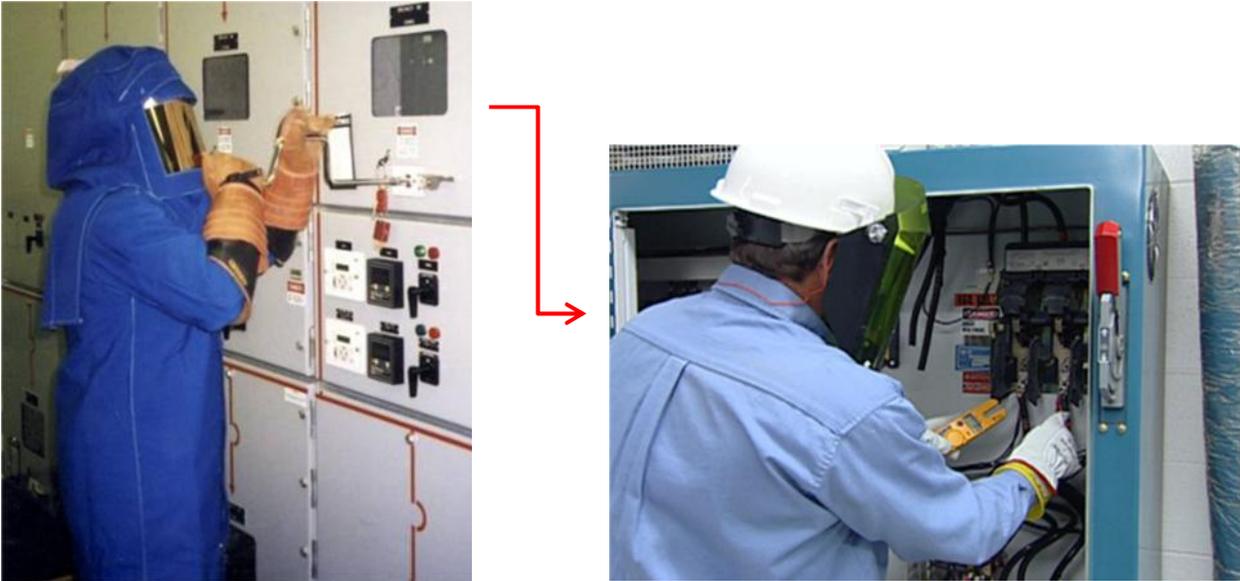
Fig. 2. After the arc flash study is complete, facility engineers review the results and identify areas of the electrical system where incident energy could be reduced, allowing workers to move from a higher level of PPE ($40 \text{ cal}/\text{cm}^2$ shown at left), to a more manageable level of PPE ($8 \text{ cal}/\text{cm}^2$ shown at right).
