Eaton Clutch Failure Analysis Guide All Clutch Models CLTS1271 EN-US

January 2025

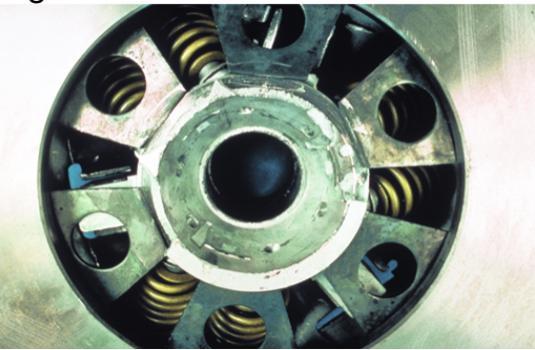
Fig 8

The broken mounting bolts, show in Figure 8, are the direct result of insufficient torquing of these (8) bolts to the flywheel. More specifically, these bolts were loose enough to allow the clutch cover to hammer back and forth against each bolt until they broke. Also, the (8) mounting bolt holes in the clutch cover were "egg-shaped" as a result of the constant hammering.

Clutch is loose on flywheel (see Figures 8 - 10)	Install a new clutch assembly and eight new mount- ing bolts.

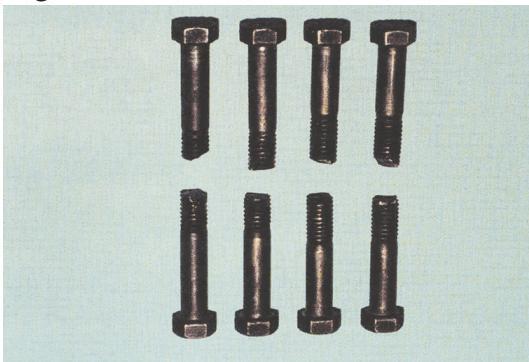
Fig 9

Additional damage occurred to both the clutch cover and the release yoke as a result of their interference with each other (refer to the arrows in Figures 9 and 10). It is worth noting that this service clutch had accumulated 50,000+ miles before it failed.

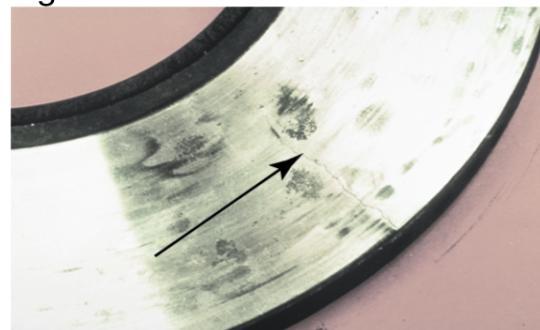
Figures 13 - 16 depict damaged clutch plates which resulted from an abnormal amount of clutch slippage/heat. Some causes of this abnormal slippage/excess heat can be one or more of the following:

Figure 13 is an example of a cracked pressure plate. The heat flow was so great that the metal could not dissipate it quickly enough.

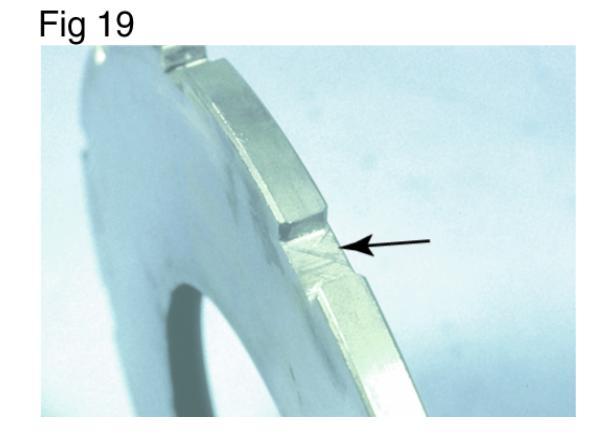
Fig 20

Figure 20 shows a broken drive pin head that has become wedged into the intermediate plate's drive slot. Figure 21 is the same intermediate plate but with excessively worn and broken drive slots. Figure 22 shows a broken drive pin. The above failures can be caused by one or more of the following:

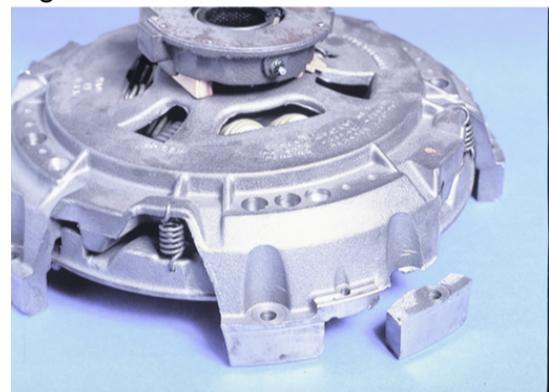
Fig 27

The photo in Figure 27 is a close-up of the broken leg shown in Figure 26. The arrow in this close-up shows where the leg contacted the concrete floor after the clutch was dropped.

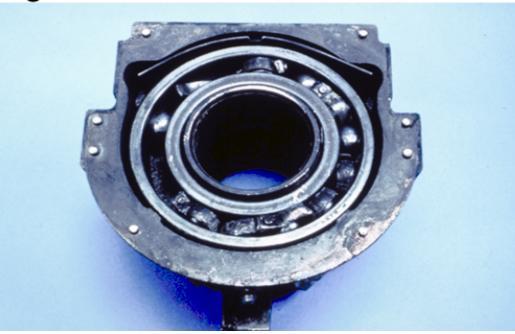
Fig 29

- A dry release bearing due to lack of periodic lubrication (does not apply to sealed bearings).
- Failure to fully release or riding the clutch pedal will place a constant thrust load on the bearing, (see arrows in Figure 29) leading to higher temperatures and consequential loss of lubricant. Failure to maintain free play up in the cab can also cause this condition. Not only will the bearing begin to fail, constant contact in this area will cause both the release yoke fingers (Figure 79), and the wear pads (Figure 29), to wear excessively.

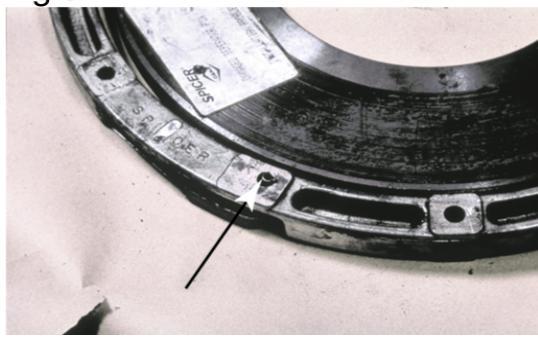
Fig 32 (EPP 15.5")

The damage done to the separator pins in Figures 32 and 33 (see arrows) is the result of using the wrong tool combined with excessive force. All four pins (on each intermediate plate) were damaged. When "setting" the four (4) roll pins, the proper tool would be a 1/4" flat nose punch used in conjunction with a small hammer (to help ensure light taps).

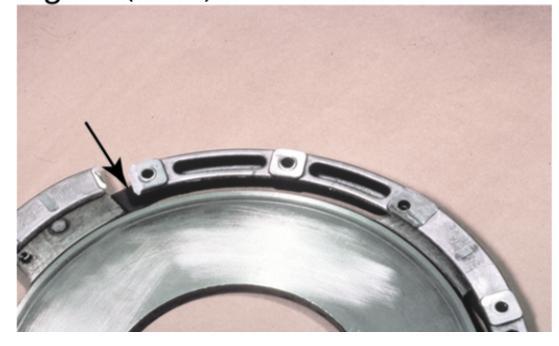
Fig 34 (SAS)

As shown in Figure 34 (see arrow), the aluminum spacer ring broke when it was bolted up backwards onto the flywheel.

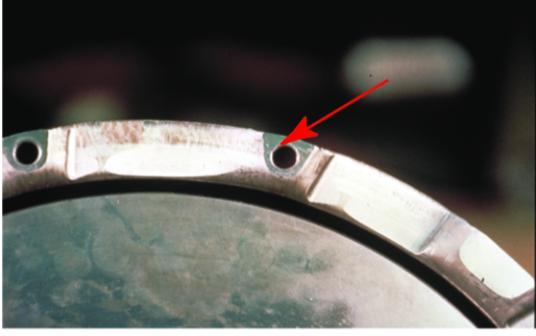
Fig 35 (SAS)

- **Note:** The cover assembly mounting hole pads (see arrow in Figure 35) have made an indentation (see arrow in Figure 36) onto the spacer ring mounting hole pads (flywheel side). This evidence will confirm that the spacer ring/intermediate plate assembly was indeed installed backwards. The words "Flywheel side" (refer to Figure 37) will face the flywheel when properly installed. Mishandling of this assembly during installation and/or removal can also cause the spacer ring to break. Some results of installing the intermediate plate backwards are as follows:
 - A clutch that will not release properly.
 - The release bearing position may be closer than normal to the transmission bearing retainer cap immediately upon clutch installation.
 - A "cracking" noise as you tighten the (8) mounting bolts that secure the cover to the flywheel.

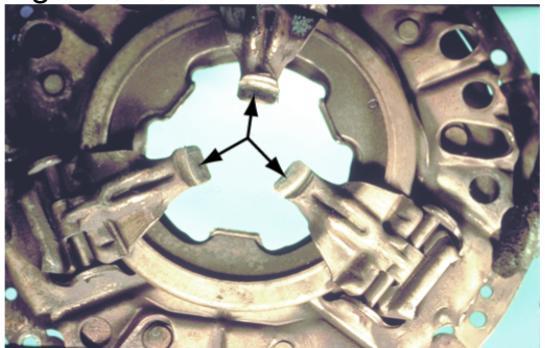
Fig 38 (AR)

As indicated by arrows in Figure 38, excessively worn levers are most likely the result of lack of maintenance. More specifically, lever wear can be the result of one or more of the following conditions:

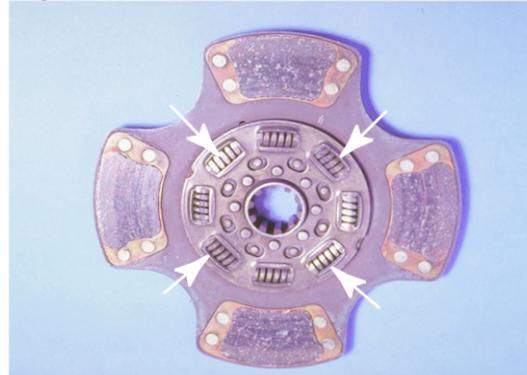
Fig 49 (EPP 14")

- The rivets of the disc (Figure 48) have been contacting the flywheel's mounting bolts. Some potential causes of this particular interference are as follows:
 - a. Loose flywheel mounting bolt(s) due to inadequate torquing.
 - b. Forgetting to tighten one or more or the mounting bolts when reinstalling the flywheel.
 - c. Installing an extra washer under the flywheel mounting bolt.
 - d. A flywheel which has been resurfaced too many times.
- The damper springs (see arrows, Figure 49 and 50) have been contacting the flywheel mounting bolts because the front driven disc was installed backwards. The driven disc (in Figure 49) had been wearing for a period of time before the interference occurred (as indicated by the full wear pattern on the ceramic buttons) while the one in Figure 50 was run for a very short period.

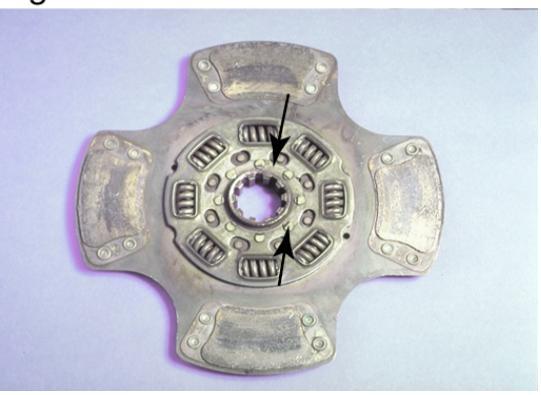
• A disintegrating pilot bearing which is interfering with both the hub and rivets of the driven disc (Figure 51).

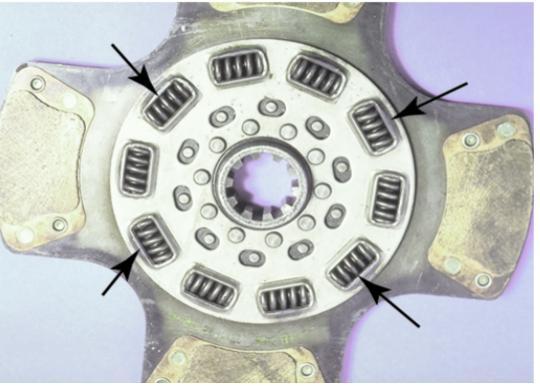
- Installation of the wrong clutch. Figure 52 (see arrows) shows the points of interference that resulted when a 10-spring driven disc was installed where an 8-spring was previously being run. In other words, the recessed area of the flywheel (mounting bolt cavity) was too small for the 10-spring driven disc. Before you mount the new clutch, consult the Eaton Installation Instructions (packaged with each Eaton Fuller Clutch) concerning "potential damper interference". A driver complaint, resulting from the above failure, can be:
 - a. The clutch does not release
 - b. The clutch is noisy during operation

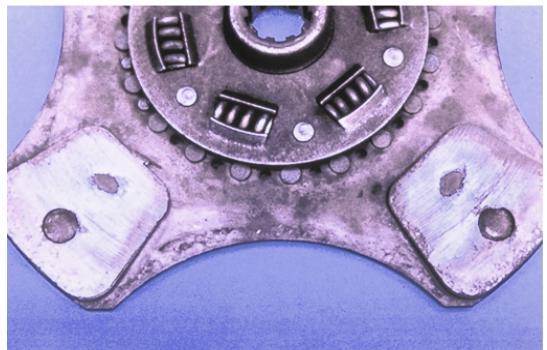
Fig 53 Ceramic Disc

The failures shown in Figures 53-56 and 58 are the result of excessive heat due to prolonged slippage. Figures 53, 54, and 58 show discs that became so hot (due to slippage) that the ceramic material began to flow and eventually separate from the disc. Figures 55 and 56 show how the organic material separates from the disc due to bonding agent failure as a result of extreme heat. Burnt discs may result from:

- Lack of free pedal
- Constantly riding the clutch pedal
- Utilizing a slipping clutch as a brake on an incline
- Partial unloading of a clutch due to a binding linkage system, interference, etc.
- Installation and use of improper clutch (wrong application)
- Worn driven disc facings

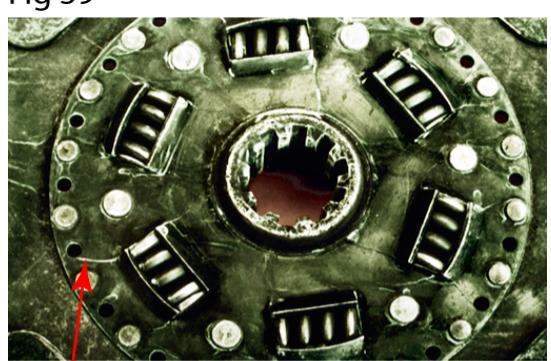
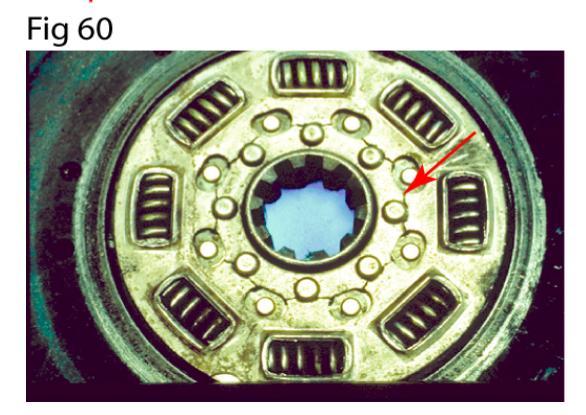
The cracks shown in Figures 59 and 60 (see arrows) can result from:

- Forcing the transmission input shaft into the disc hub during installation
- Allowing the transmission to hang unsupported in the driven disc(s) during installation
- Misalignment between the engine housing and the transmission bell housing

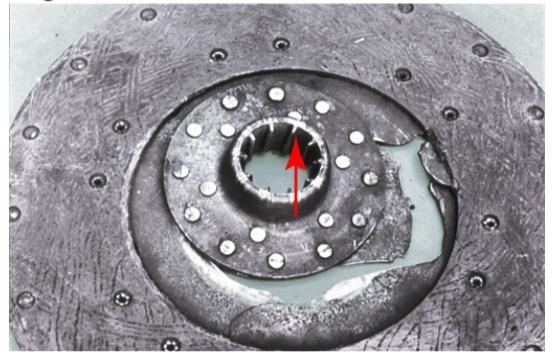
Fig 61

Figure 61 shows a disc hub that has worn excessively (see arrow) and has also broken away from the disc. Note the narrow width of each spline compared with those on a new disc. Figure 62 reveals a hub in which the splines have been completely "pounded" out (see arrow.) The typical cause of worn splines is either torsional vibrations or misapplication of the clutch. A broken or cracked disc hub can be attributed to one or more of the following:

- A severe shock load, such as engaging the clutch while coasting down a hill.
- Misalignment between the transmission bell housing and engine housing due to loose transmission mounting bolts and/or worn mating faces of either housing.
- Misapplication—a rigid disc should not have been used, but rather a dampened disc assembly (D.D.A.).
- Torsional vibrations from the engine.
- Excessive flywheel runout.
- Allowing the transmission to hang unsupported in the driven disc during installation.

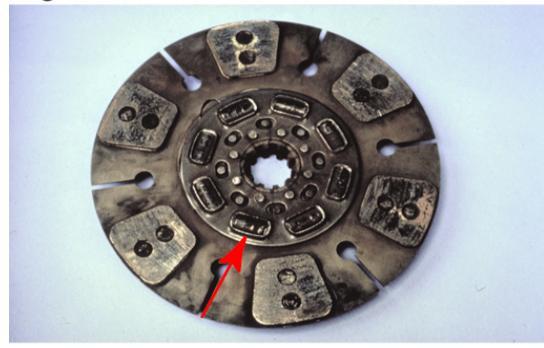
Fig 63

Figure 63 is the disc of a non-Eaton rebuilt clutch. It is an old disc that was rebuilt, as indicated by the presence of dampener springs encased in rubber (see arrow). Consequently, the rubber covered springs can make the disc act as a rigid disc, thus increasing wear to the input shaft and the disc itself. As shown by an arrow in Figure 64, parts of this disc have broken. Also, the springs are wrapped in rubber to prevent any worn ones from falling out after the disc is put into service. Contrast this with the Eaton Fuller Reman Clutches in which only new discs are used.

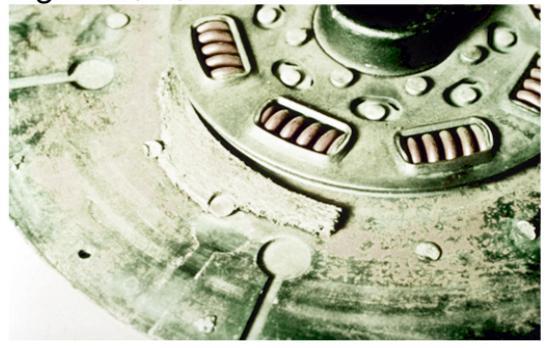
Fig 67 (AS)

Example: Coasting a tractor down an unloading ramp can burst a driven disc. See Figures 67, 68, and 69.

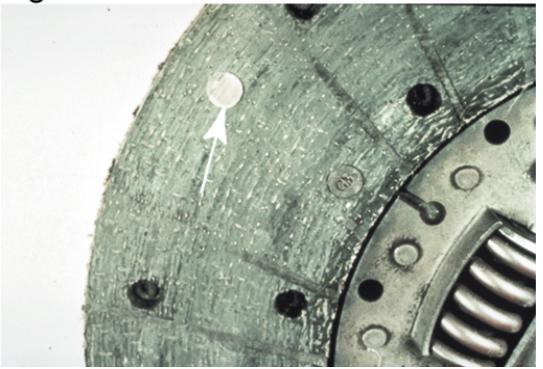
Fig 70

When the rivets (those which secure the facing material to the driven disc) begin to contact either the pressure plate, intermediate plate, or flywheel, then the entire clutch assembly is ready for replacement. Referring to the arrow in Figure 70, this rivet has been making contact with the pressure plate shown in Figure 17. Note the "shiny" appearance of the rivet and also the resulting "groove" on the pressure plate.

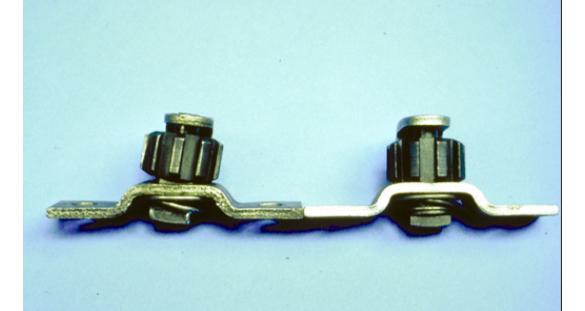
Fig 71

Referring to Figure 71, the kwik-adjust mechanism at the right is a normal and properly functioning adjuster while the one at the left has been damaged, as evidenced by the bent mounting bracket. The one pictured in Figure 72 also has a bent mounting bracket in addition to some broken gear teeth (see arrow). Some causes of these failures can be:

- Forgetting to depress the kwik adjuster while attempting to rotate the gear.
- Only partially depressing the mechanism while attempting to rotate the gear.
- Attempting to rotate the gear while the clutch pedal is in the up position (clutch is not released).

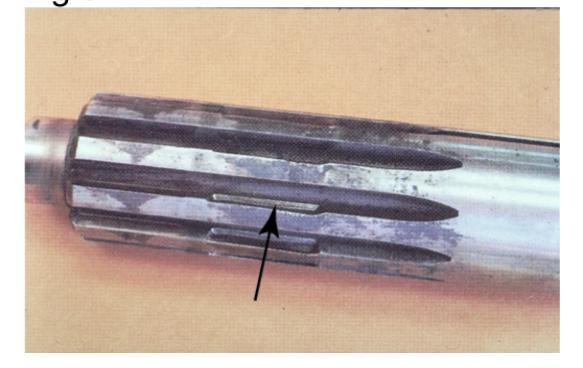
Fig 84

Drive gear spline wear will cause clutch release problems since the driven discs cannot slide freely on the splines. This is especially true if new driven discs are installed on a worn input shaft (Figure 84). Excessive spline wear can be attributed to torsional vibrations. This type of wear can be eliminated or lessened by the use of dampened driven discs. Spline wear will also occur on the mating driven disc hubs (see Figures 61-62). Misalignment can also be a factor in abnormal spline wear. It is important to always inspect the input shaft for wear before installing a new clutch. If worn, it is recommended that a new input shaft be installed to eliminate possible clutch problems later on.

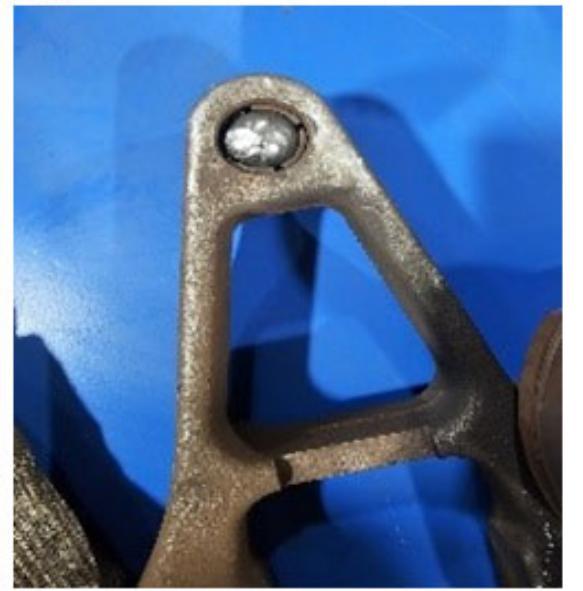
Fig 87

• Pivot pin fractures (Fig 87 & 88) occur when there is excessive wear or force on the pivot pin causing it to break.

• Pivot pin fractures will result in the release yoke not functioning correctly and will not allow for engagement and/or disengagement.

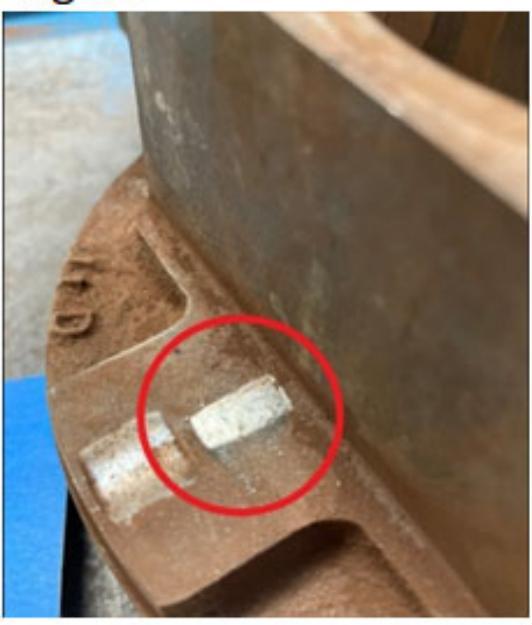
Fig 89

• Roller wear occurs when the release yoke casting contacts the release bearing casting and causes a secondary divot on the release bearing. (Fig 89)

- When the rollers of the release yoke wear into the release bearing wear pad, the rollers create a divot. When this divot reaches a depth of 0.5mm or greater, the casting of the release yoke will contact the release bearing, causing a secondary divot. Figure 89 shows the secondary divot. Figure 90 shows the wear on the release yoke casting.
- A yoke pivot pin failure will cause the release yoke assembly casting to wear secondary divots.

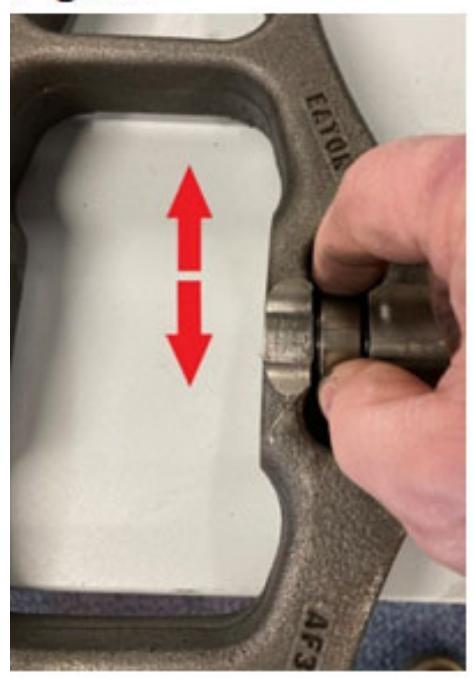
Fig 91

- Visually inspect release yoke roller bushings for any signs of damage or wear. Attempt to move the rollers in the fore and aft direction (Fig 91). Also, attempt to move the rollers in the up and down direction (Fig 92).
- If any detectable movement is observed in the fore and aft or up and down direction, proceed to replacement of the release yoke, release bearing and pivot pin.

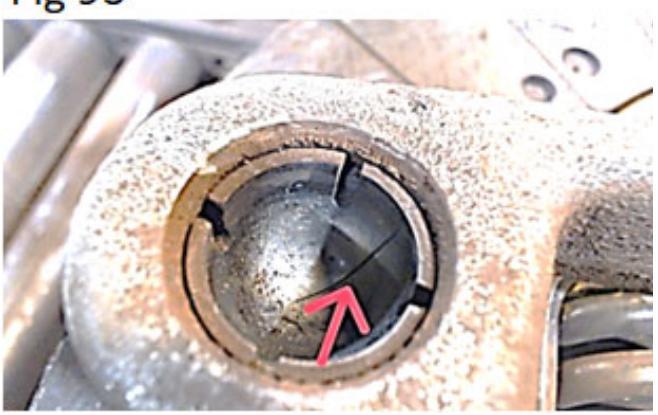
Fig 93

- When the plastic sockets on the release yoke assembly are cracked, broken, or exhibit any form of damage, it is necessary to replace both the release yoke assembly and the pivot pin.
- Figure 93 depicts a plastic socket that is cracked. Figure 94 illustrates a broken plastic socket and an indentation on the release yoke assembly resulting from a pivot pin fracture.

• The plastic sockets will become damaged because of a pivot pin fracture.

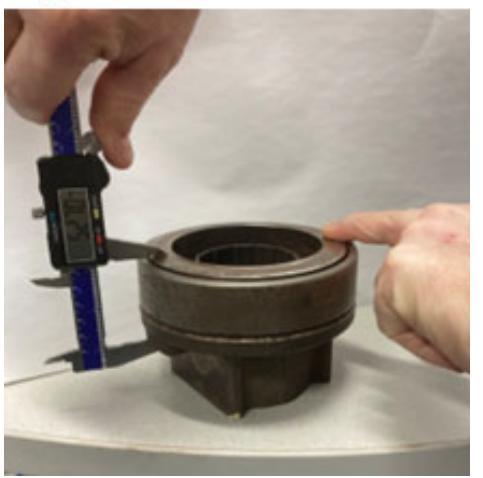
Failure - Release Bearing Seized (Fault Code 706 FMI 17, 18)

• A release bearing seized failure (Fig 95) occurs when the release bearing is no longer able to spin freely, resulting in damage to the diaphragm spring fingers. (Fig 96)

- A seized release bearing will occur when the release bearings internal lubricant evaporates, preventing the ball bearing from moving.
- Release yoke assembly failure which leads to excessive pressure on the release bearing and causes premature bearing failure.

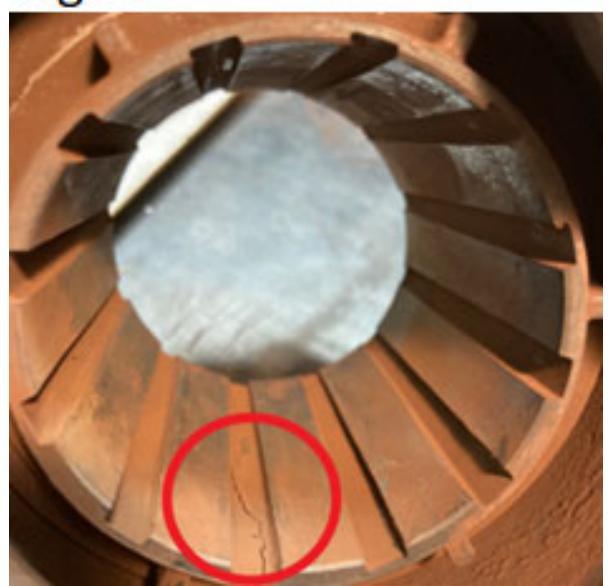
Fig 98

Failure - Release Bearing Inner Sleeve Cracked/Broken

• When the plastic inner sleeve of the release bearing exhibits a crack (Fig 98) or is completely broken off, the release bearing should be replaced.

- A seized release bearing generates excessive heat, melting the inner sleeve and causing the inner sleeve to dislodge from the bearing.
- Dropping or mishandling the release bearing can result in a cracked inner sleeve.

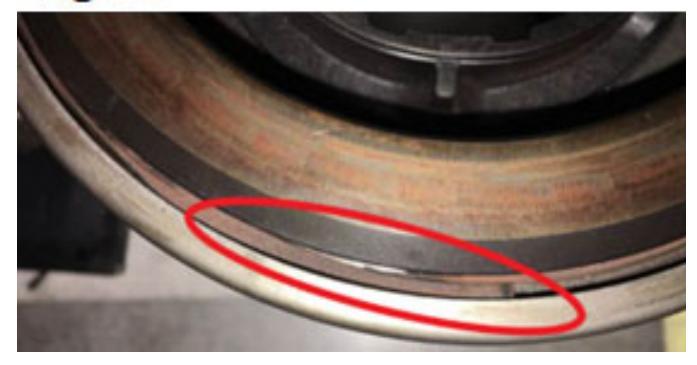
Failure - Inner Wave Spring Failure

• When the inner wave spring of the release bearing fails, the inner wave spring will protrude out of the face of the bearing (Fig 99). A release bearing with this failure should be replaced.

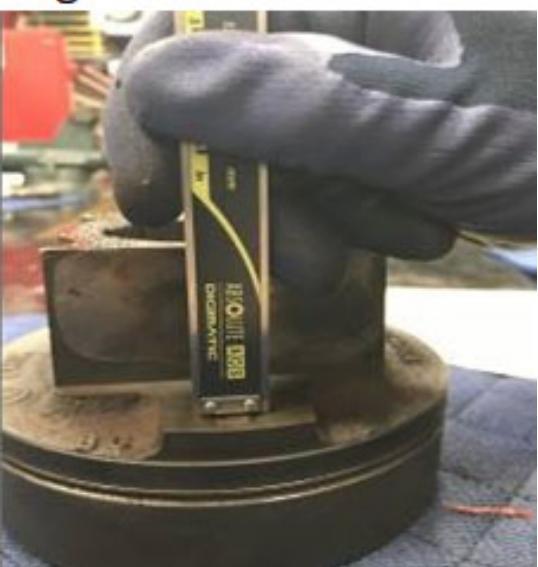
Failure - Release Bearing Wear Pad "Divot" (Fault Code 706 FMI 17, 18)

• When the wear and/or "divot" measurement exceeds 0.5mm in depth, replace the release bearing assembly. To measure "divot" wear, use a proper caliper as illustrated in figure 101.

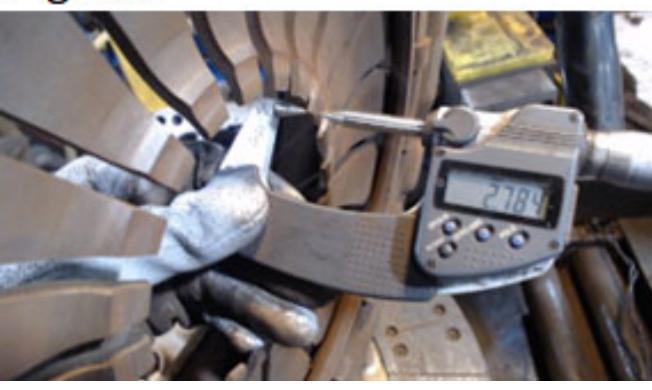
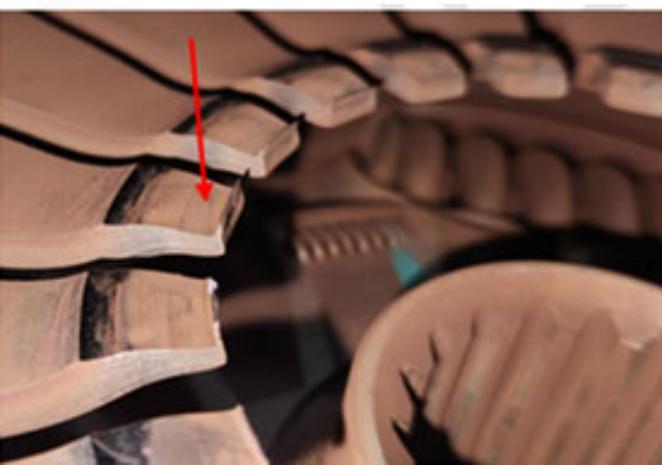
Failure - Diaphragm Spring Finger Wear from Release Bearing (Fault Code 706 FMI 17, 18)

- To assess wear on the clutch diaphragm spring fingers, use a digital pointed-tip micrometer to measure their thicknesses. If A diaphragm spring finger thickness is less than 3mm, replace the clutch. Take pictures of the measurements for documentation, as shown in Fig 102.
- If ALL clutch diaphragm finger thicknesses are 3mm or greater, the clutch can be reused.
- If the clutch diaphragm spring finger has a "hook" feature, take finger measurements as indicated in Fig 103.

Note: DO NOT measure hook height, measure behind the hook as Fig 103 shown.

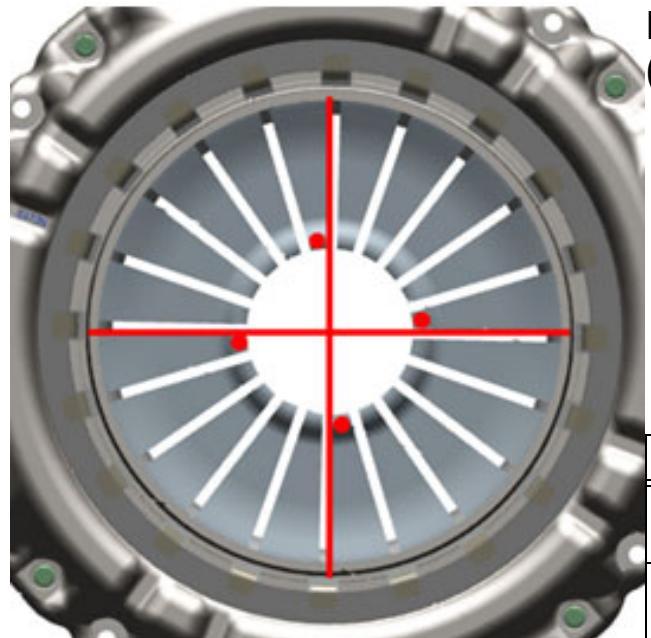
Fig 104

Failure - Clutch Finger Height Out of Spec (Fault Code 706 FMI 17, 18)

• While the clutch is mounted to the flywheel, use digital vernier calipers, measure the heights of the clutch diaphragm spring fingers at minimum in the 4 positions indicated in Fig 104. Take pictures of measurements. Reference TRSM0950 - Clutch Section. If A diaphragm spring finger does NOT meet the height measurement criteria in the table below, record and take a picture of the measurement, replace the clutch.

Clutch Condition	Finger Height
New Install	17mm-21mm (0.669-0.827in)
Less than 100,000mi / 160,934km	Maximum 22mm (0.866in)
Greater than 100,000mi / 160.934km	Maximum 24mm (0.944in)

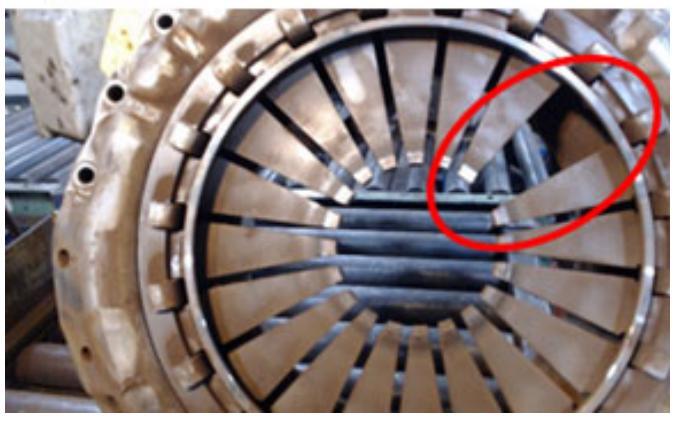
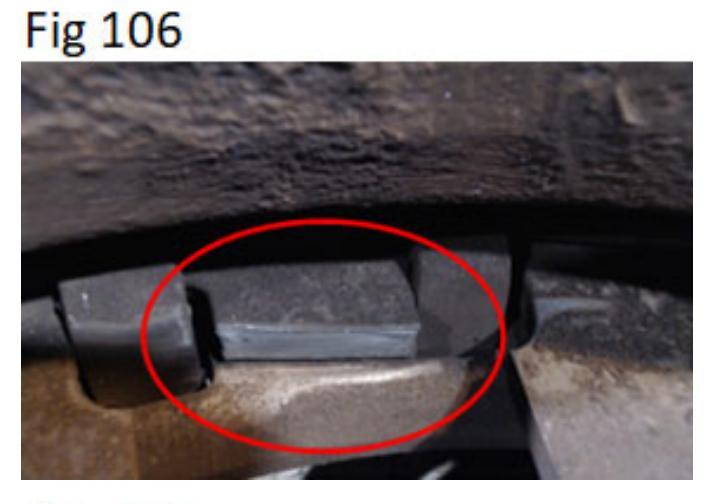
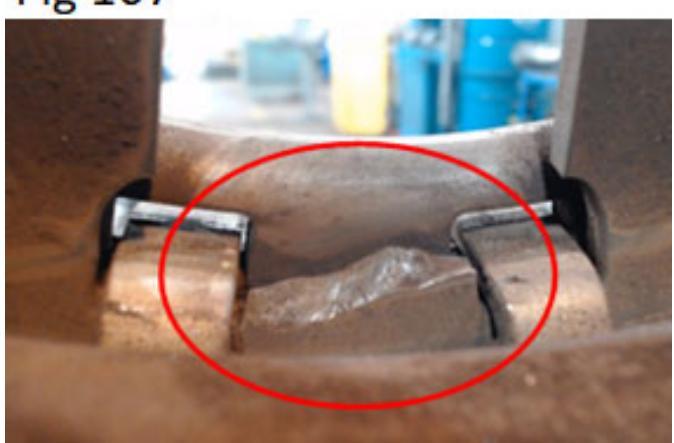
Fig 105

Failure - Broken Diaphragm Spring Finger (Fault Code 570 FMI 7, 10)

A diaphragm spring finger will break (Fig 105) due to one of two primary causes:

- Micro-crack development: A micro-crack CAN form within the diaphragm spring finger material. Over time, repeated clutch actuations exert force on the fingers, causing the finger with the micro-crack to break. This results in a straight break, as depicted in Fig 106.
- Abnormal wear: One side of the clutch diaphragm spring finger exhibits abnormal wear; the release bearing catches on the worn finger and rips it out. This results in a diagonal break, as shown in Fig 107. This type of break is indicative of a release bearing issue.

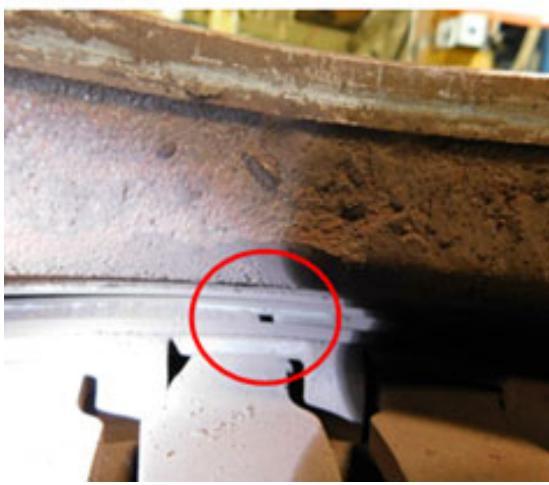
Failure - Diaphragm Spring Broken Radially (Fault Code 570 FMI 7, 10)

- Fig 108 shows a diaphragm spring broken radially. This break is caused by the diaphragm spring getting mishandled during the manufacturing process. After the clutch is installed, the actuations of the clutch will lead to this break happening.
- This radial break will cause engagement issues. The radial break causes the fingers to move independently as opposed to moving together during actuation. This independent movement is depicted in Fig 109.

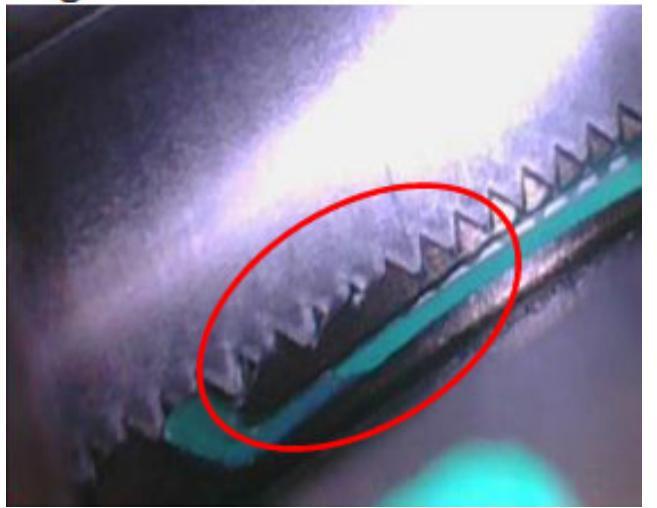
Failure - Anti-Back Drive Spring Teeth Worn/Sheared (Fault Code 250 FMI 9)

• As illustrated in Fig 110, this failure occurs when engine torque is applied to the clutch. The internal adjusting mechanism, consisting of the back drive-spring and cam baffle assembly, malfunctions due to an insufficient coefficient or friction resulting from excessive rust preventative. This leads to a mis-adjusted clutch.

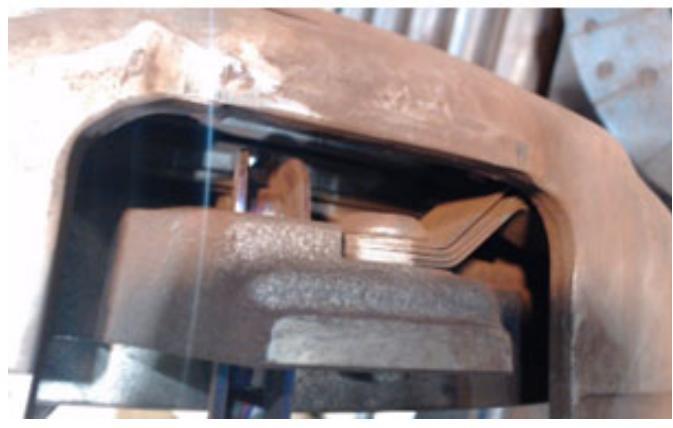
Failure - Drive Strap Bent

• As illustrated in Fig 111, this failure is caused by an engine failure or sudden reverse torque. When the drive straps become bent, this will cause engagement or disengagement issues.

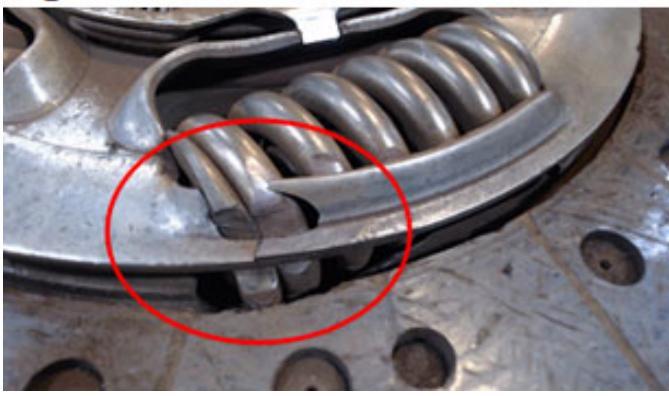
Failure - Spring Cover Cracked

• Fig 113 illustrates a cracked spring cover. The driven disc assembly experiences wear rates exceeding expectations on the spring cover. Wear from the springs cause the spring cover to crack.

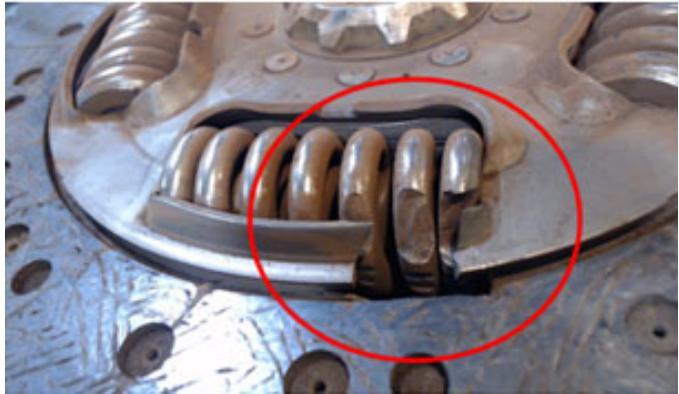
Failure - Spring Cover Broken

Similar to the cracked spring cover, the broken spring cover illustrated in Fig 114 occurs when the driven disc assembly experiences wear rates exceeding expectations. The spring cover will crack and, if left unnoticed, lead to a broken spring cover. There is potential for the springs to become dislodged from their seeded positions when this happens.

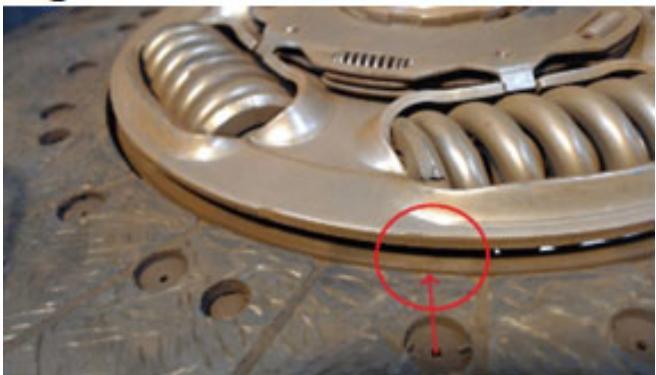
Fig 115

Failure - Cracked Stack Plate

• Elevated wear rates occur within the stack plate of the driven disc assembly. This wear includes cracking in the stack plate near the spring's edge, as illustrated in Fig 115.

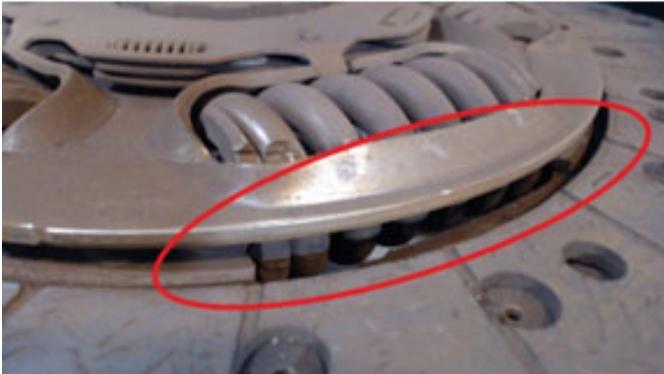
Fig 116

Failure - Broken Stack Plate

• Similar to the cracked stack plate, a broken stack plate, as illustrated in Fig 116, occurs when the driven disc assembly experiences wear rates exceeding expectations. The stack plate will crack and, when left unnoticed, leads to a broken stack plate.
