Display Firmware Upgrade Procedure

UPS model : Bladeups

Eaton® BladeUPS Display Firmware Upgrade

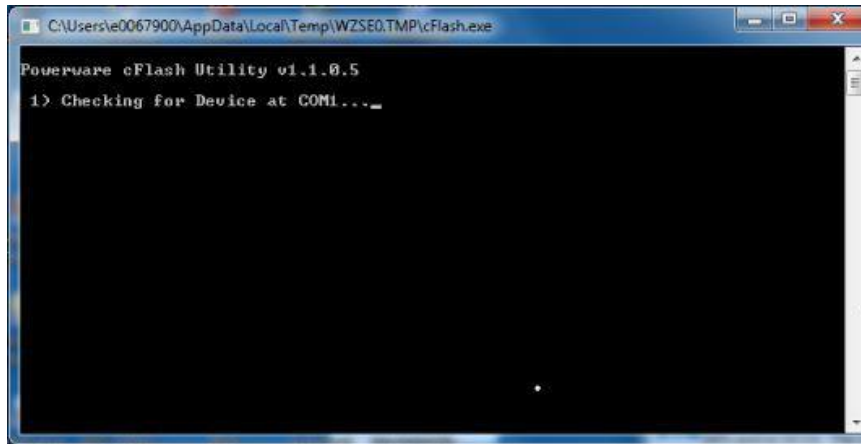
- The Firmware will begin to load automatically.

```
C:\Users\ve0067900\AppData\Local\Temp\WZSE0.TMP\cFlash.exe
Powerware cFlash Utility v1.1.0.5
1) Checking for Device at COM1...
```

```
C:\Users\E0067900\AppData\Local\Temp\WZSE0.TMP\cFlash.exe
Powerware cFlash Utility v1.1.0.5
1) Checking for Device at COM1...Success!
   XCP communications established on COM1, 19200 baud
2) Putting Device into Service Mode...Success!
3) Checking for Flash Capability...Success!
4) Reading ROM File...Success!
5) Starting Flash Data Programming...
   Programming Address: 007B9280
```

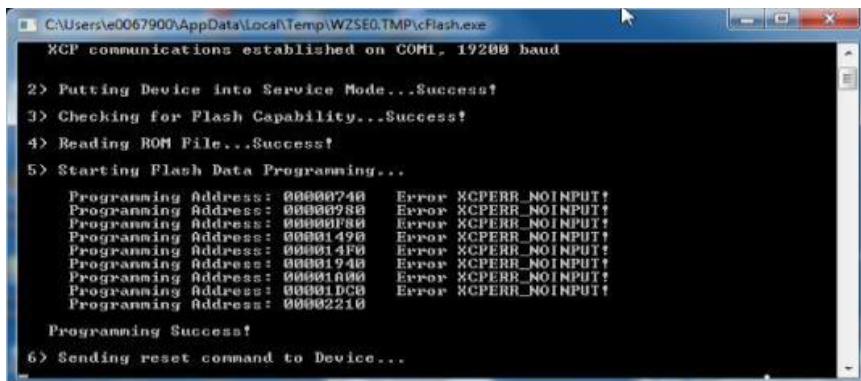
- When the firmware is done loading you will see the following screen:

```
C:\Users\ve0067900\AppData\Local\Temp\WZSE0.TMP\cFlash.exe
XCP communications established on COM1, 19200 baud
2) Putting Device into Service Mode...Success!
3) Checking for Flash Capability...Success!
4) Reading ROM File...Success!
5) Starting Flash Data Programming...
   Programming Address: 00000740 Error XCPERR_NOINPUT!
   Programming Address: 00000780 Error XCPERR_NOINPUT!
   Programming Address: 00000F60 Error XCPERR_NOINPUT!
   Programming Address: 00001490 Error XCPERR_NOINPUT!
   Programming Address: 000014F0 Error XCPERR_NOINPUT!
   Programming Address: 00001940 Error XCPERR_NOINPUT!
   Programming Address: 00001A00 Error XCPERR_NOINPUT!
   Programming Address: 00001DC0 Error XCPERR_NOINPUT!
   Programming Address: 00002210 Error XCPERR_NOINPUT!
   Programming Success!
6) Sending reset command to Device...
```

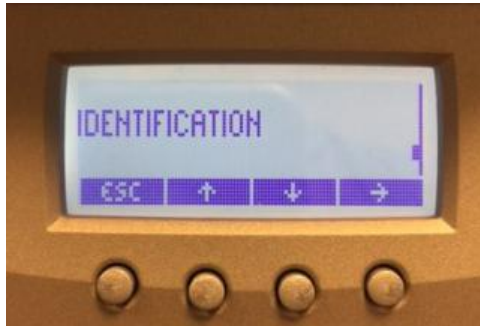
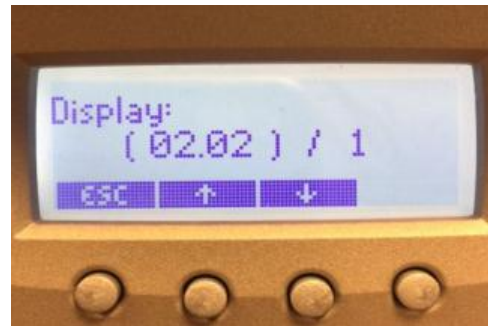
- When the upgrade is complete, (typically 1 to 2 minutes per UPS) the UPS will return back to the mode that it was in when the firmware update was started so either on internal bypass, or in a UPS off state. Upgrade the remaining modules by repeating steps 2 and 3. After All the Modules have been upgraded return the UPS to a load protected state.
- Verify flash was successful. On the UPS display panel, press the down arrow button until the display reads *Identification*. Press Enter and arrow down until the display firmware version. The display version should read (02.02) / 1.

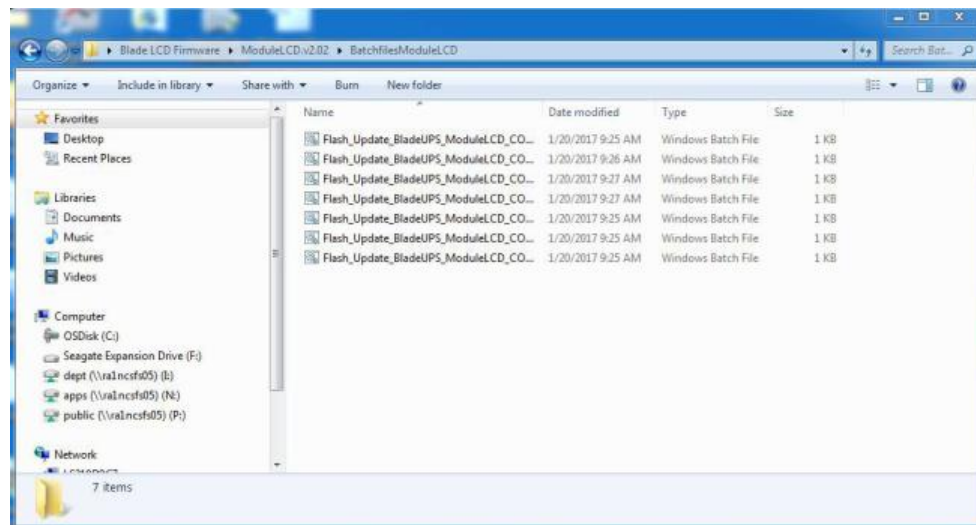
- Double click on the Batch files Module LCD folder. This will display all of the batch files for the different Com ports.

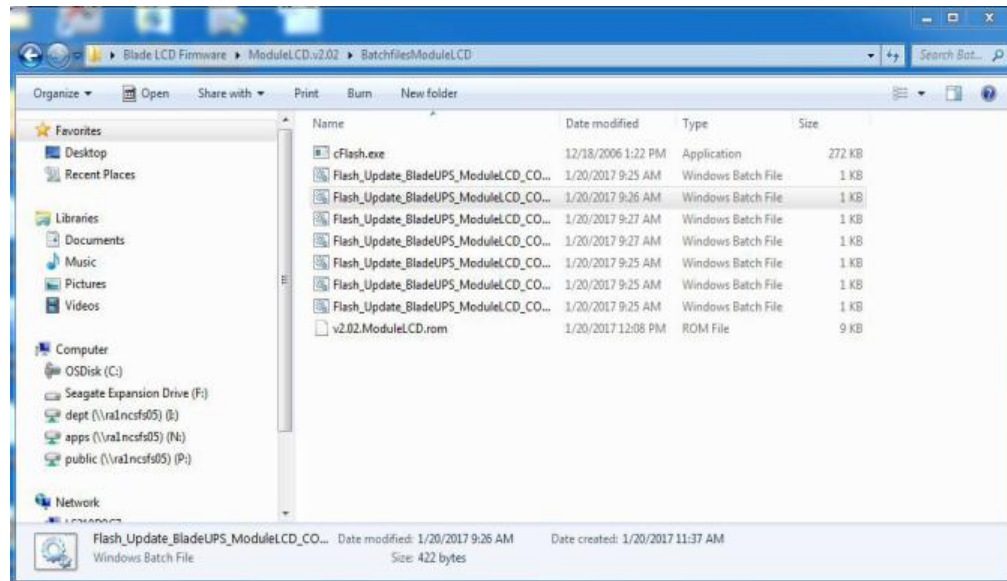
- Copy the .rom file and the CFlash file to the folder where the batch files are located. The folder should now look like this.

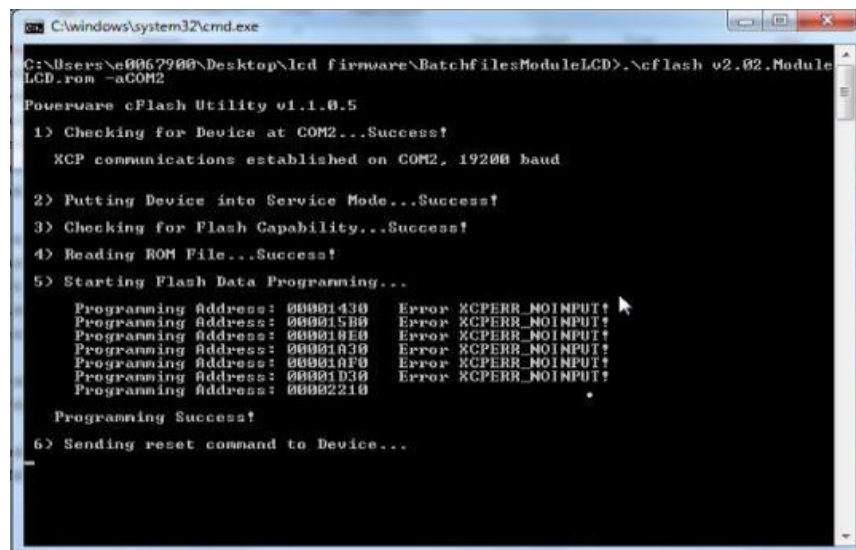
- Run the batch file from the window/run dialog or a command line to start the upgrade. You can also double click on the batch file with the corresponding com port you wish to use. If the flash process fails restart the upgrade by running the batch file again. The figure below represents the command window during the upgrade; after the upgrade is complete the window will close.

```
C:\windows\system32\cmd.exe
C:\Users\eb067908\Desktop\lcd_firmware\BatchfilesModuleLCD>.\cflash v2.02.ModuleLCD.rom -aCOM2
Powerware cFlash Utility v1.1.0.5
1) Checking for Device at COM2...Success!
   XCP communications established on COM2, 19200 baud

2) Putting Device into Service Mode...Success!
3) Checking for Flash Capability...Success!
4) Reading ROM File...Success!
5) Starting Flash Data Programming...
   Programming Address: 00001430 Error XCPERR_NOINPUT!
   Programming Address: 000015B0 Error XCPERR_NOINPUT!
   Programming Address: 000018E0 Error XCPERR_NOINPUT!
   Programming Address: 00001A30 Error XCPERR_NOINPUT!
   Programming Address: 00001AF0 Error XCPERR_NOINPUT!
   Programming Address: 00001D30 Error XCPERR_NOINPUT!
   Programming Address: 00002210
   Programming Success!
6) Sending reset command to Device...
```
