**PRODUCT NEWS BULLETIN**

PN154080906

**Product Improvement  
Hardened Wire Swivel Races**

Applicable to All Carter 61154, 64155 and 64254 Dry Break Swivel Quick Disconnects

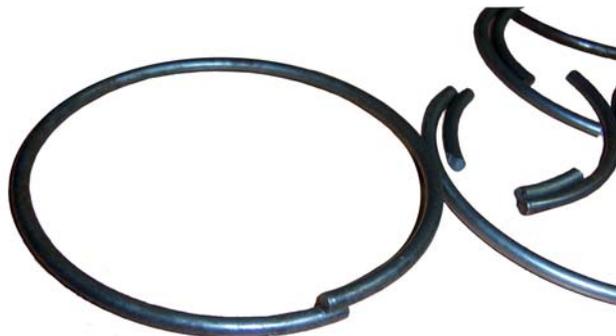
Hydrogen embrittlement makes the metal very brittle and will manifest itself in wire race rings that are fractured or broken, possibly in several different places. When the race rings are fractured the ball bearings that ride on them will no longer run smoothly, making the swivel difficult to rotate.

Knowing that many airports around the world are located by the sea, Carter has decided to change the material of these wire races to 17-7 pH corrosion resistant steel per AMS 5673 and hardened to C49 Rockwell. These new wire races will be passivated and, due to the high chrome and nickel contents of this high strength stainless steel, they will be less susceptible to hydrogen embrittlement.

*"Inspect the race rings (\*item xx, fig. xx) for wear or damage. Remove and measure the wire diameter in several places around its circumference. If the wire diameter is found to be less than .104 (2.64 mm) inches the ring should be replaced. Also inspect for cracks, which could result in breaks, by removing the rings from the Adapter. Removal of affected race rings is likely to result in breakage of the rings."*
