## Soap Maker Bubbling Over on Eaton Filters

Eaton's DCF-800  
Mechanically Cleaned Filter

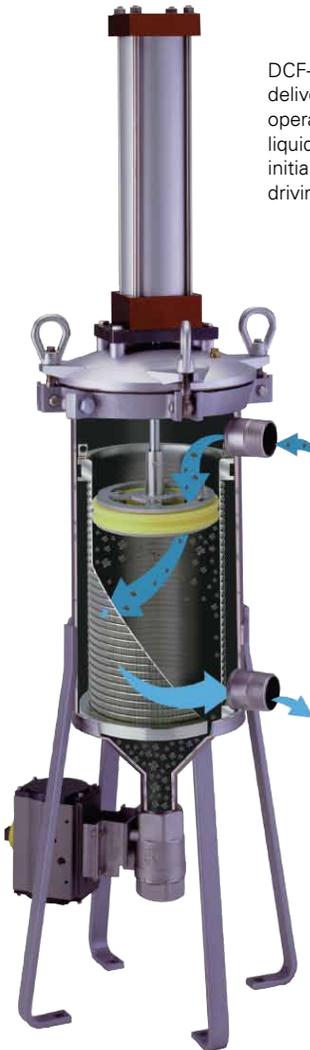
DCF-800 - One actuator delivers simple, reliable operation with water-like liquids. Ideal where a low initial investment is a key driving factor

Both perform a self-cleaning action by mechanically scraping collected debris from the filter screen with a disc that moves

up and down the screen, parallel to the liquid flow. Collected debris is then automatically purged from the collection chamber at the bottom of the filter.

This self-cleaning action is performed without halting production and provides the highest quality filtering under continuous demand. Because the screen is cleaned continuously, a consistently high flow rate is maintained.

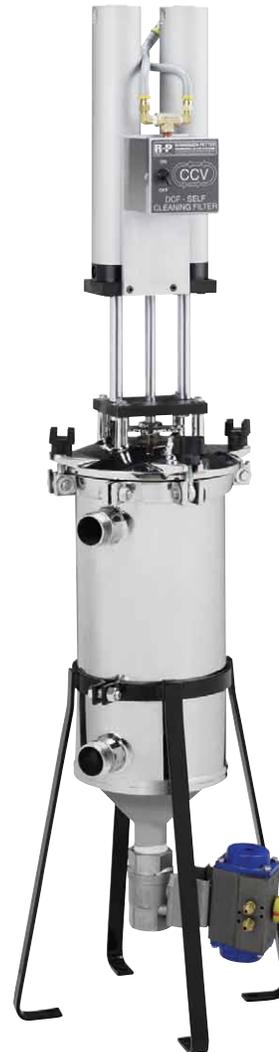
DCF-800 twin actuator model
